## HISTORIC RESOURCES INVENTORY - BUILDING AND STRUCTURES

Building Name (Common) Marble Valley Farm / Kent Land Trust Record No. 6888  
 Building Name (Historic) Carlson Farmstead  
 Street Address or Location 170 Kent Road South (US Route 7)  
 Town/City Kent Village \_\_\_\_\_ County Litchfield  
 Owner(s) The Kent Land Trust, Inc., P.O. Box 888, Kent CT 06757  Public  Private

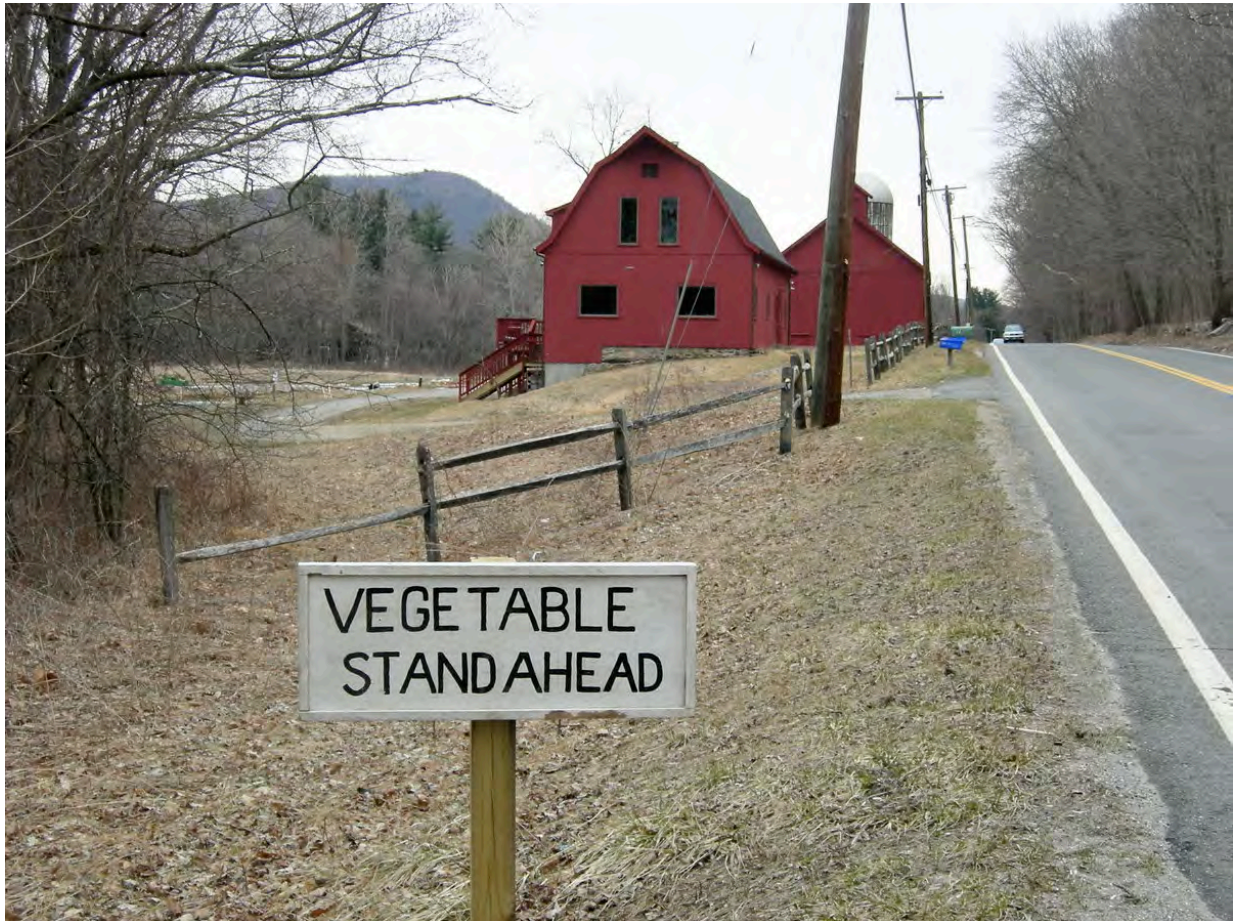
4. South view of South Barn with North Barn at rear, camera facing north.

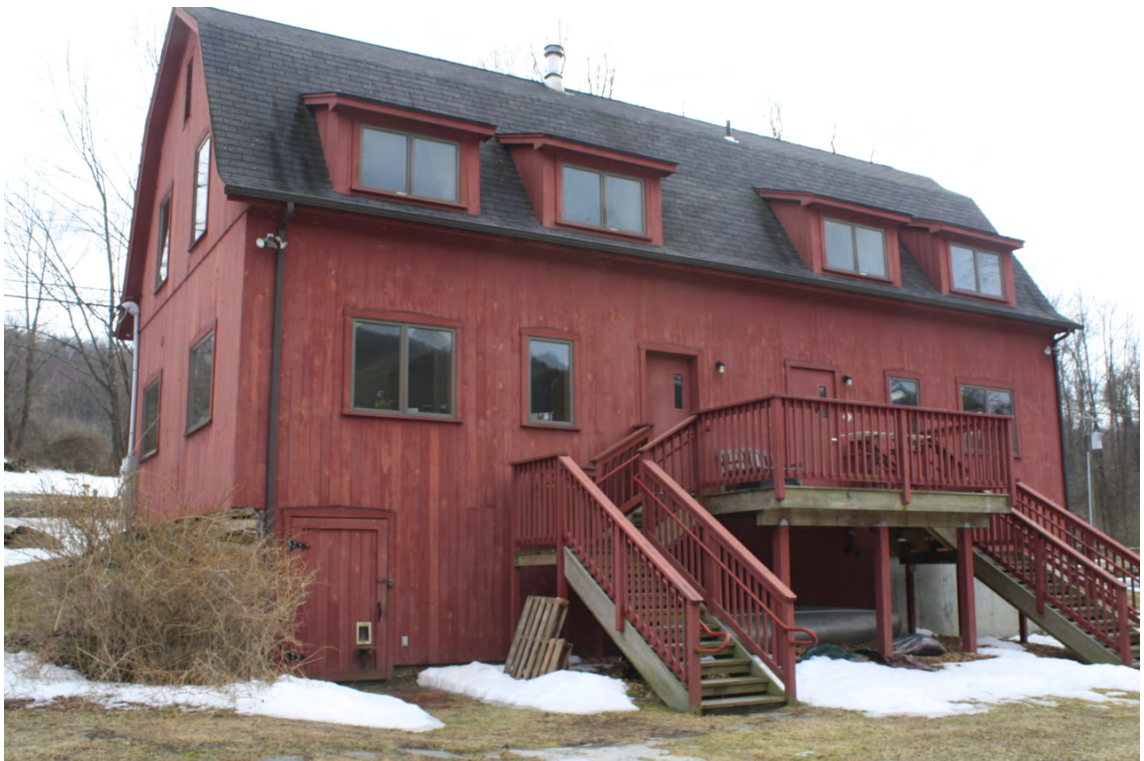
6. West view of South Barn, camera facing southeast, showing the alterations for the current uses as office space at the main level and an apartment above.

The South Barn office/residence is a 1 ½-story Dutch gambrel-roofed barn, approximately 27' x 49', with a banked basement level. Grade slopes down toward the west exposing the basement level. Mortared fieldstone foundations and some new concrete walls are visible on the north and south gable-ends. The main level and attic gable walls are vertical wood siding; a number of residential casement and picture windows are installed in the main level and attic gables. There is a porch and steps from an entry door in the west side, and another entry door in the east side off-center toward the right. Modern picture and casement windows have been installed, utilizing many of the opening locations in which windows had been inserted by the previous users.

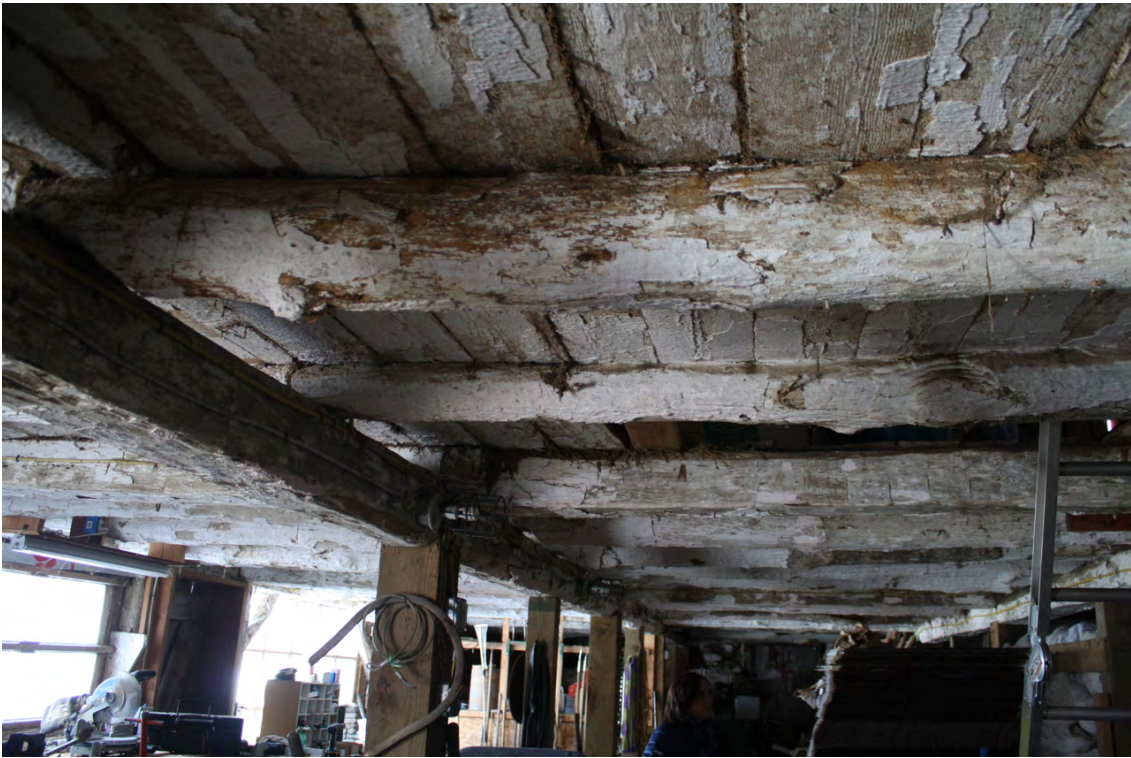
13. Interior view of North Barn basement level, camera facing north. Note hand hewn girders and joists.

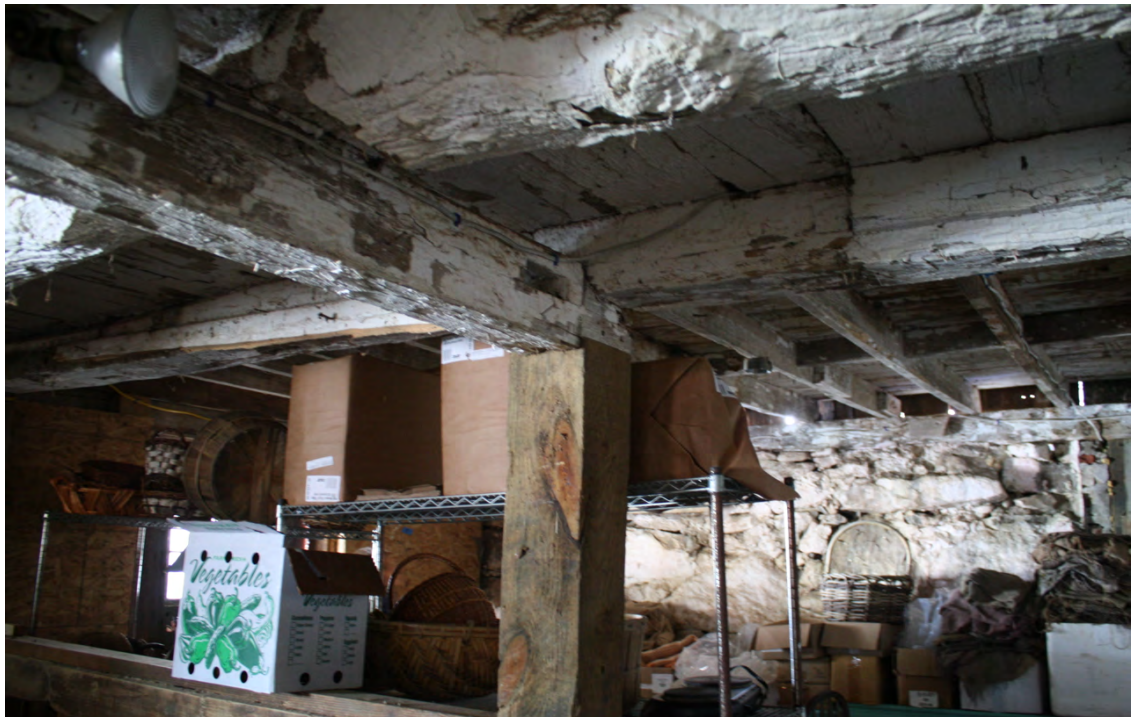
14. Interior view of North Barn basement level, camera facing north, showing the change in framing at the northern bay (right rear of photograph).

The northern bays, Bay 4 and Bay 5, appear to be of later construction. The plates in Bay 4 are jointed at the north face of the fourth bent, indicating that Bay 4 is an addition. The timbers forming Bays 4-5 are hand hewn but the rafters are sawn dimension lumber as is the floor framing below Bay 5, again indicating later construction. Bay 4 may be the first addition and Bay 5 a second addition, based on the floor framing, or both may have been concurrent, with later repairs of the roof and floor framing.

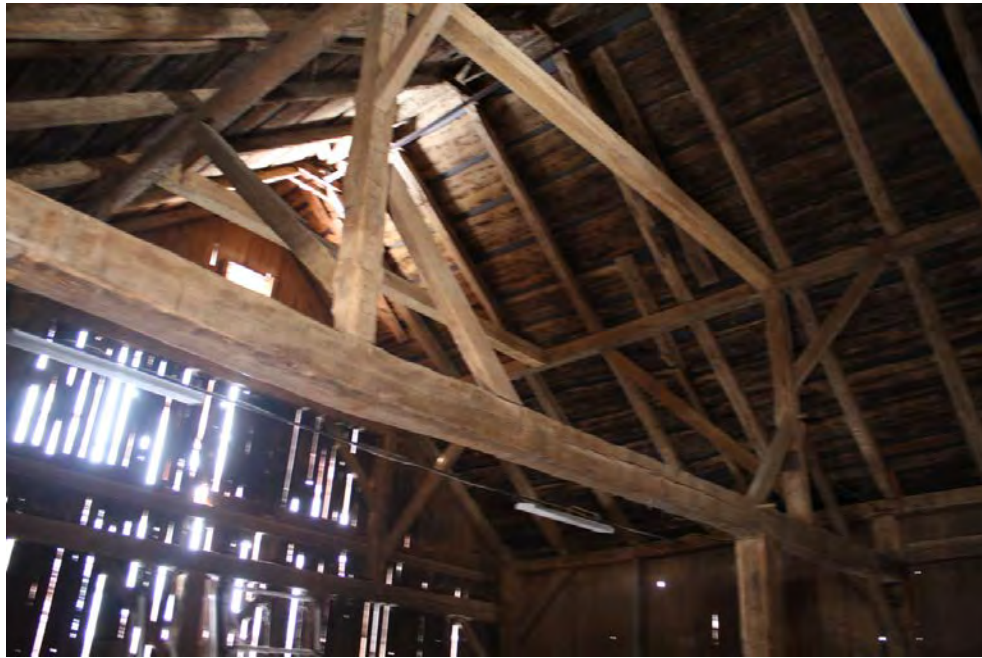
15. Interior view of North Barn main level, camera facing south, showing the framing at Bay 1. Note the hand hewn rafters along with other hewn timbers.

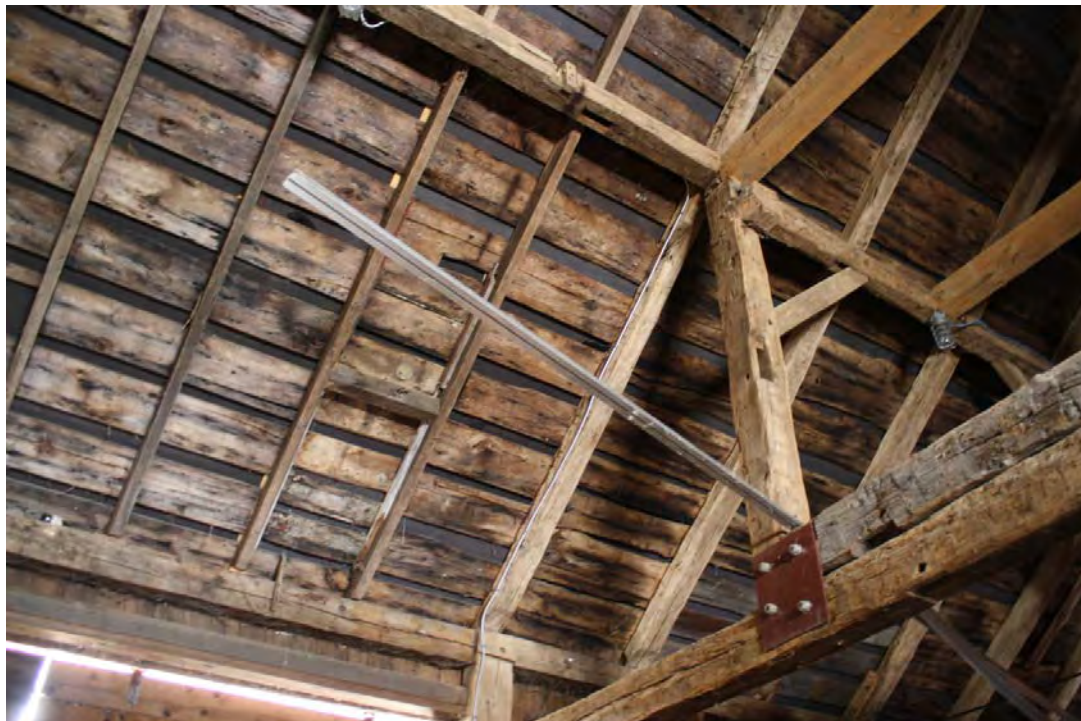
16. Interior view of North Barn main level, camera facing east, showing Bay 4. Note discontinuous plate and change from hewn rafters (right) to sawn dimension lumber (left).

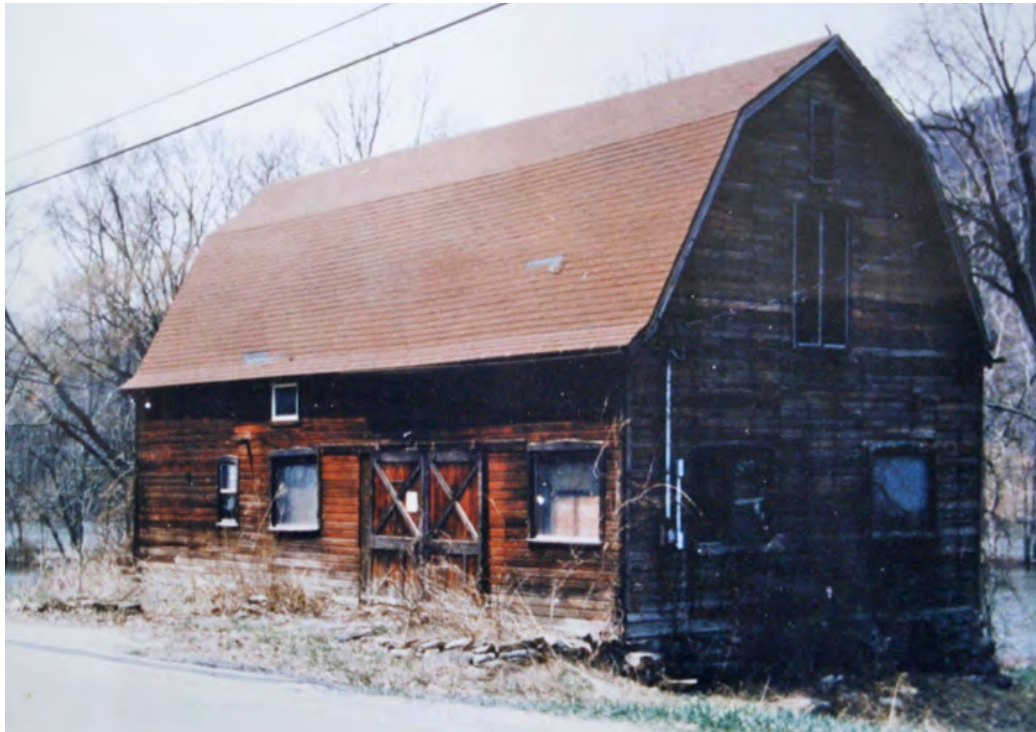
17. Photograph of South barn c. 1996 prior to renovation, camera facing southwest, courtesy of Kent Land Trust.

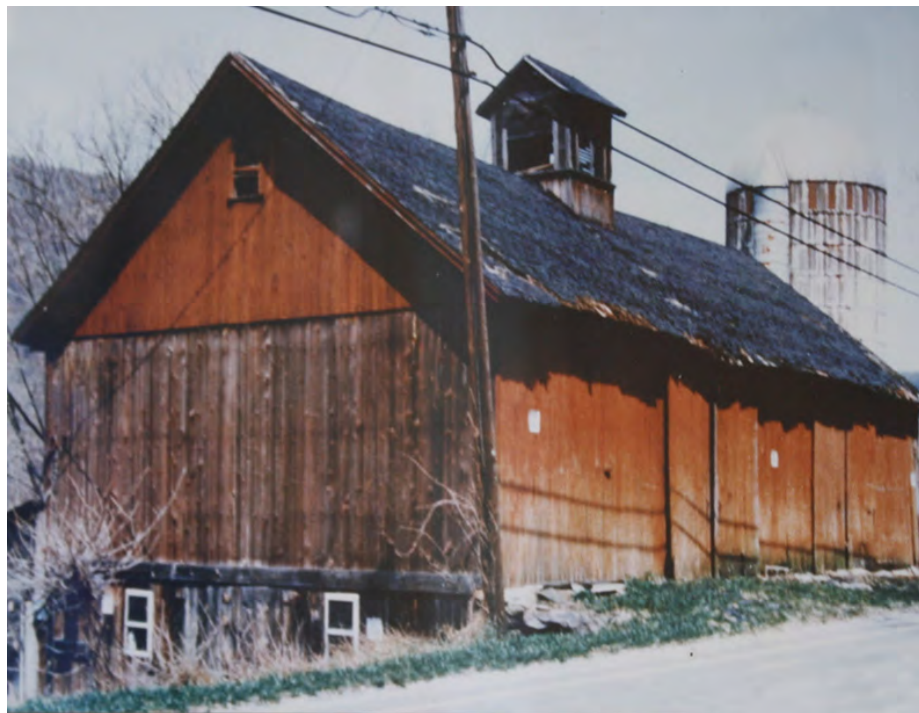
18. Photograph of North barn c. 1996 prior to renovation, camera facing northwest, courtesy of Kent Land Trust.

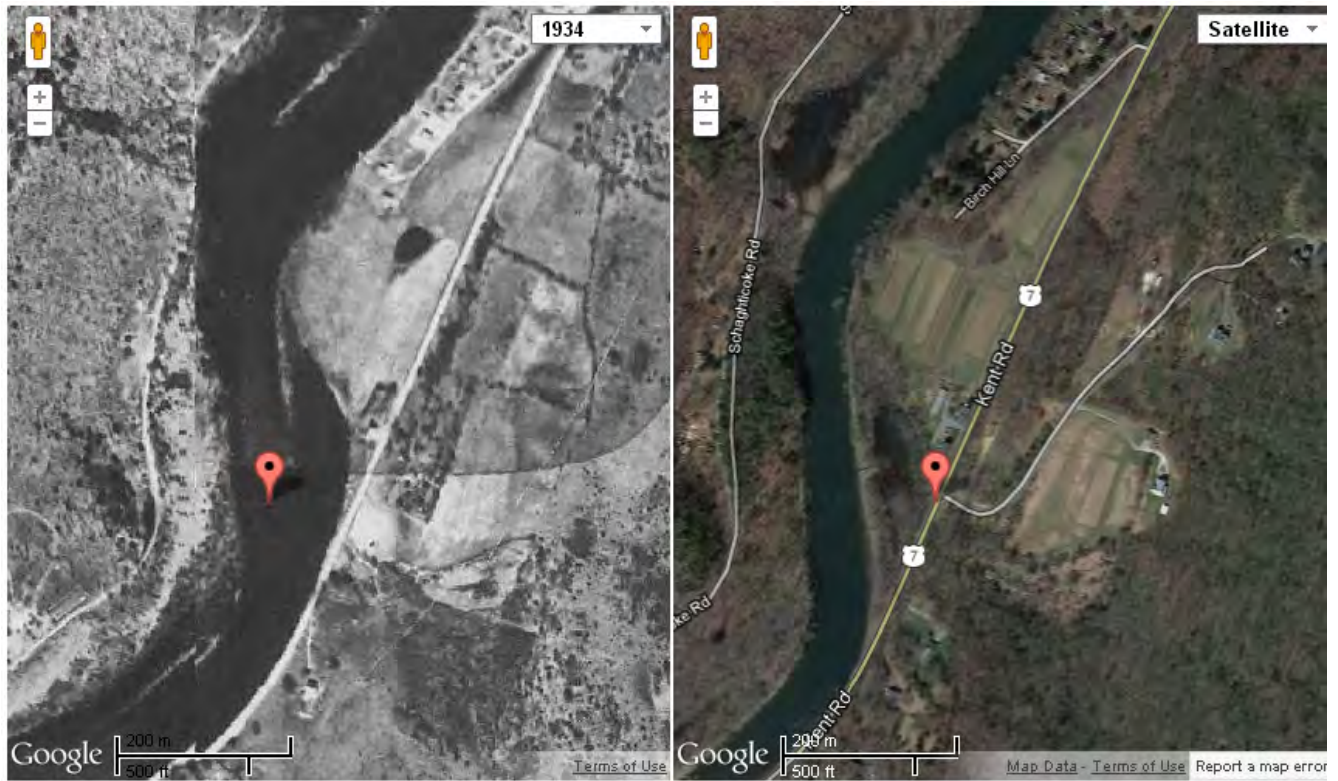
19. Fairchild 1934 aerial photograph at left, showing the site comparison with Google Map view at right; from UConn MAGIC web site, accessed 3/20/2013.

The gambrel form of the South Barn suggests an early 20<sup>th</sup>-century date, when the construction of gambrel roofs with dimension lumber truss-work became common; however the structure is no longer exposed to view on the interior so it was not observed. An aerial view from the 1934 Fairchild photograph shows that the river's course has narrowed and silted in, and although the resolution is grainy, it appears that there was only one barn at that time.
