HISTORIC RESOURCES INVENTORY - BUILDING AND STRUCTURES

Building Name (Common) Walker-Upham-Canavan House & Barn Record No. 7410
 Building Name (Historic) Walker, James and Isabell, Farmstead
 Street Address or Location 166 Woodstock Road
 Town/City Woodstock Village East Woodstock County Windham
 Owner(s) Deborah & Richard Canavan, 166 Woodstock Rd, Woodstock CT 06281 Public Private

Style of building Extended English bank barn, Vernacular style Date of Construction 18th c.

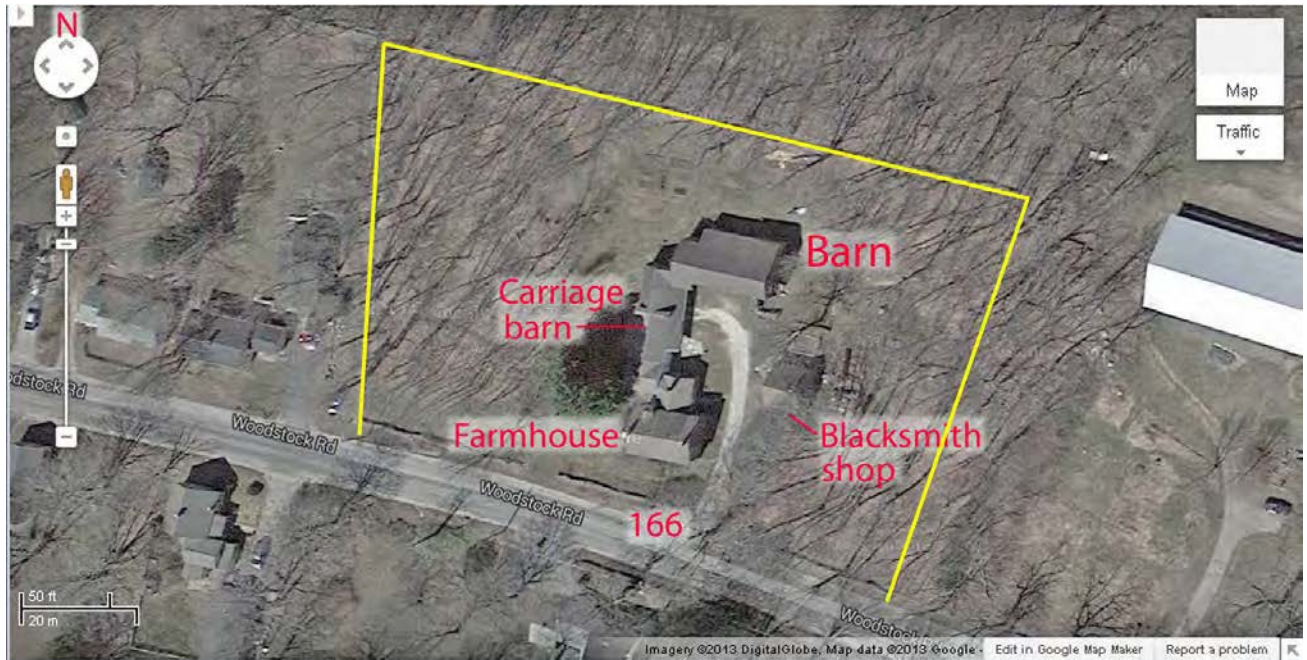
4. Detail Site Plan Sketch showing contributing resources – base image from <http://maps.google.com/>.

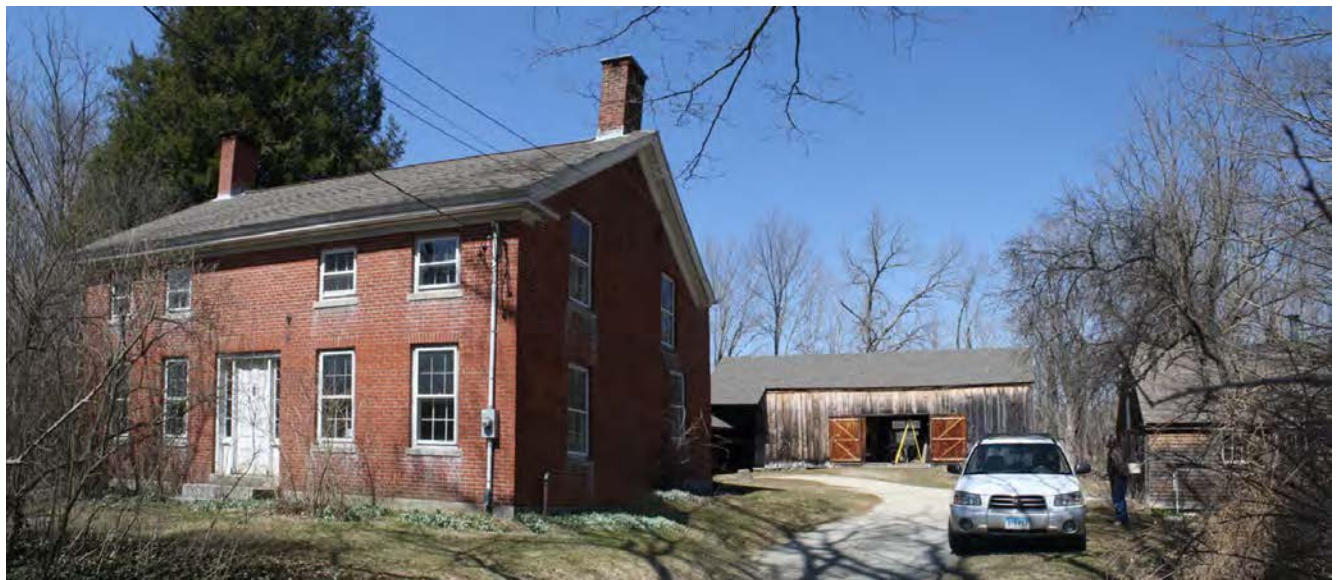
5. South context view of 166 Woodstock Road, Woodstock CT, camera facing north; from left to right are the Farmhouse, Barn, and Blacksmith shop.

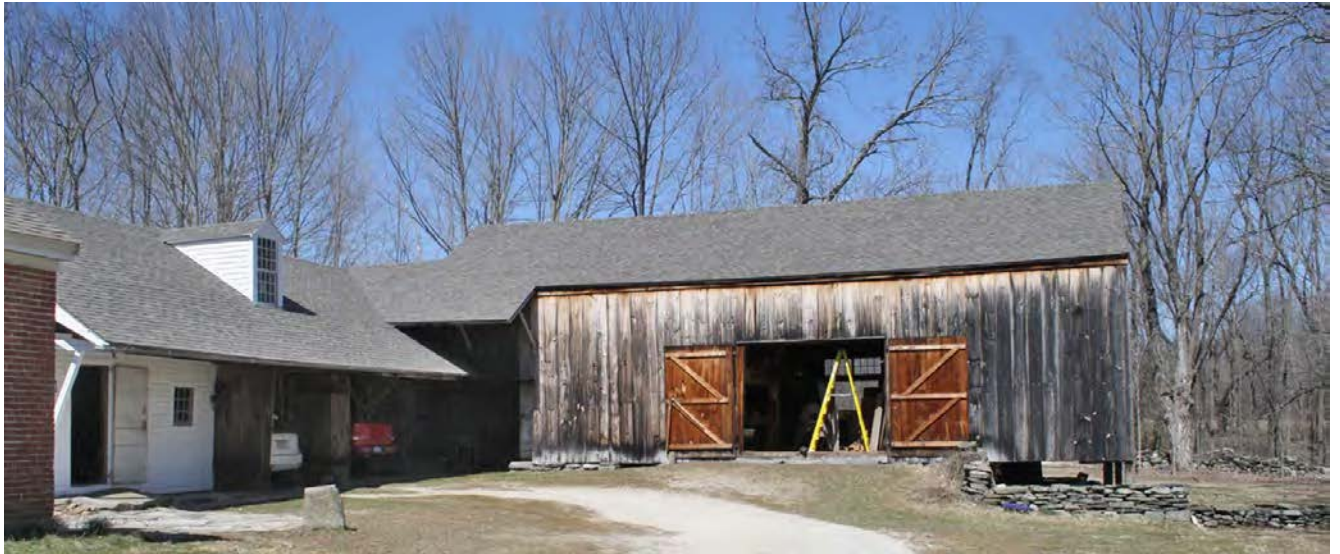
10. Southeast view of Carriage barn and main Barn, camera facing north.

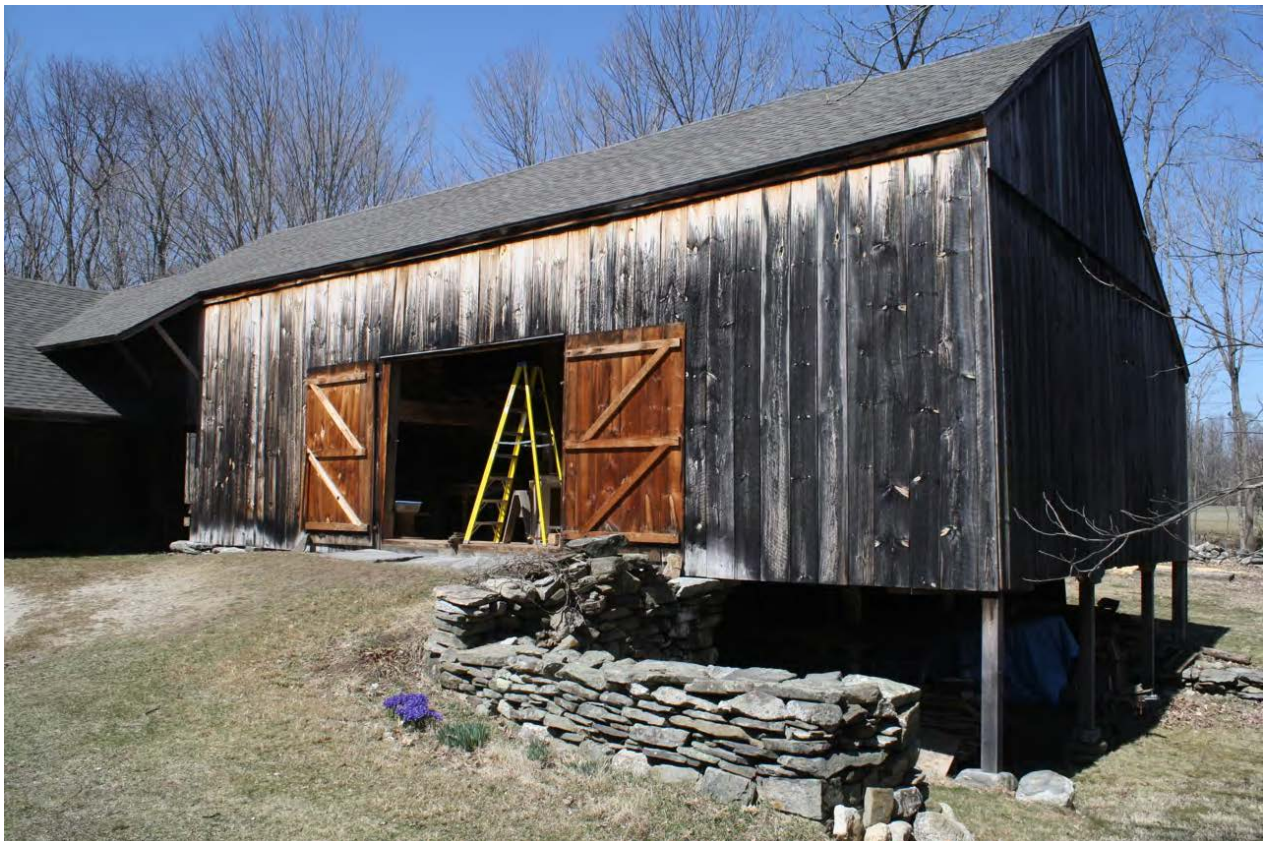
11. Southeast view of Barn, camera facing northwest.

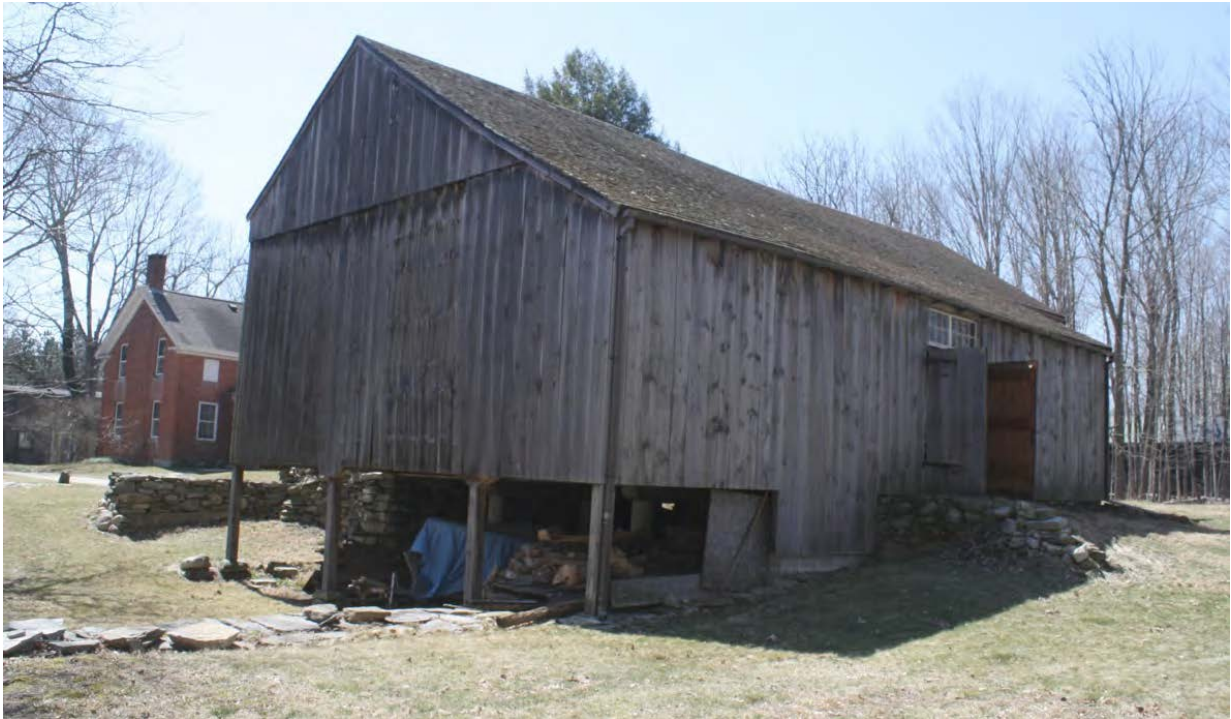
12. Northeast view of Barn showing open banked basement and saltbox-roofed shed addition, camera facing southwest. Farmhouse is at left rear.

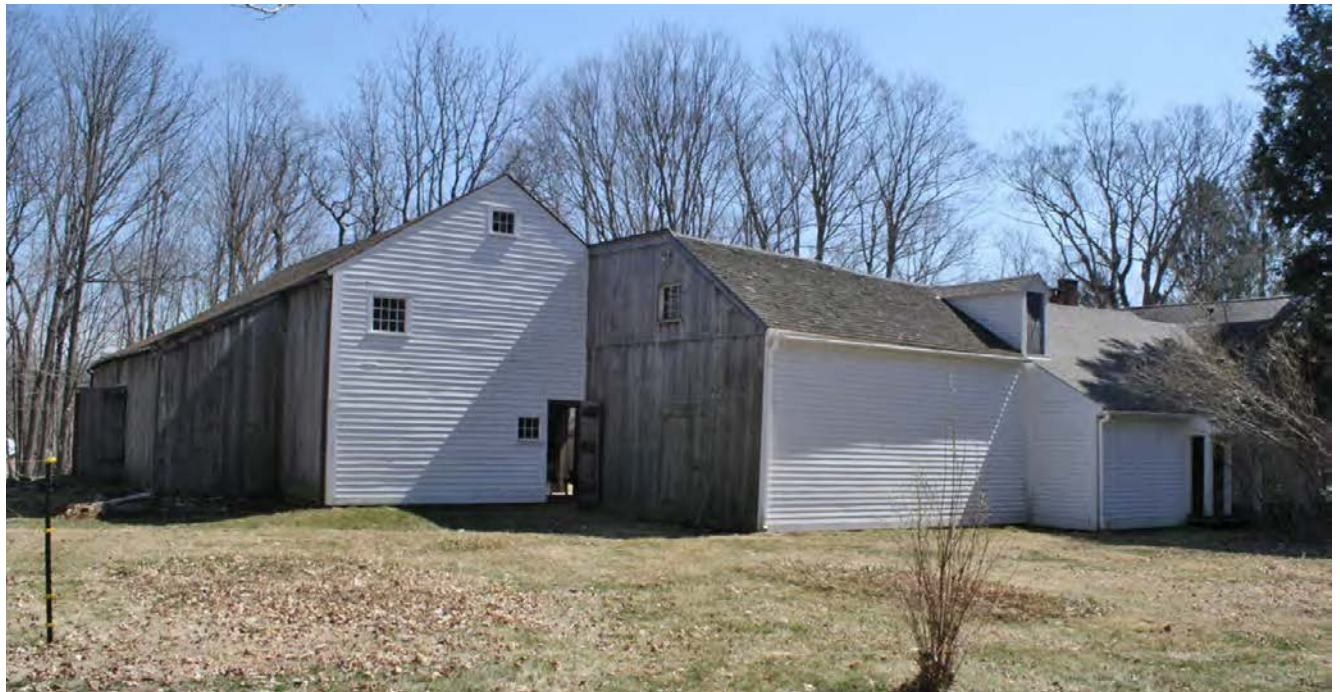
13. Northwest view of Barn with west side of Carriage barn at right, camera facing southeast.

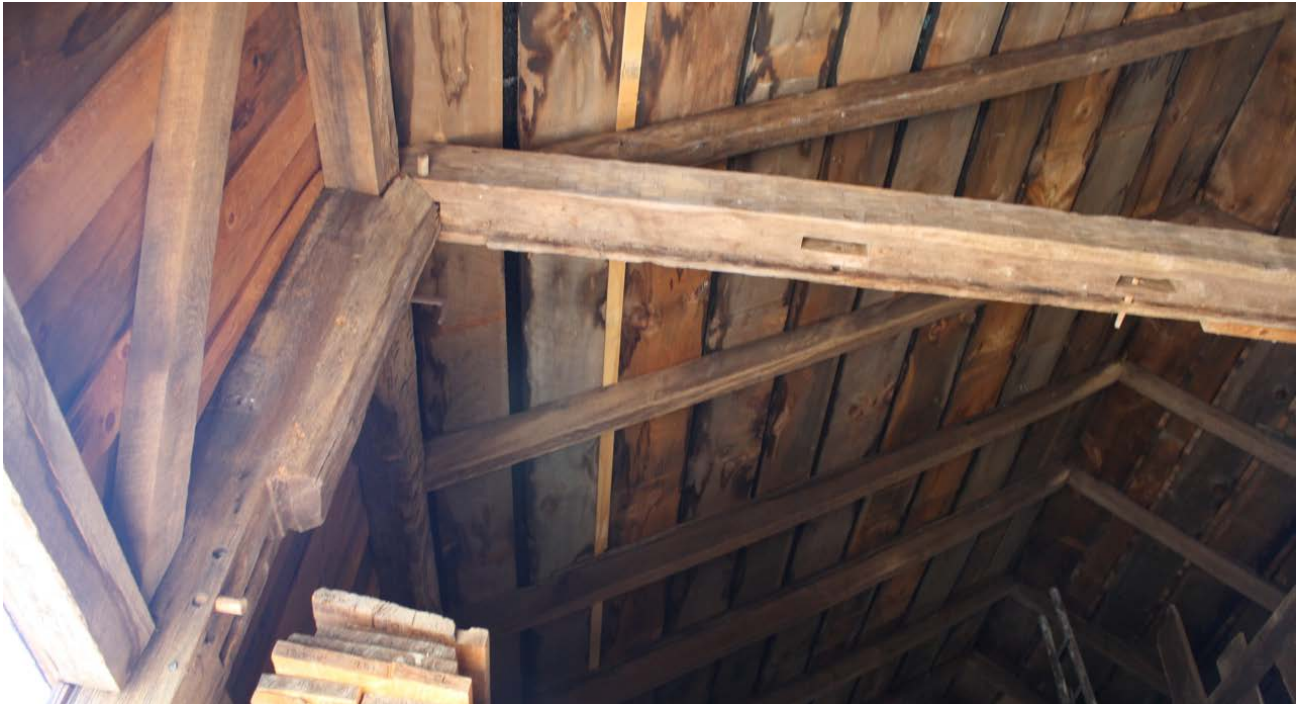
14. Interior view of Barn, camera facing west, showing the bent between bays 1 and 2, south wall. Note the jowled post, the English tying joint where the tie-girt and plate meet the post, and the boarding groove in the lower face of the tie-girt.

The oldest portion of the barn framing appears to be the bents forming bays 2 and 3. These have been repaired with some new material in the 1980s, but much original material can be seen. The bent between bays 1 and 2 exhibits scribe rule framing, jowled or flared gunstock posts, and English tying joints in which the tie-girt is joined at the top of the plate. The plate to the west in bay 1 is joined with a rare jowled plate, a technique for splicing a new plate onto an existing bent by using the larger butt end of a timber to form a tenon lower on the pre-existing post (Sobon). Boarding grooves can be seen on this bent and also the bent between bays 3 and 4. These are indications of the former exterior wall, with the siding boards inserted into the groove to secure them while they were nailed to lower wall girts. The north side plate, now an interior member with the shed addition along the north side, projects beyond its posts and likewise has a boarding groove. These bents have one interior post at the center below the tie-girts. The common rafters are half-lapped and pinned in these center bays, though they appear to be butted in bays 1 and 4.

The central bays of the Barn, with gunstock posts, English tying joinery, jowled plates, and other early framing details, appear to be of 18th century date. The connected complex – Farmhouse, summer kitchen, carriage barn, English bank barn, blacksmith shop, and the foundations of additional structures – altogether form an unusually well-preserved and carefully maintained example of a farmstead of the late Colonial or post-Revolutionary period. The adjacent landscape of village homes and a mix of open fields and woodlands, still retains much of its historic appearance. The history of ownership by a single extended family from the 18th century through most of the 20th, makes this a rare and exceptional property.

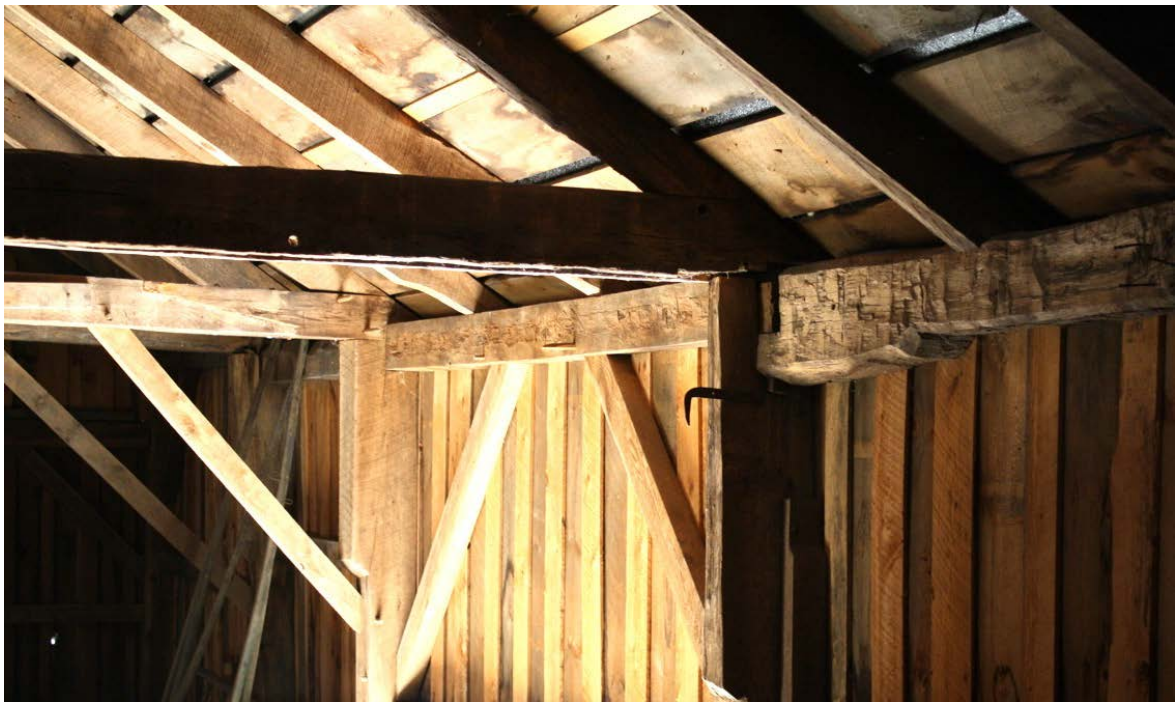
15. Interior view of Barn, camera facing southeast, view from bay 1 into bay 2. The same bent as above, seen from the west side, shows the rare jowled plate connection of the added bay to the older frame.

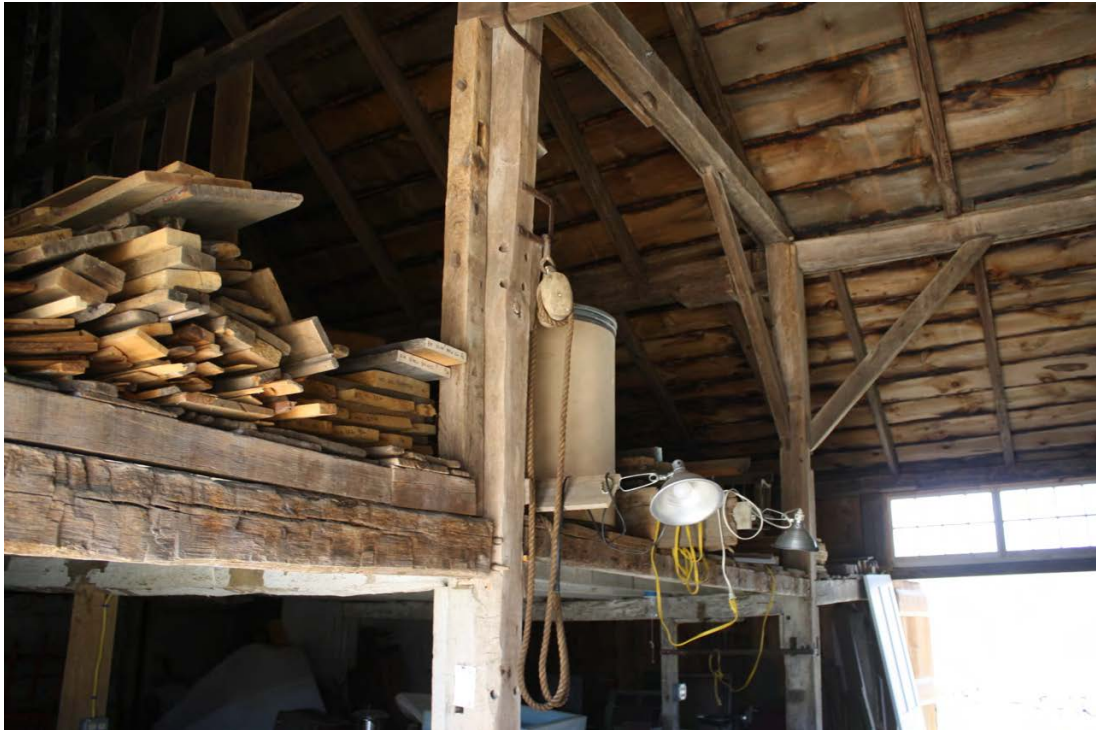
16. Interior view of Barn, camera facing north, showing the bent between bays 1 and 2, center and north wall. The saltbox addition is beyond the northern post of the bent, and forms the north exterior wall. Note the flared gunstock post and English tying joint.

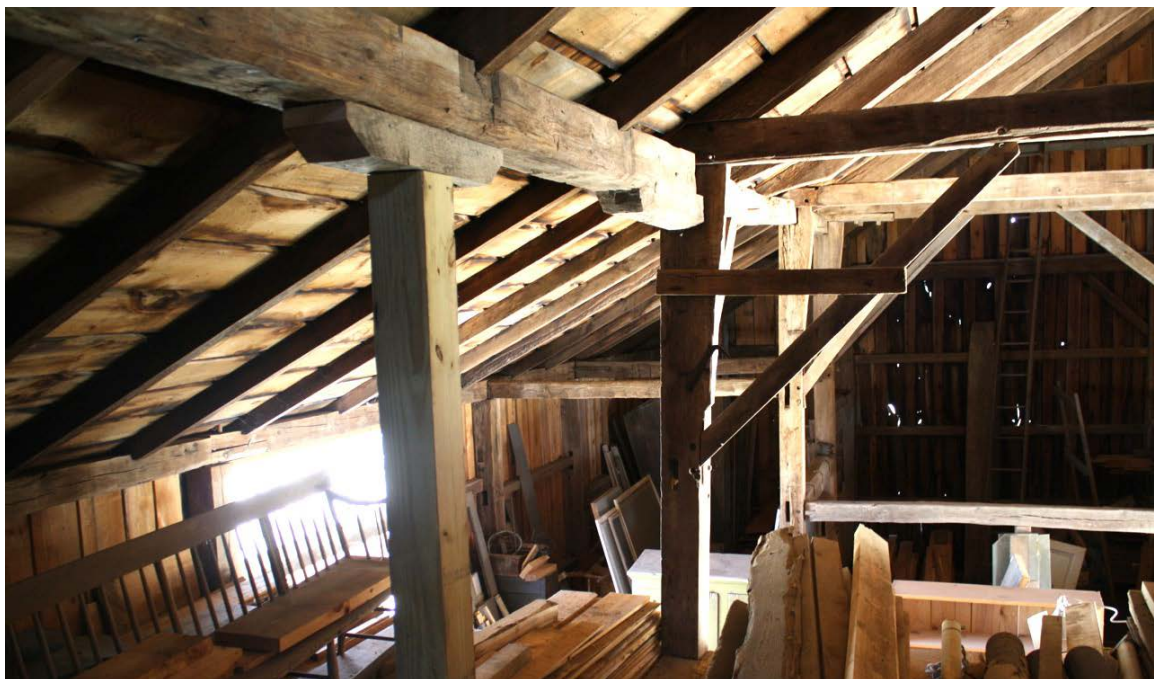
17. Interior view of Barn seen from bay 1 looking into bay 2, camera facing northeast. Note the same bent as above, with the north wall post and the saltbox leanto to the left. The jowled plate is seen here also.

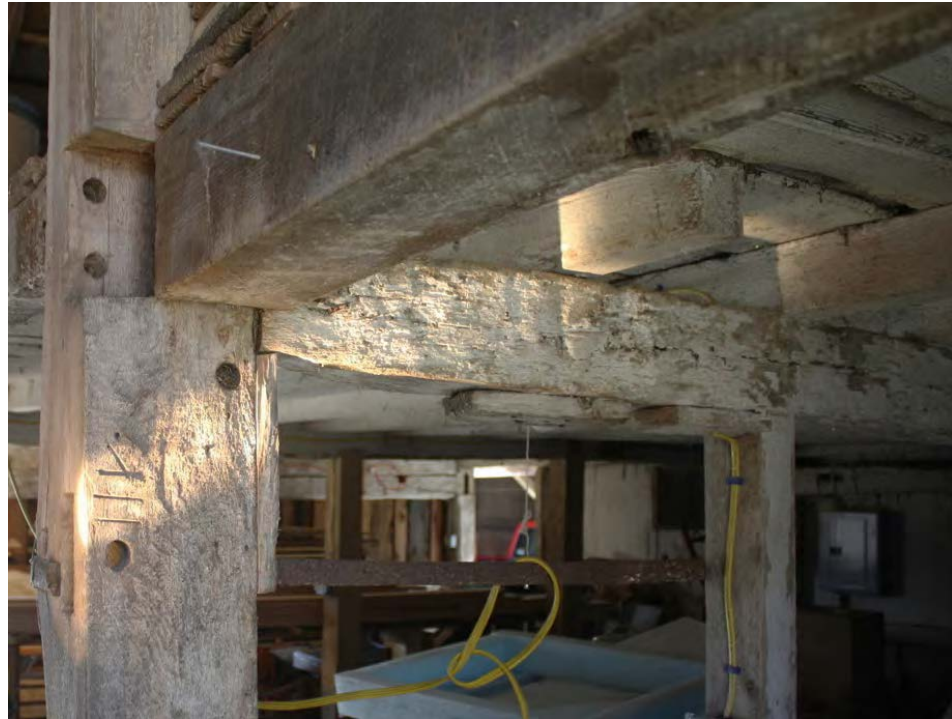
18. Interior view of Barn showing scribe rule marriage mark on the lower part of the interior post between bay 1 and 2, camera facing southwest. The corresponding brace is missing, suggesting that this post may have been re-purposed since the time of the scribe rule mark.

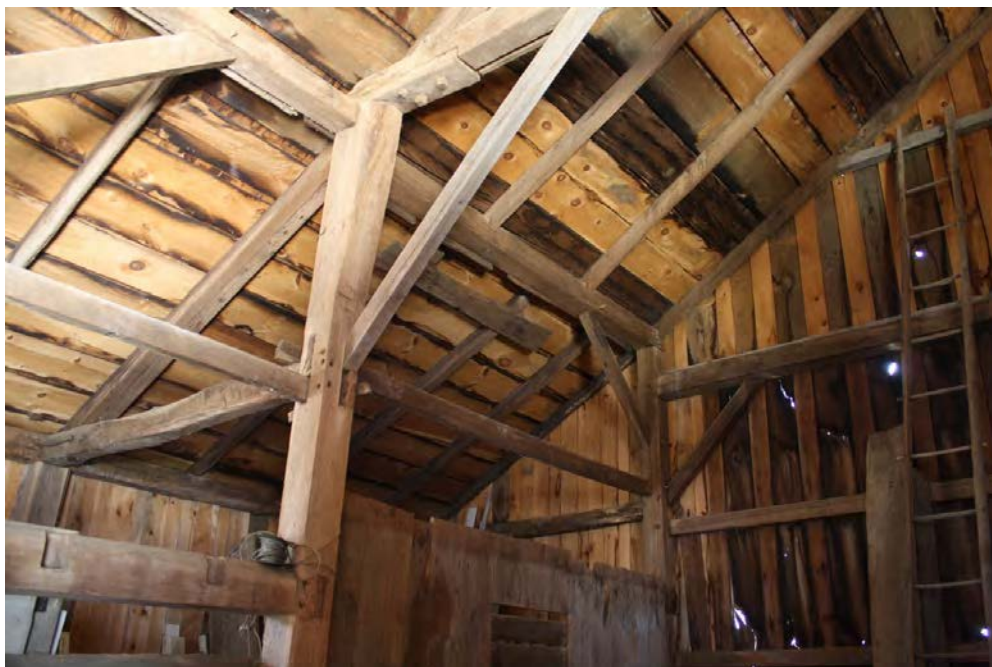
19. Interior view of Barn seen from bay 3 looking into bay 4, camera facing northeast. Note the end girt with its square rule framing and dropped tie-girt, indications that this bay was an addition. The saltbox extension to the north (left rear) continues across all four bays.

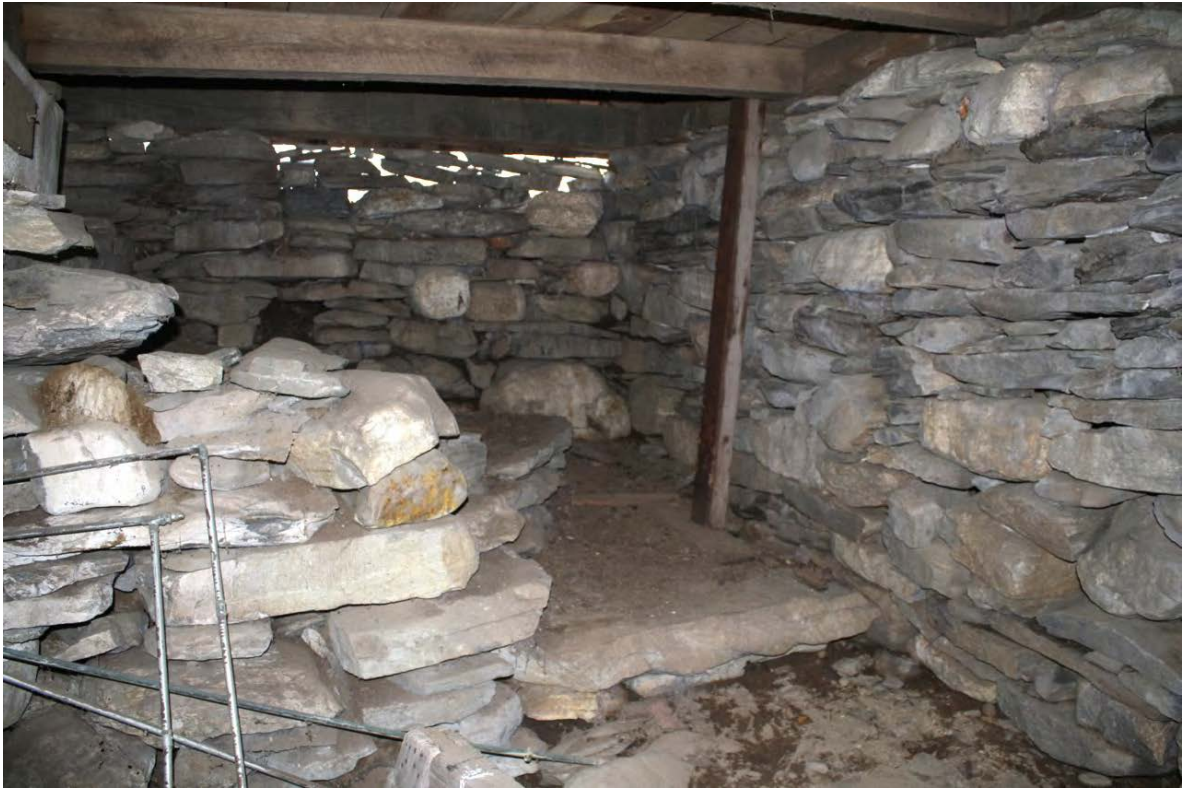
20. Interior view of Barn basement with cow ramp, camera facing northwest.
