**HISTORIC RESOURCES**

**BUILDING AND STRUCTURES**

Building Name (Common) Mad Mares Farm Record No. 121  
 Building Name (Historic) Northernmost Doolittle Farmstead  
 Street Address or Location 329 Downs Road  
 Town/City Bethany Village \_\_\_\_\_ County New Haven  
 Owner(s) Forman, David; Outremont, Gilda; 329 Downs Road, Bethany CT 06524  Public  Private

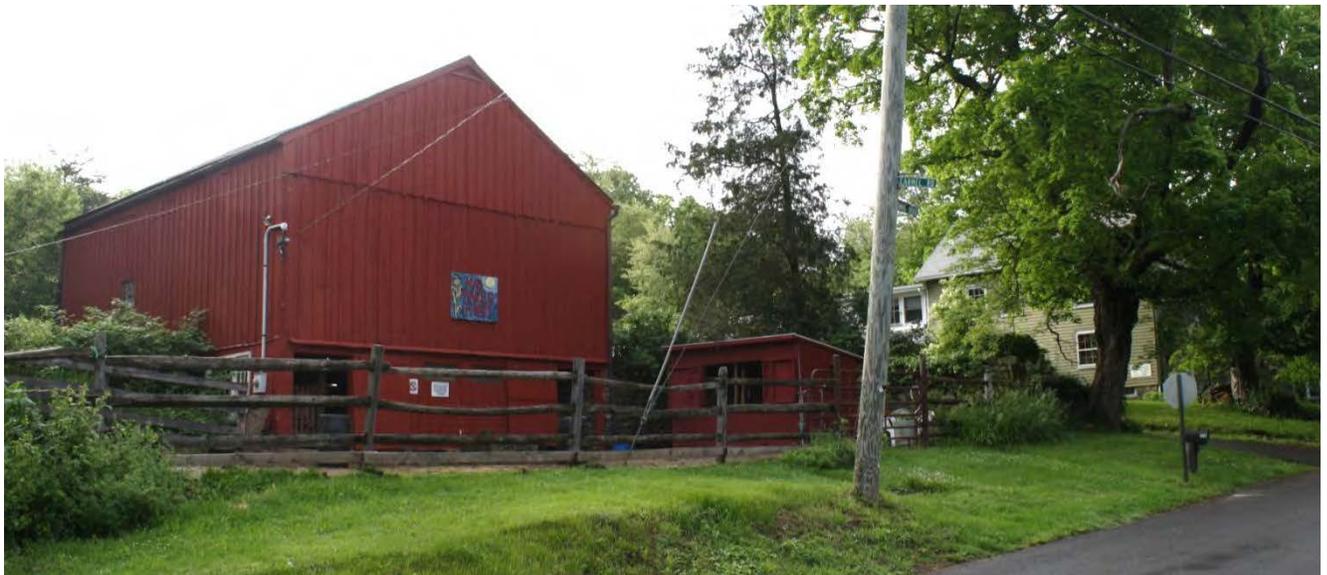
4. Southeast view of 329 Downs Road, Bethany CT, camera facing northwest. Barn is at left, house at right rear.

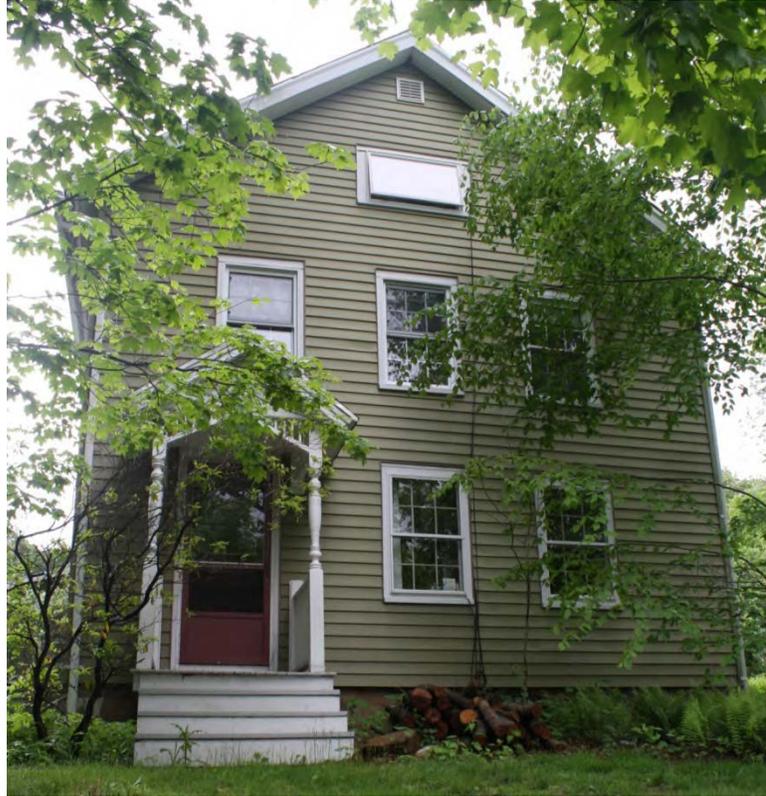
5. East view of Farmhouse, camera facing west.

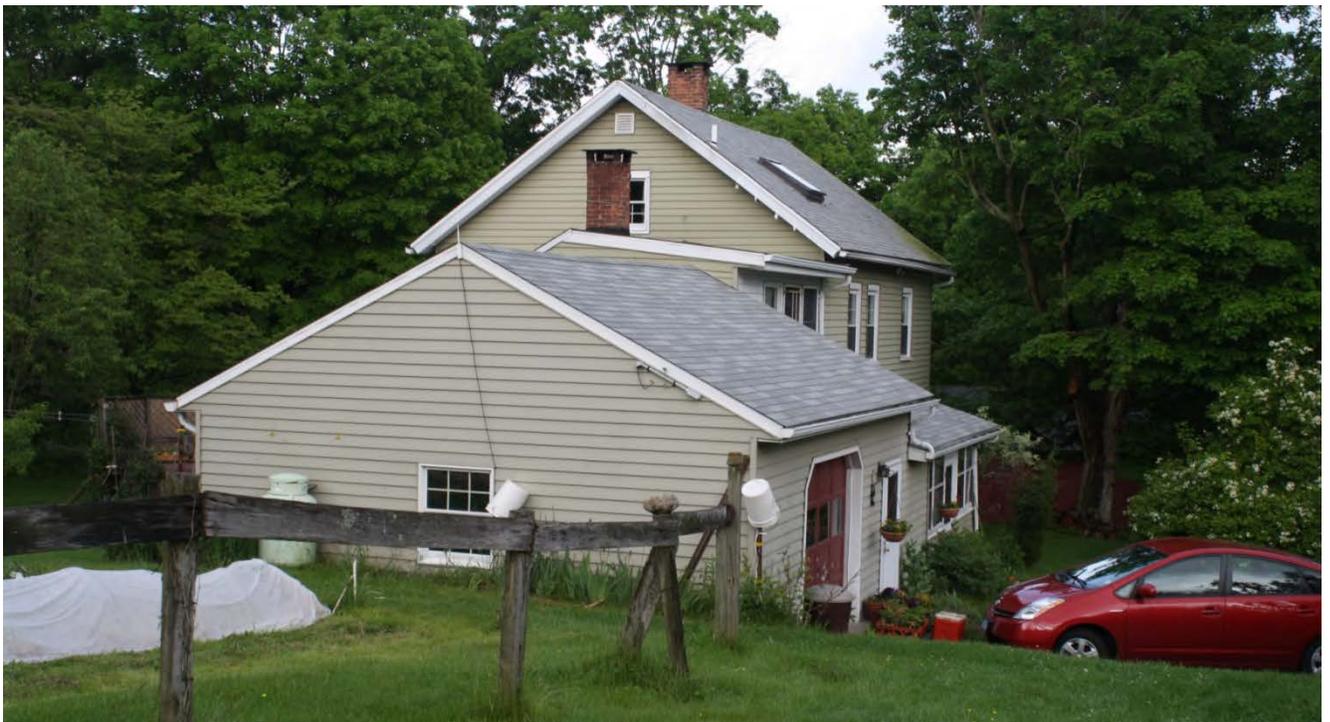
6. Southwest view of Farmhouse, camera facing east, showing rear additions and garage, main block at rear.

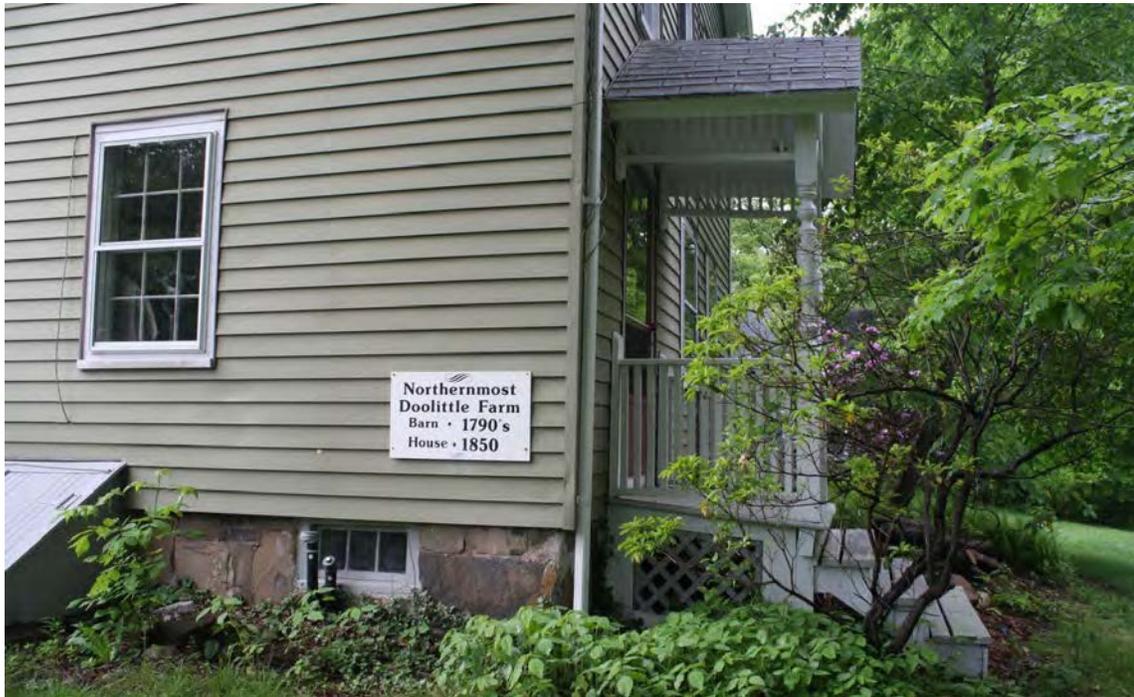
7. Detail view of Farmhouse southeast corner, camera facing south. Note traprock foundation masonry, porch with turned posts.

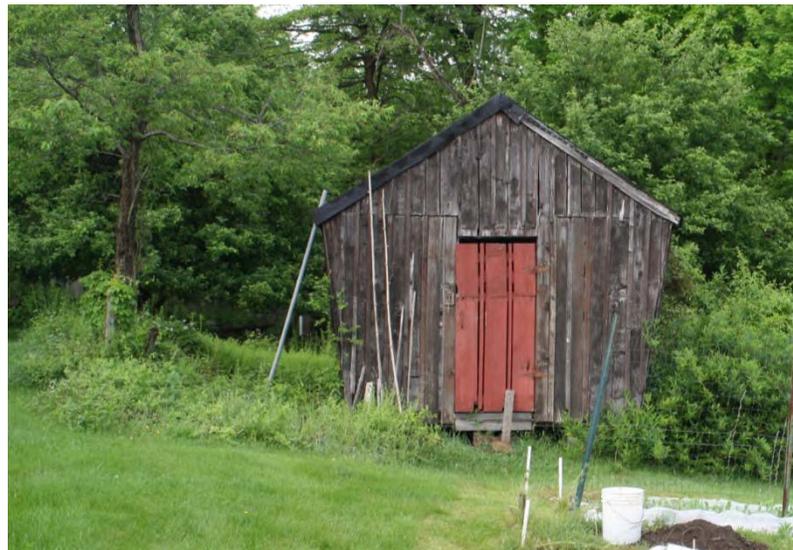
8. South view of corn crib, camera facing north.

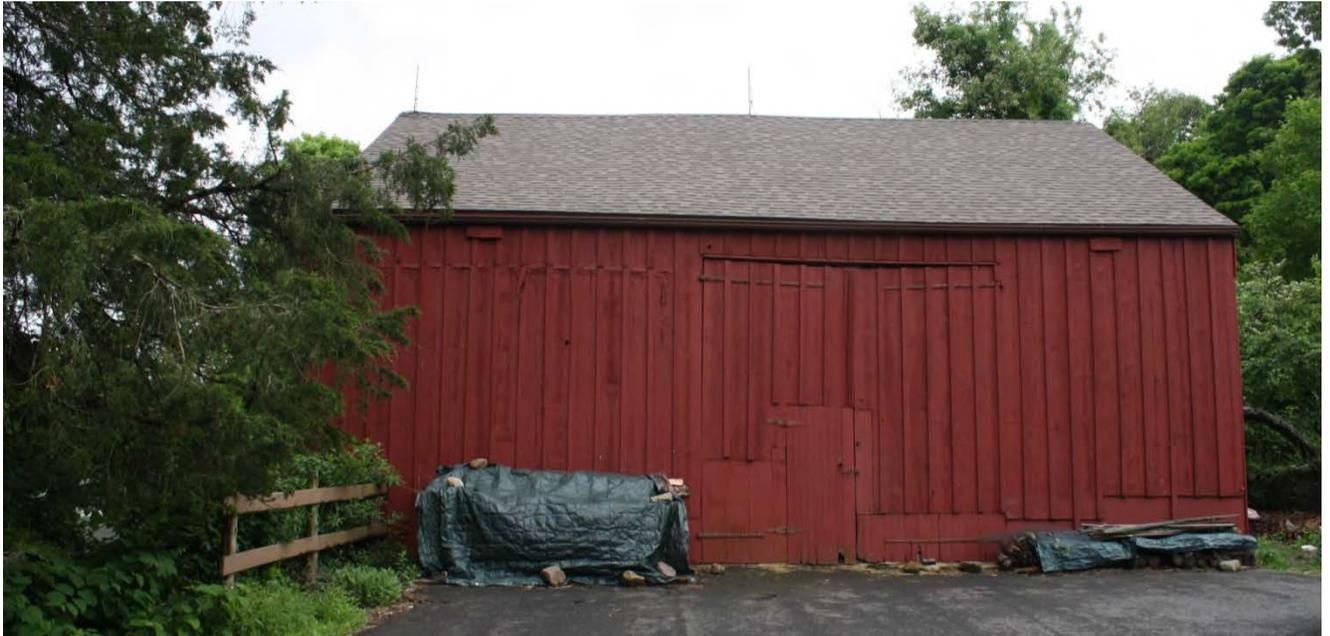
9. North view of Barn, camera facing south.

This is a 1 ½-story, gable-roofed three-bay English bank barn. The main eave-side faces north and the ridge-line of the barn is oriented east-west, perpendicular to Downs Road. Grade slopes down from west to east, and the lower grade to the east exposes the basement on the east gable-end. Siding is board-and-batten, foundations are of local traprock (basalt) fieldstone and random ashlar masonry, and roofing is asphalt shingles.

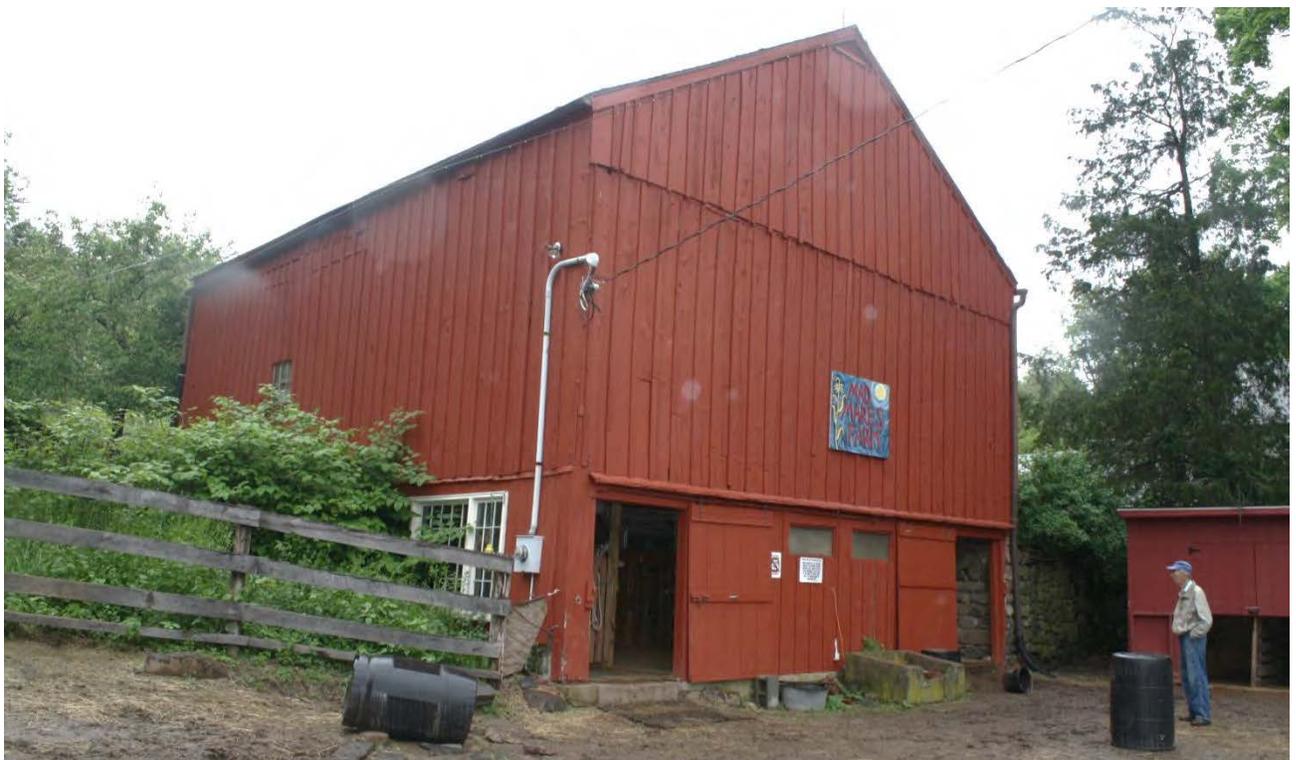
10. Southeast view of Barn, camera facing northwest. At right is Chuck Forman, who bought the property from Pansy Doolittle Quinn in 1953.

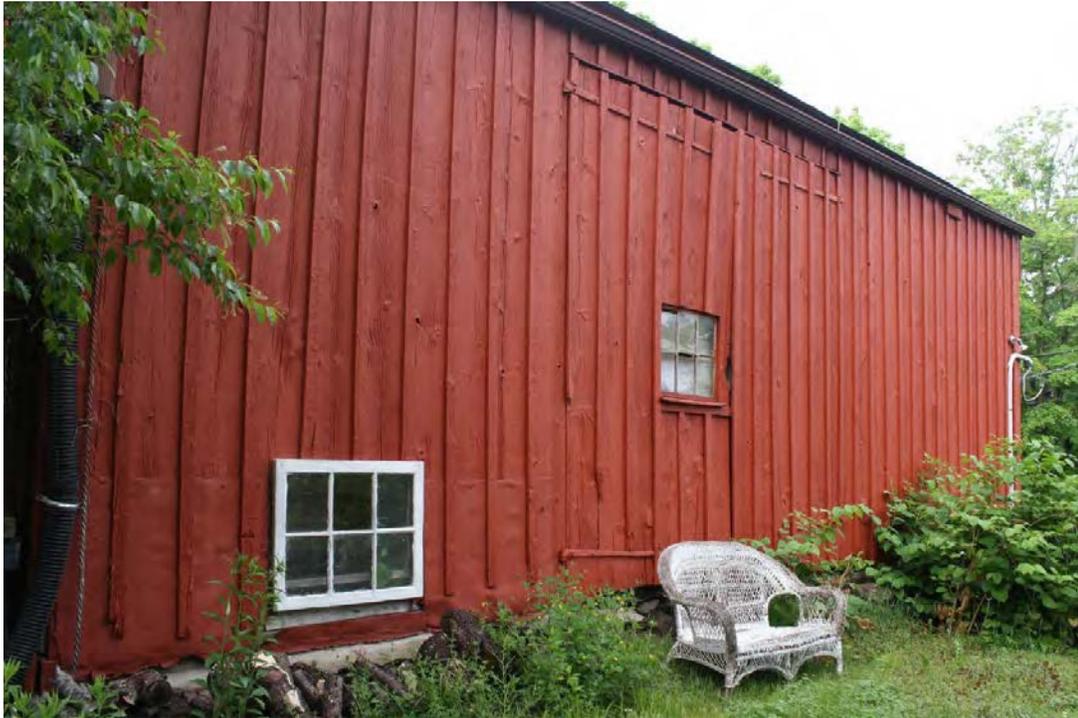
11. East view of Barn, camera facing northeast.

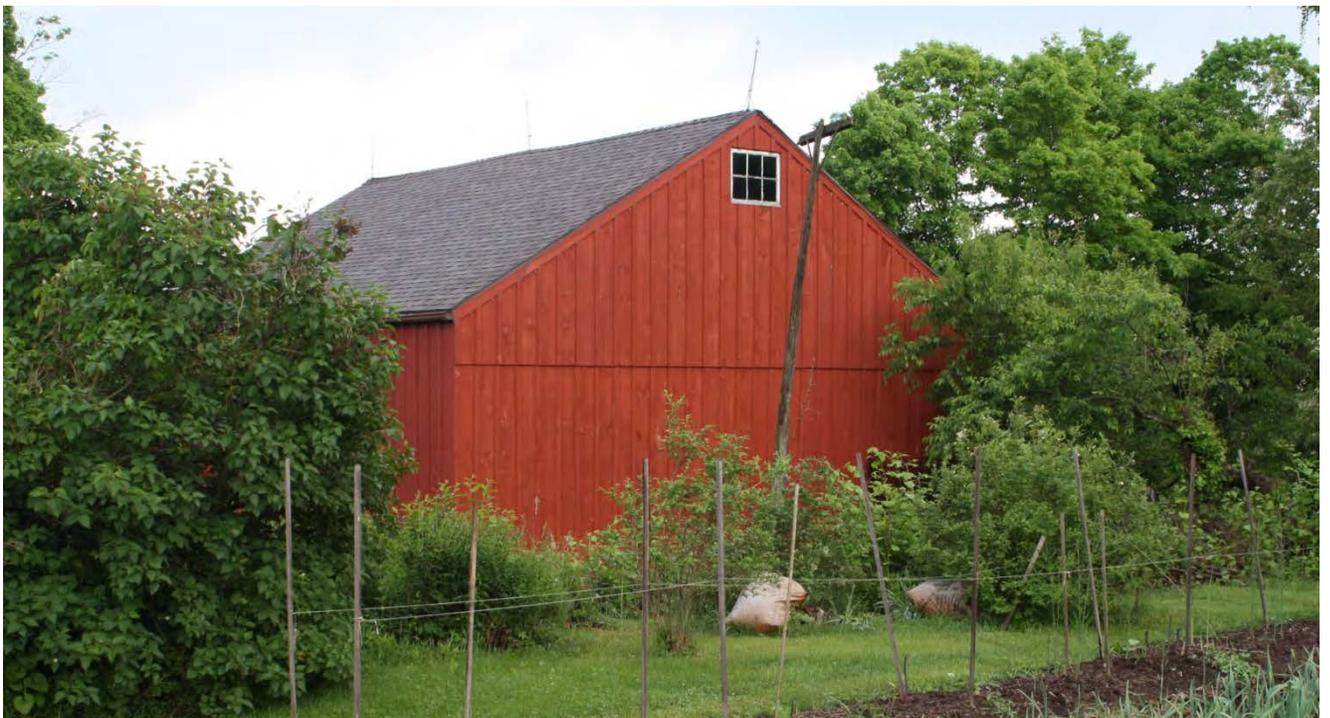
12. West view of Barn, camera facing southeast.

The west gable-end has a six-pane window in the attic near the peak. Adjacent to the west wall is the circular foundation of a silo; the silo itself is said to have been sold to a neighbor, Shepherd's Farm (1990 Litchfield Turnpike, Woodbridge) and relocated. A small areaway connecting to the barn allowed silage to be transferred into the stable area. To the west of the silo site another stone retaining wall creates terraces as the grade rises.

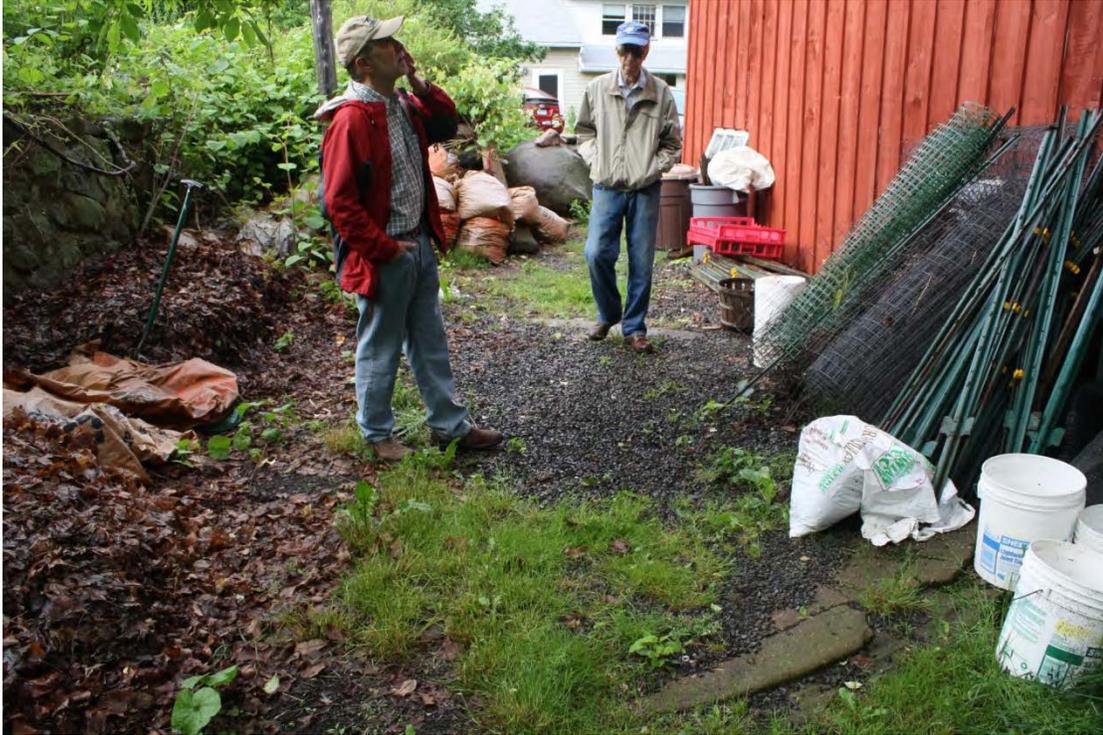
13. View of silo foundation at west end of Barn, camera facing north. Dave Forman, left, is the current owner, Chuck Forman, right rear.

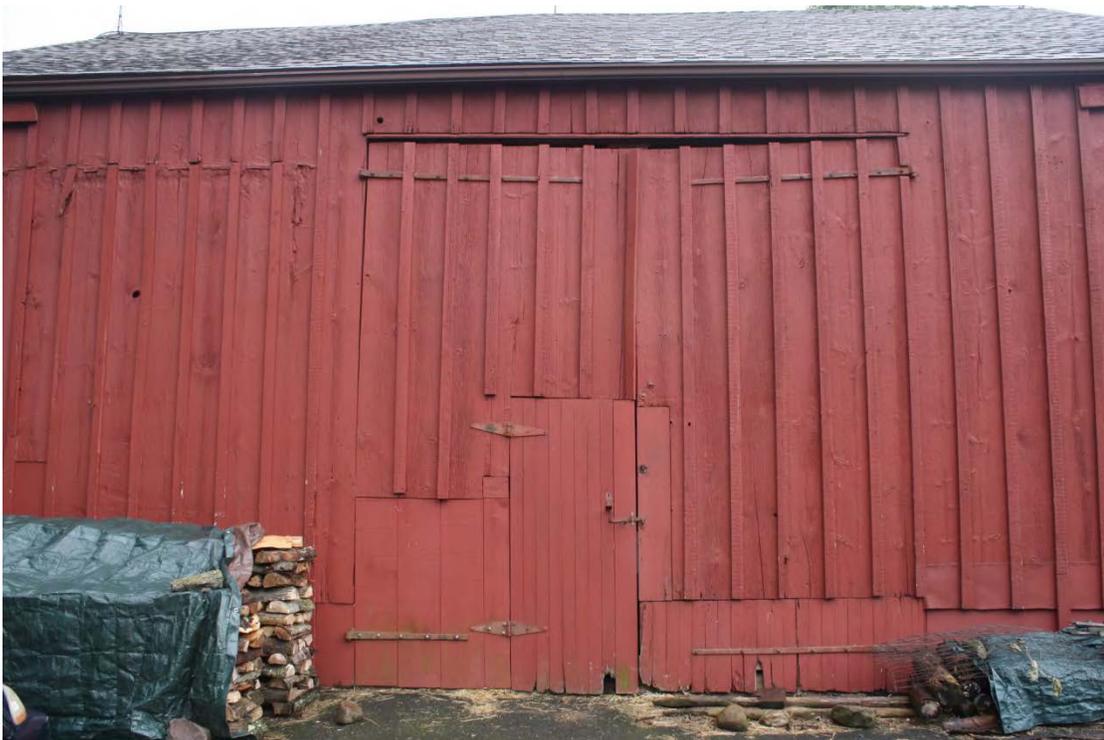
14. Detail view of north side doors, camera facing south. Note iron strap hinges and weather door.

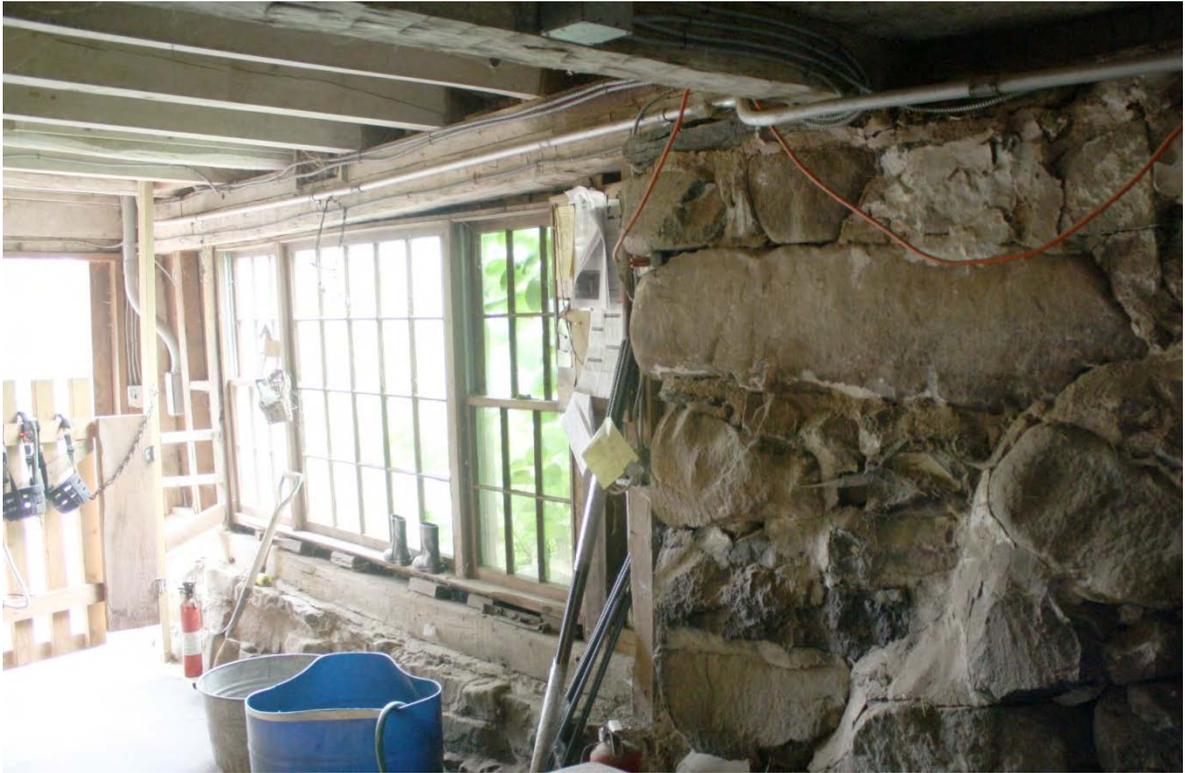
15. Interior view of Barn basement southeast corner, camera facing south. Note traprock masonry.

The interior of the basement level is a three-sided traprock foundation wall made with randomly sized and irregularly coursed blocks, some dressed and others appear to be naturally faced. Some of the blocks are large. The three bays have different framing layouts: the center bay has the plank floor of the main level laid over full-width unfinished pole girders running north-south across the width of the foundation. The end bays have joists supported at a higher elevation forming a step up at the main level. The east bay is framed with dimension lumber, suggesting a remodeling subsequent to the earliest construction. An open-riser stair oriented north-south connects the basement and main level. The floor is concrete, with manure gutters from a period of dairy use filled in by the current owners. Along the east wall two horse stalls have been inserted.

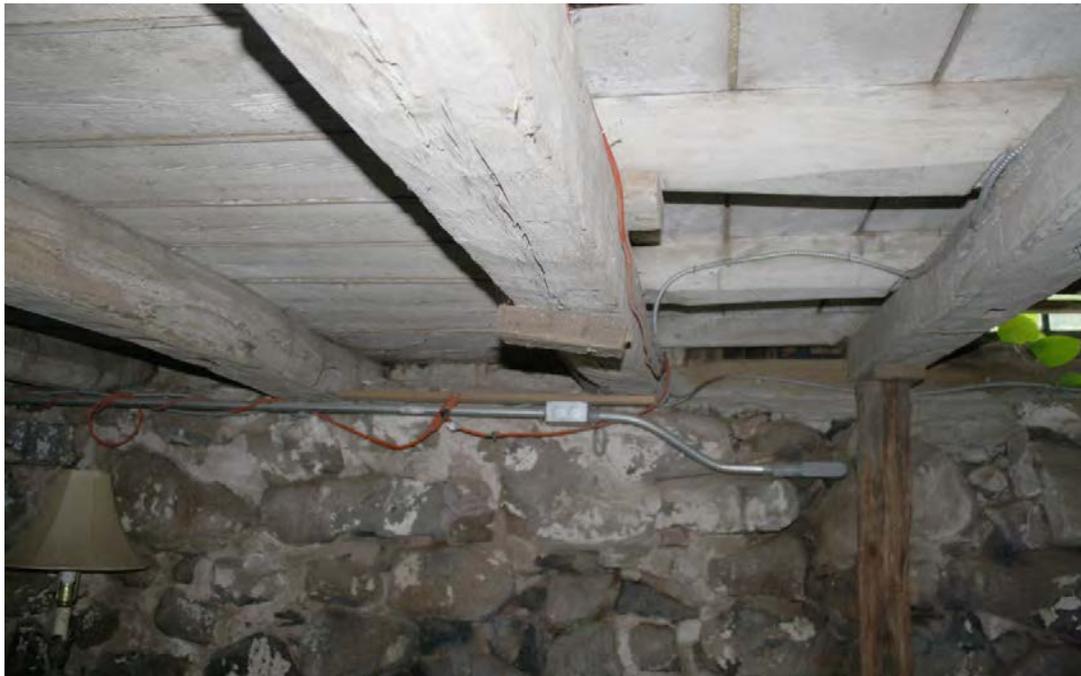
16. Interior view of Barn basement south wall, camera facing south. Note framing: at left is the center bay with full width joists and at right joists are oriented east-west with floor planks elevated and perpendicular to center bay. At right is the clerestory window that can be seen in the south eave-side exterior view..

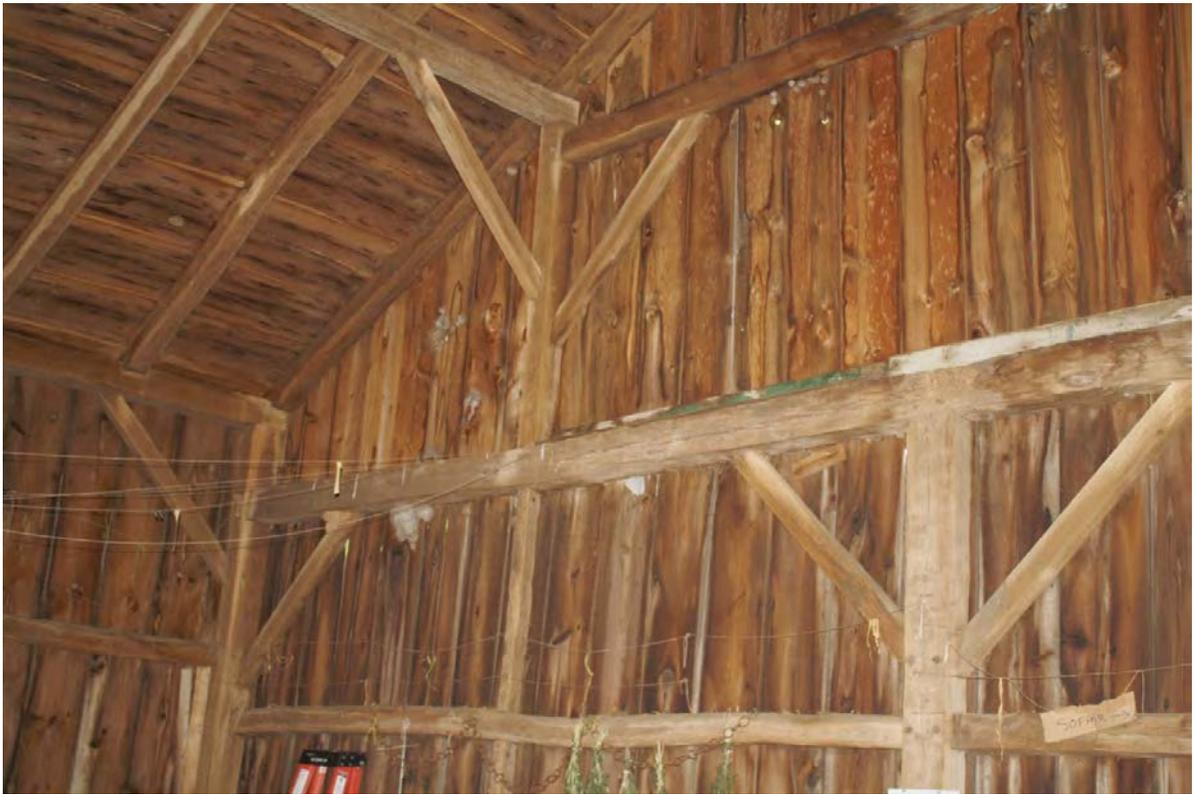
17. Interior view of Barn main level northeast corner, camera facing northeast, showing typical timber framing.

The interior of the main level has a square rule post and beam pegged frame with four bents, two interior and one at each end wall. These have a single interior post at the center, a dropped tie girt, and queen posts supporting purlin plates at the center of the span of the common rafters. The rafters are square hewn members butted at the ridge with no ridge-board and with birds-mouth toes at the plate. Deck boards are random width; original wood shingle roofing has been replaced by asphalt shingles over plywood. Some repairs to the frame have been made at the southeast corner, with steel plate connections reinforcing a split post in the area of the dropped girt connection. Frame members appear to be a mix of chestnut and oak. The floor level in the end bays is stepped up approximately six inches above the elevation of the drive bay; the matching barn doors in the eave-sides allowed for a hay wagon to drive through. The hay track and fork are extant suspended below the ridge. As in many barns, the upper cross ties at the top of the queen posts have been cut and removed to make room for the hay loading process. The west gable-end wall siding has been replaced in recent years to match the existing. Electricity was installed in 1995 at the time of the CSA (Community Supported Agriculture) farming operation.

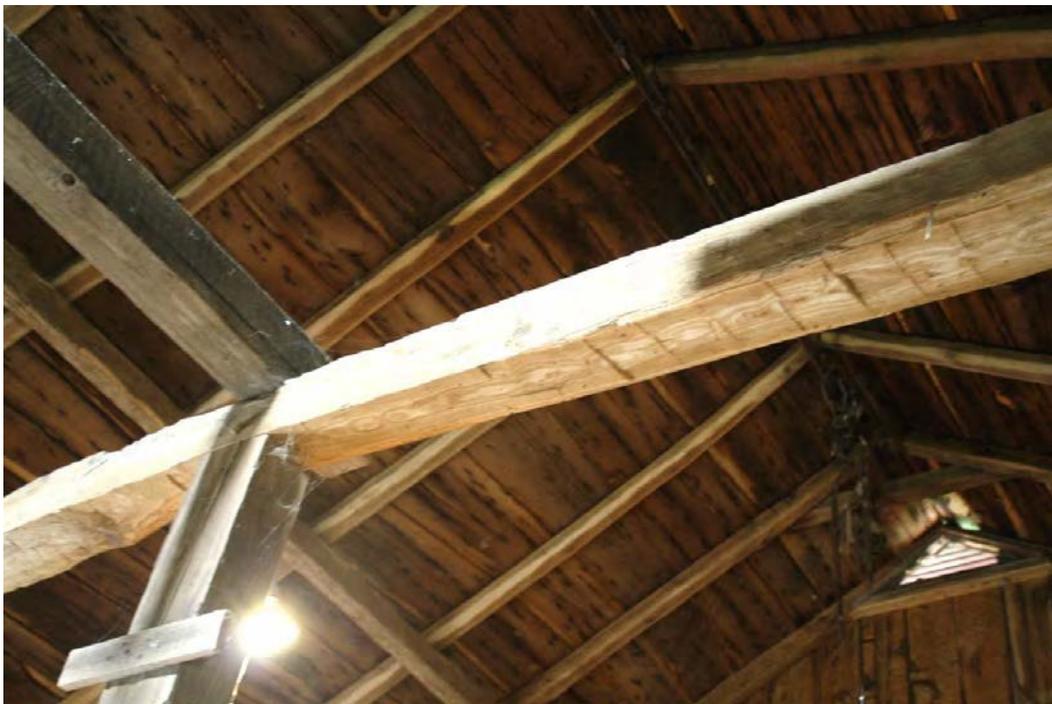
18. Interior view of Barn main level roof framing, camera facing east. Hand-hewn tie girt and post are in foreground; hay track and horse fork are at peak of the roof.

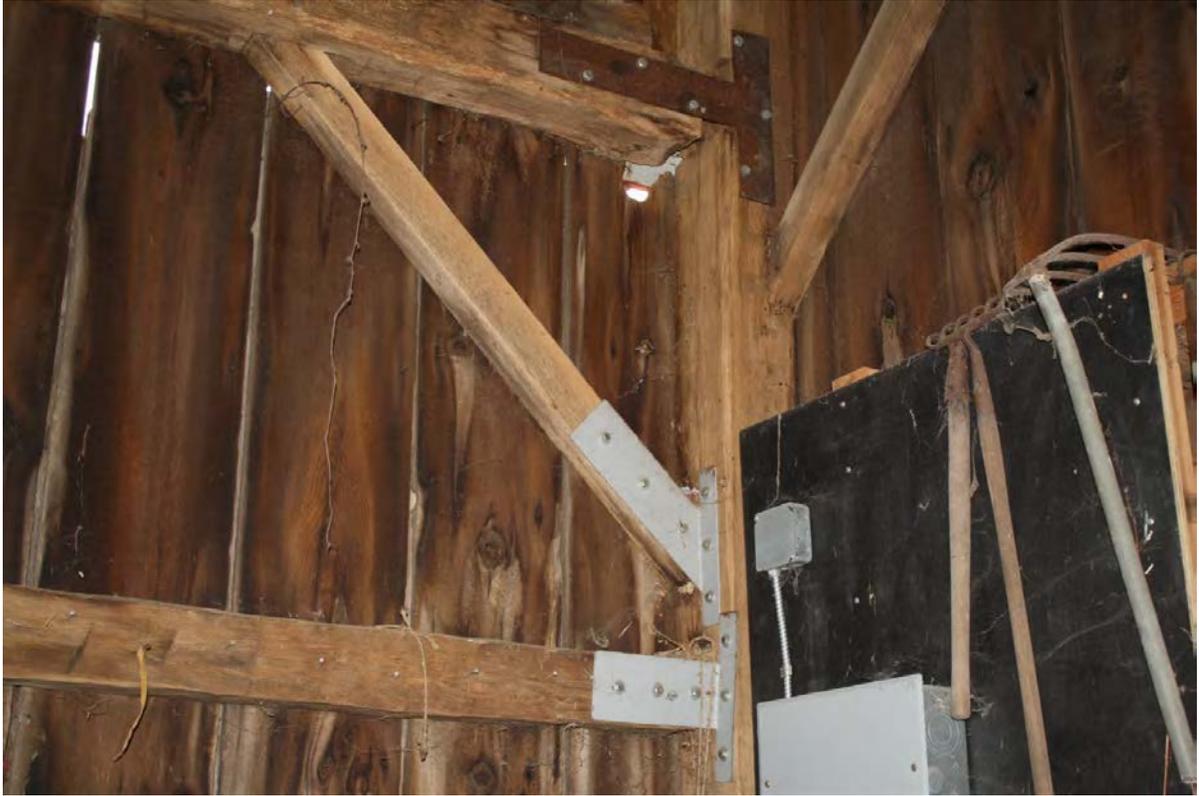
19. Interior view of Barn main level southeast corner, showing area of timber framing repair.

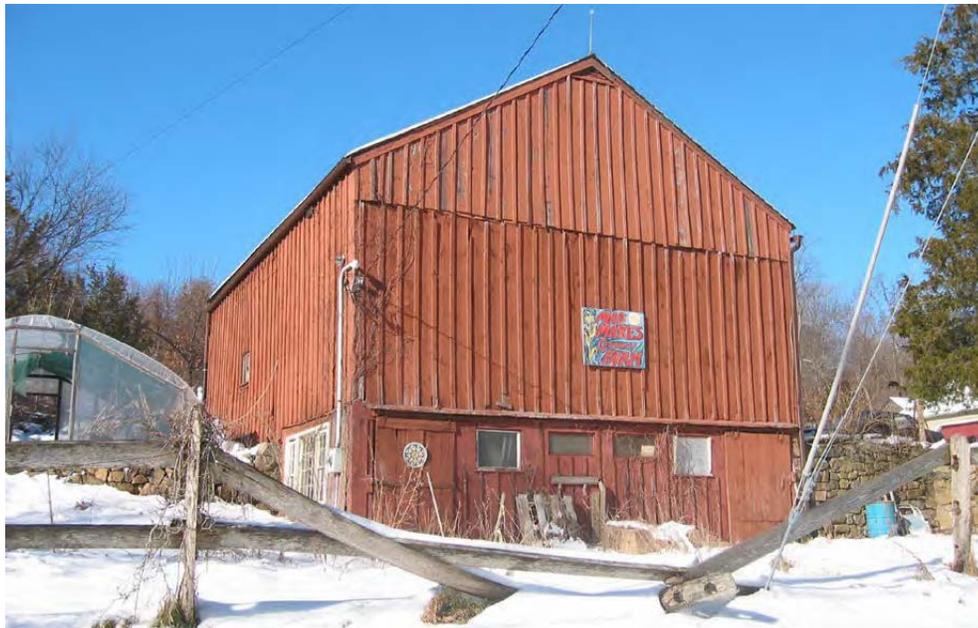
20. Southeast view of Barn, camera facing northwest.
