**HISTORIC RESOURCES**

**BUILDING AND STRUCTURES**

Building Name (Common) Davidson Farmstead / Minnow Brook Farm Record No. 4981  
 Building Name (Historic) Davidson, Samuel Gilbert, Farmstead / Minnow Brook Farm  
 Street Address or Location 539 Litchfield Turnpike  
 Town/City Bethany Village \_\_\_\_\_ County New Haven  
 Owner(s) Dawn & Jordan Stark, 539 Litchfield Turnpike, Bethany CT 06524  Public  Private

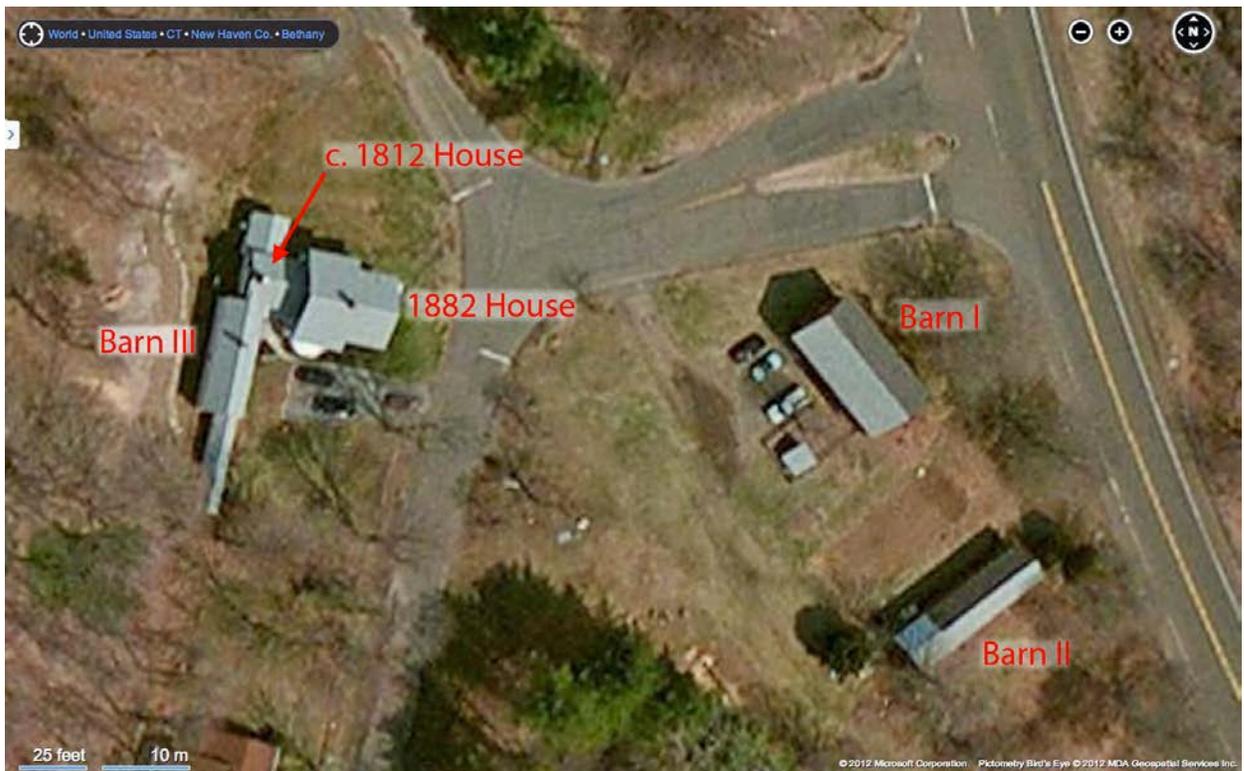
4. Detail Site Plan showing contributing resources – base image from Bing Maps.

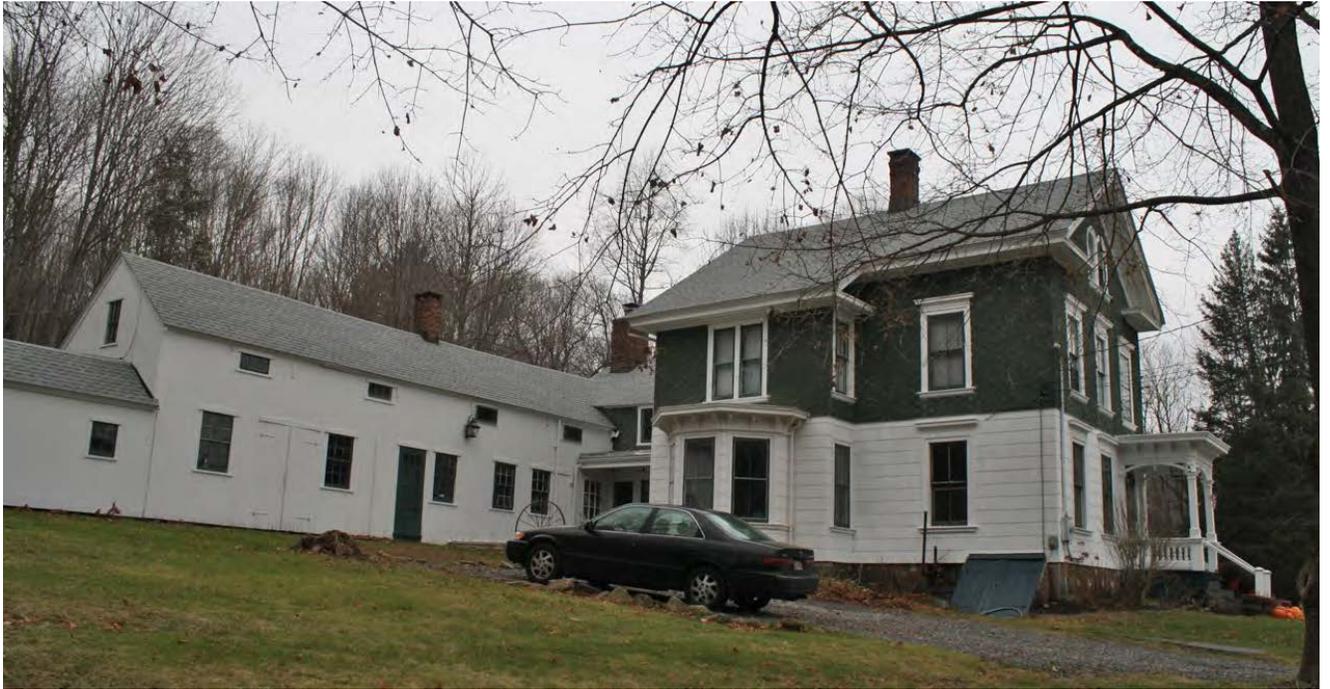
5. Southeast view of Farmhouse (right) and Barn III (left), camera facing north.

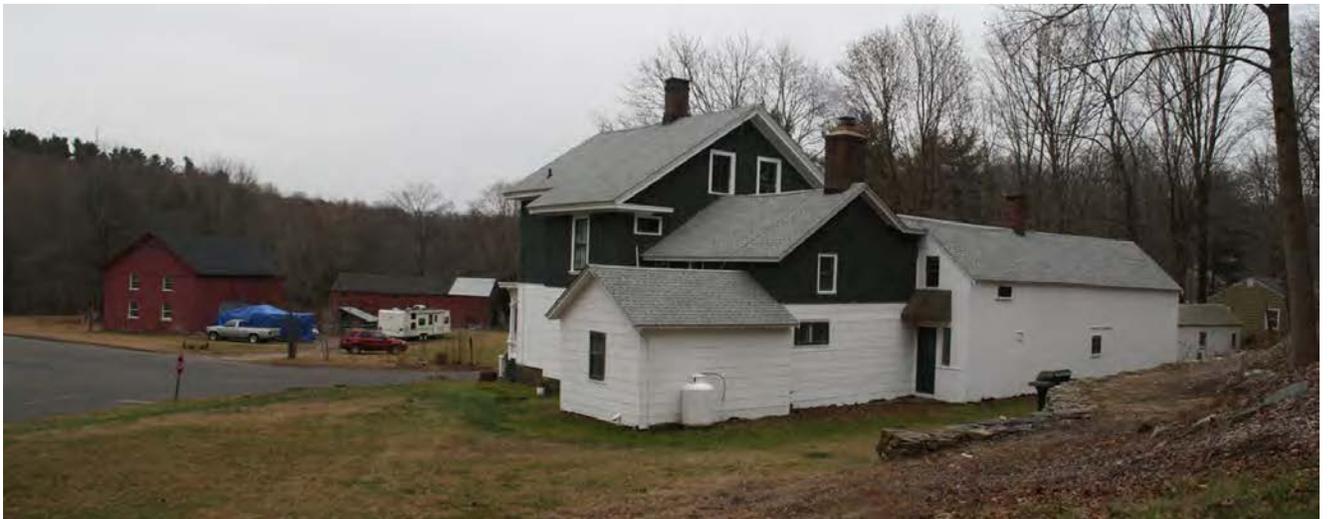
6. Northwest view of the Farmhouse, camera facing southeast. The Borning Room addition is in foreground, the c. 1812 house is to its right, and the 1882 house is to the left rear (taller). Barn III is the white shed attached at the right. Barn I and Barn II are red barns beyond at rear across Carrington Road.

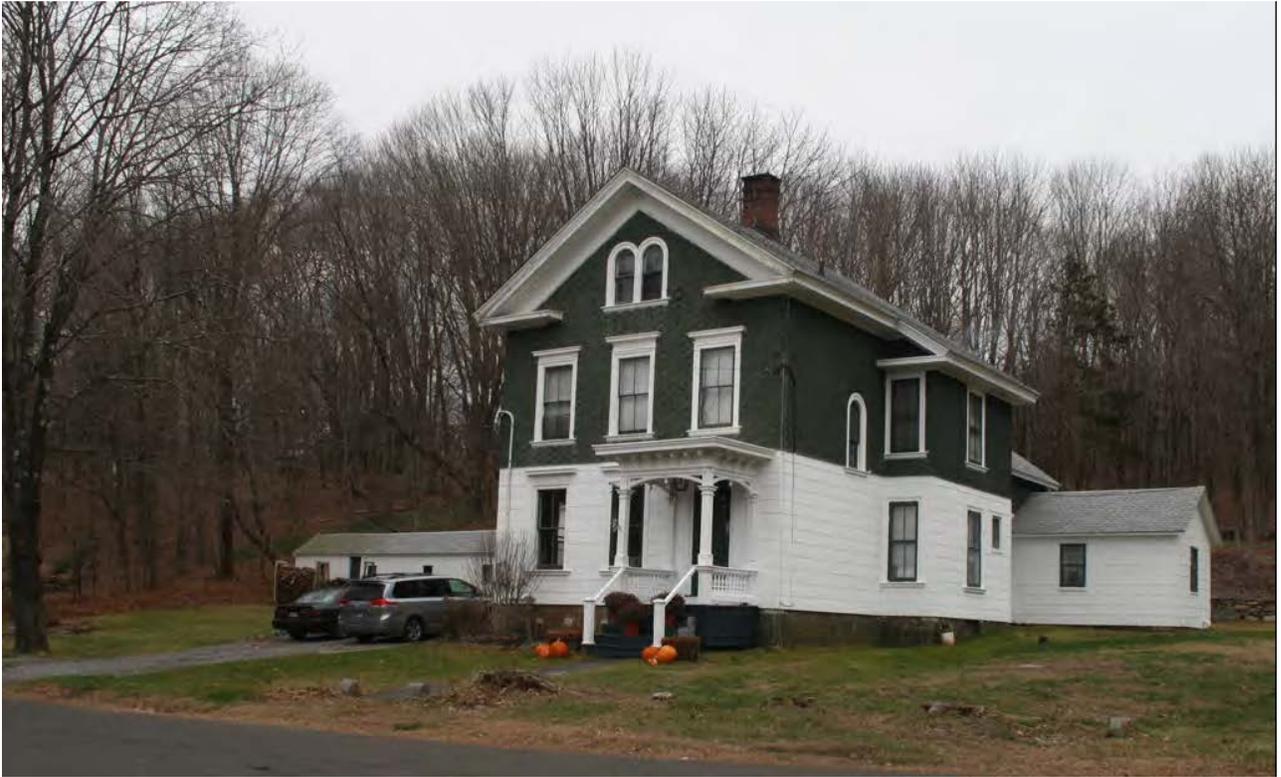
7. Northeast view of the Farmhouse, camera facing southwest.

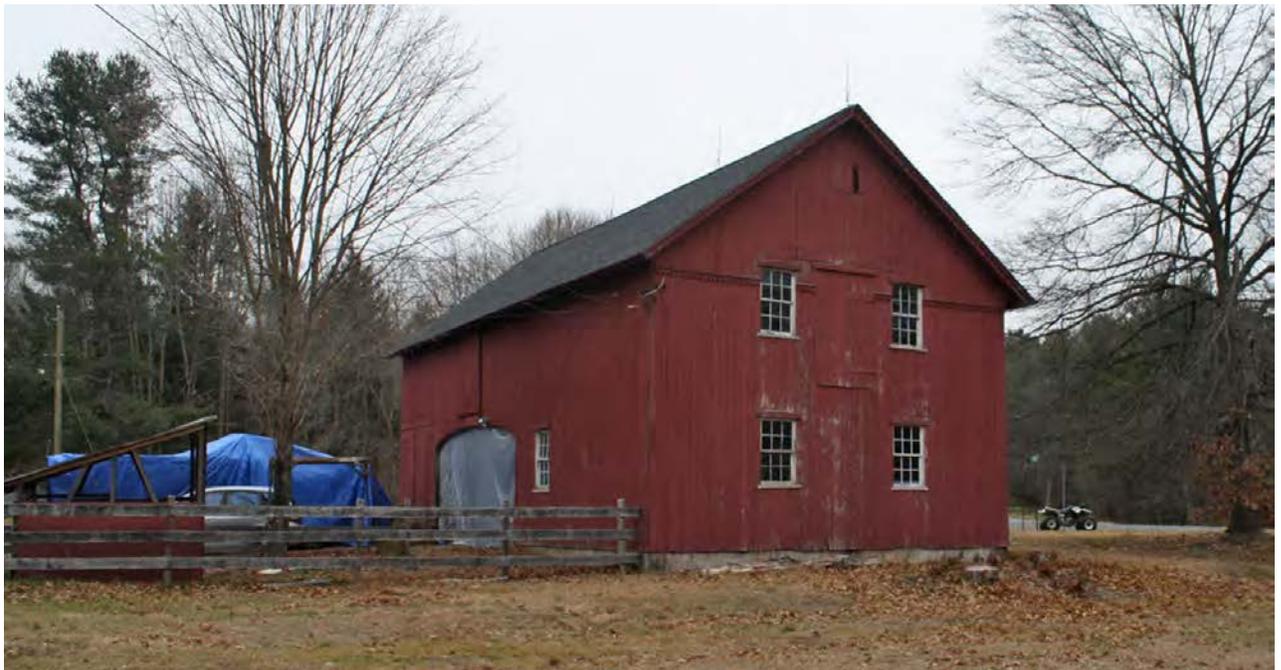
8. Southwest view of Barn I, camera facing northeast.

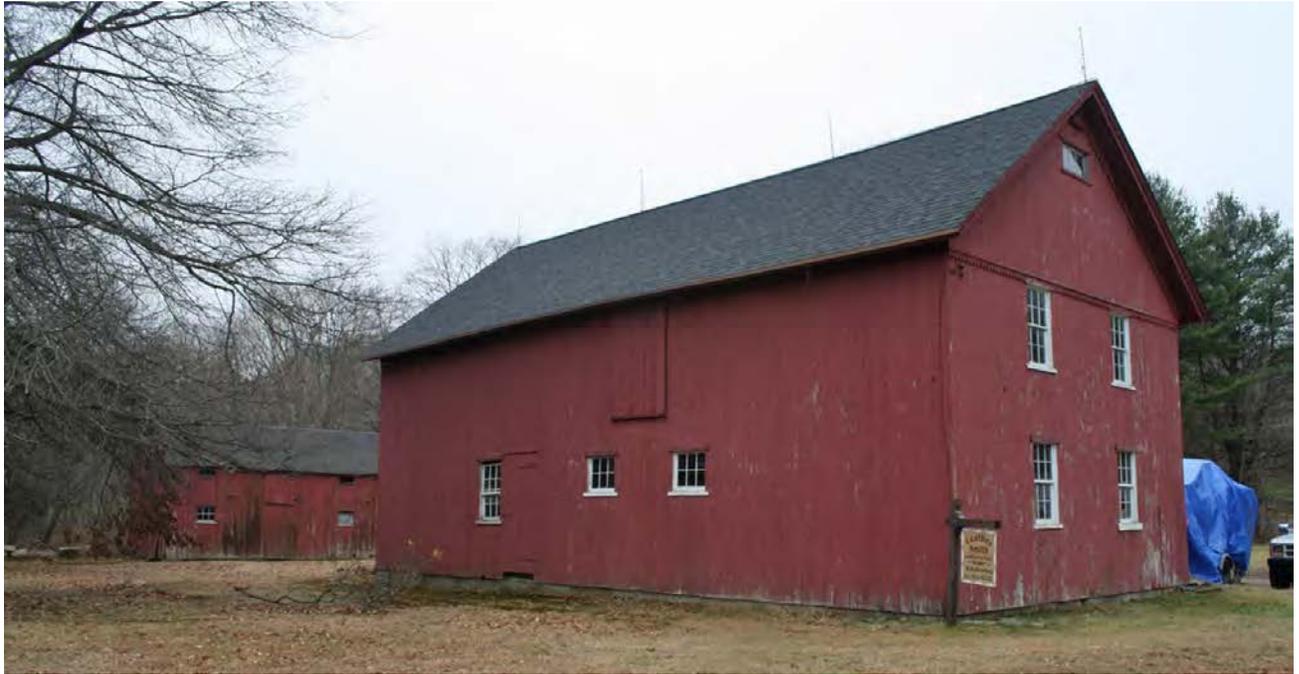
9. Northwest view of Barn I, camera facing southeast. Barn II is at left rear.

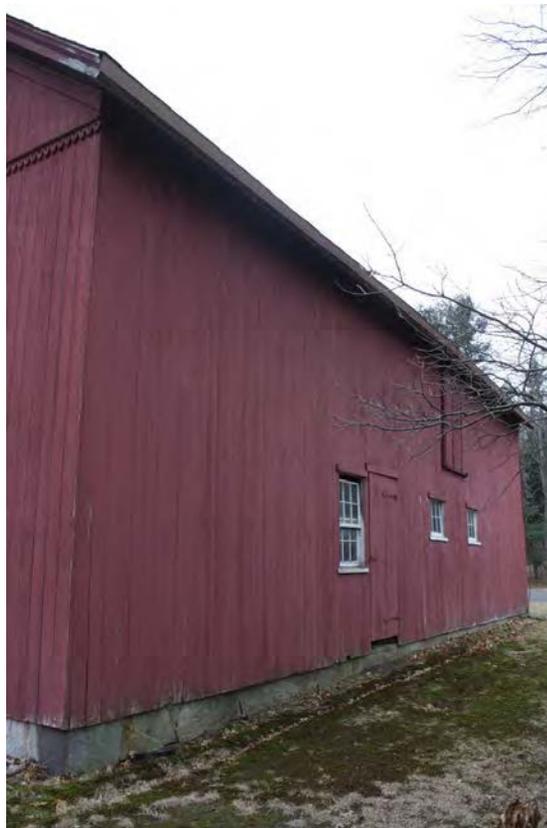
10. East eave-side of Barn I, camera facing northwest. Note the cut stone foundation.

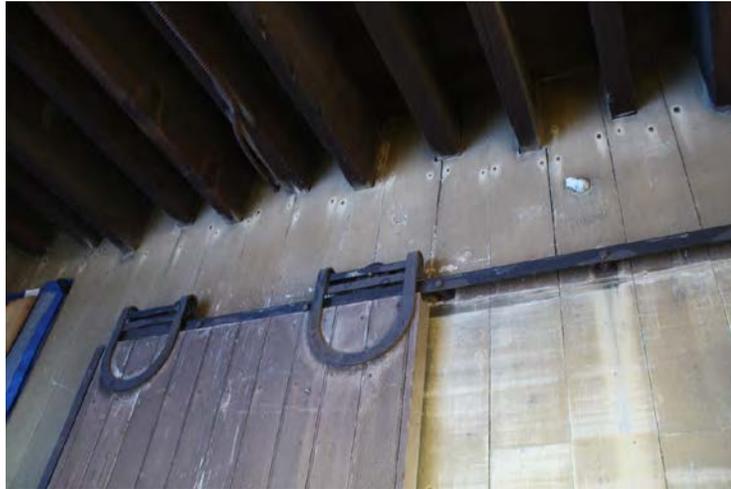
11. Interior view of Barn I ground floor center bay interior, showing sliding door leading to north bay; camera facing north. Note the closely-spaced joists above the center bay.

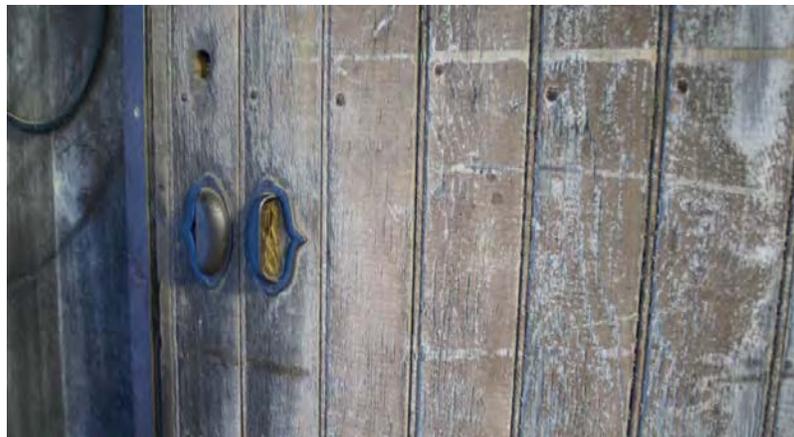
12. Interior view of Barn I ground floor center bay interior, showing pulls on sliding door leading to north bay; camera facing north.

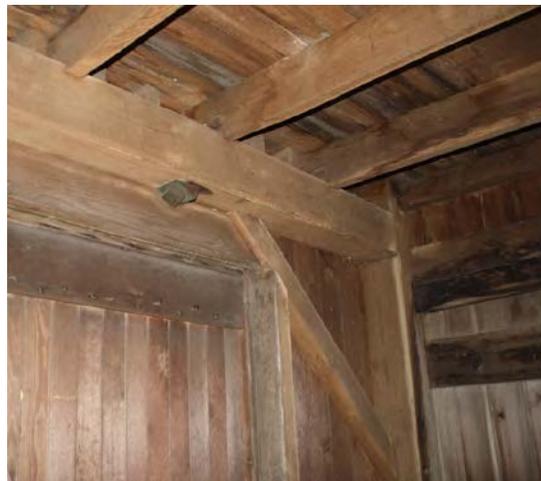
13. Interior view of Barn I ground floor south bay interior bent, showing framing detail, camera facing northeast.

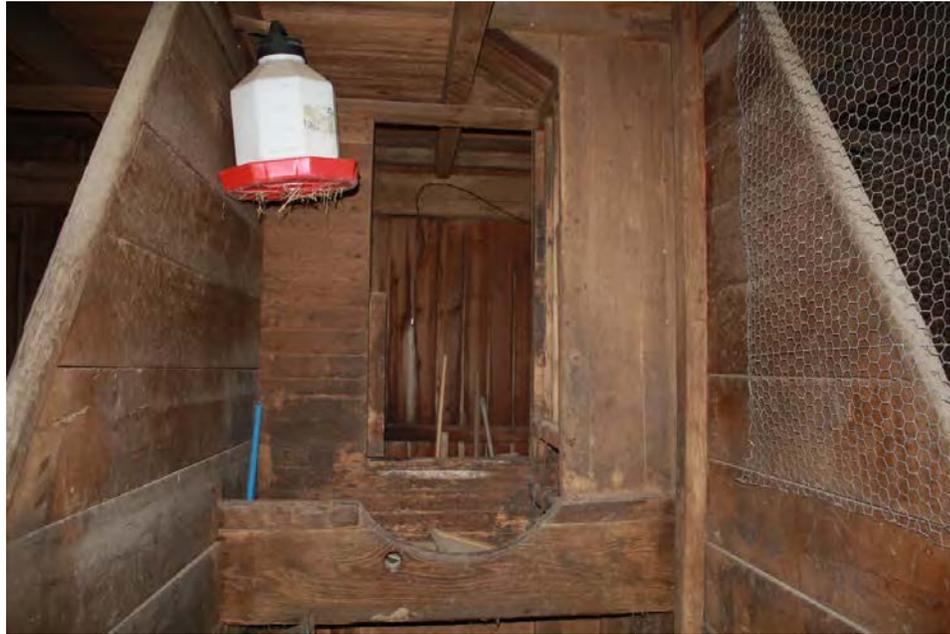
14. Interior view of Barn I ground floor south bay, showing typical horse stall with manger, camera facing south.

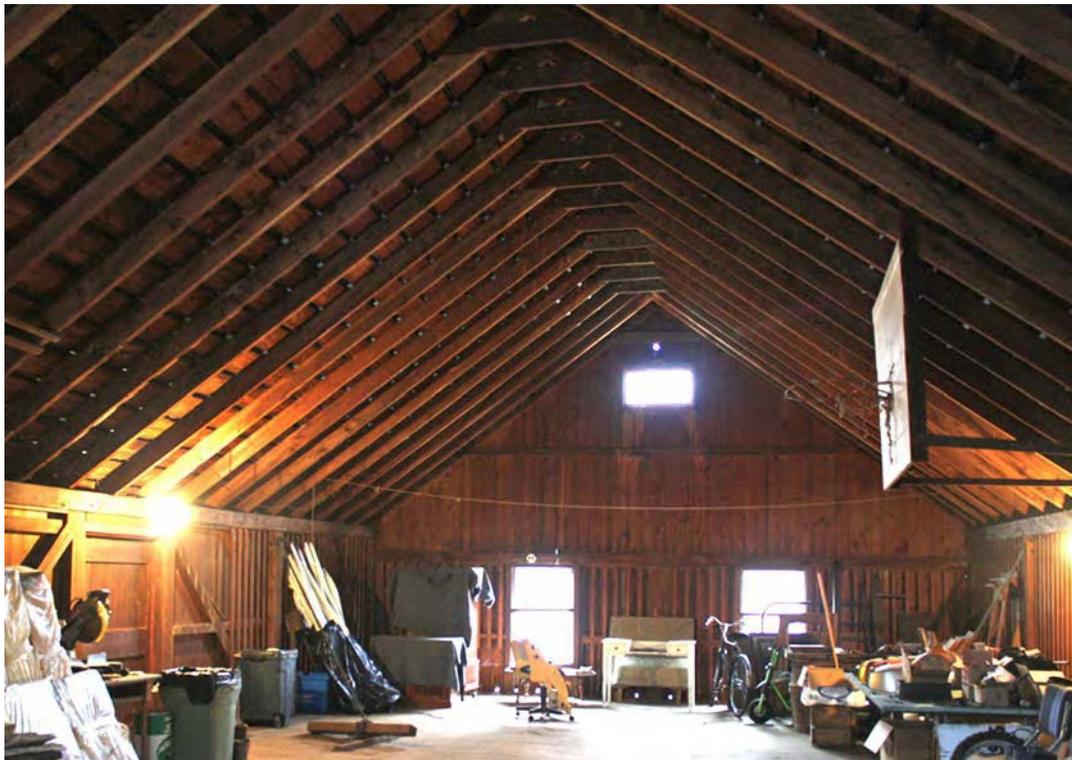
15. Interior view of Barn I second floor level, camera facing north.

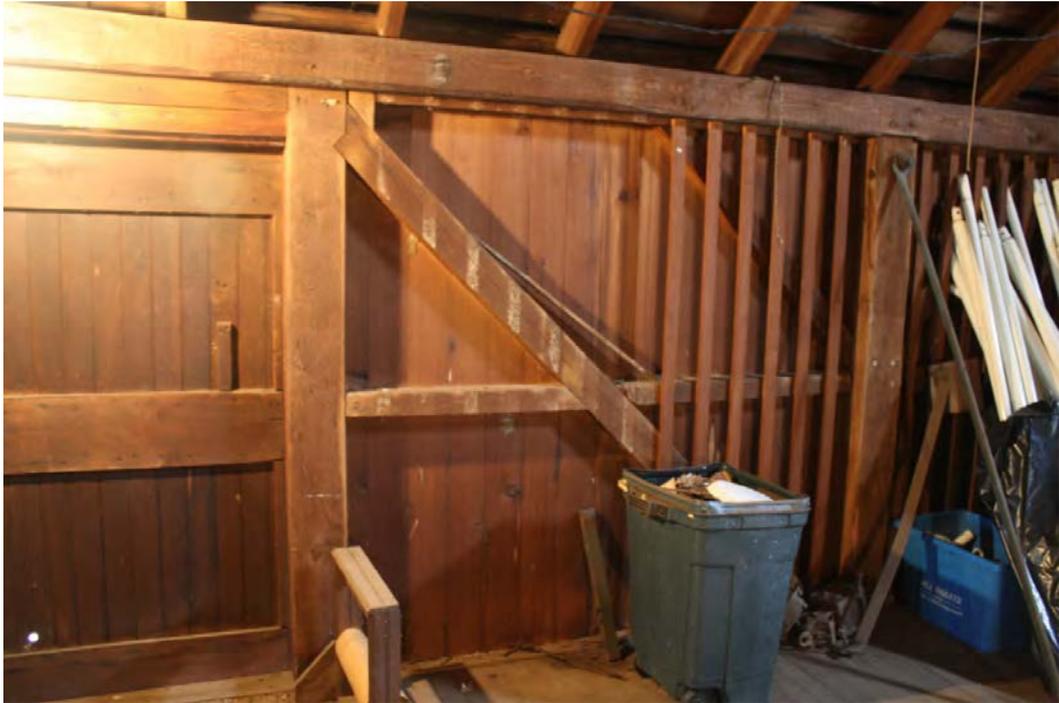
16. Interior view of Barn I second floor level west wall, showing at left the hay door above the arched entrance, at right a typical iron brace, and at center vertical slats lining the wall; camera facing west.

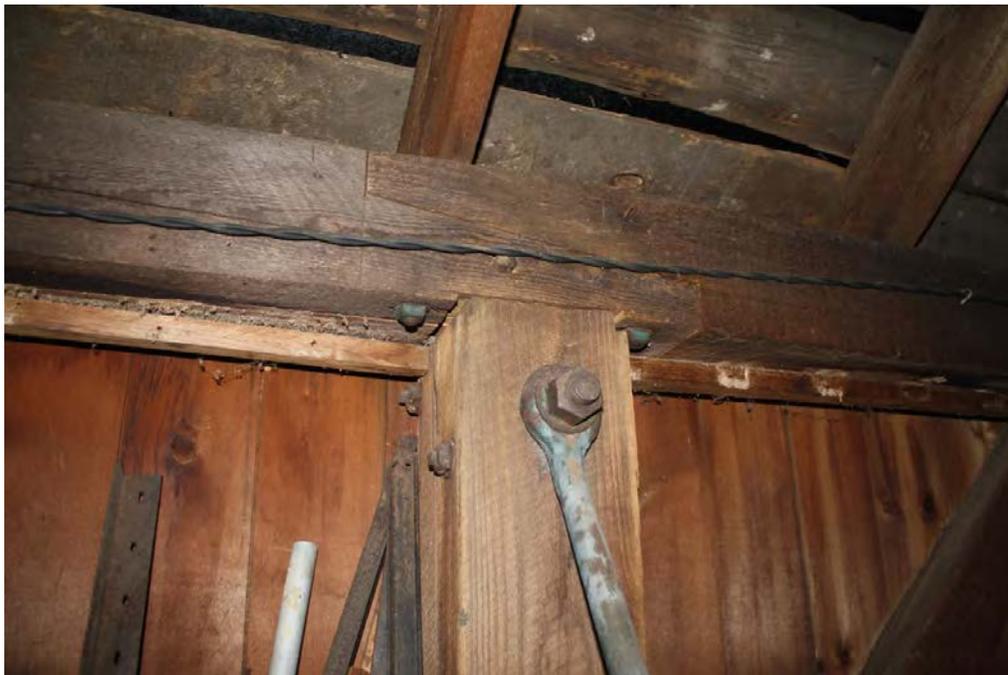
17. Interior detail view of Barn I second floor level east wall, showing a scarf joint in the plate and iron brace connection, camera facing east.

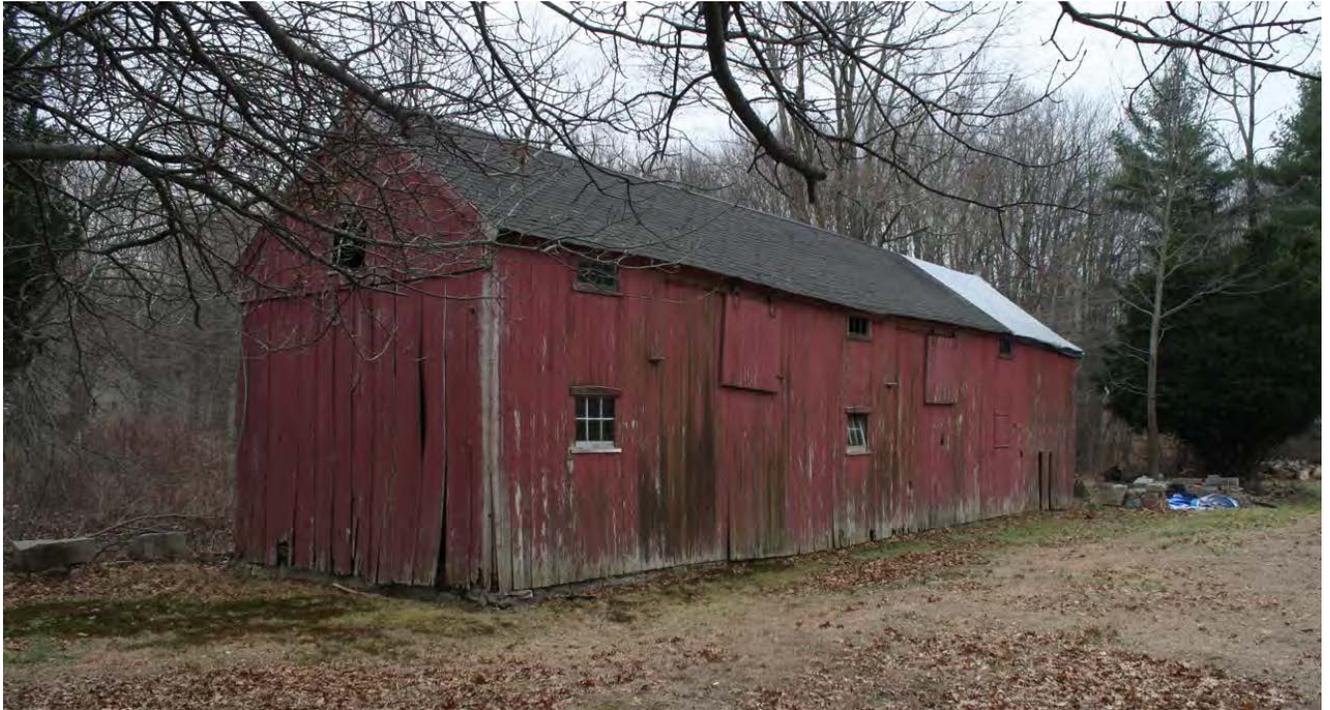
18. Northeast view of Barn II, camera facing southwest.

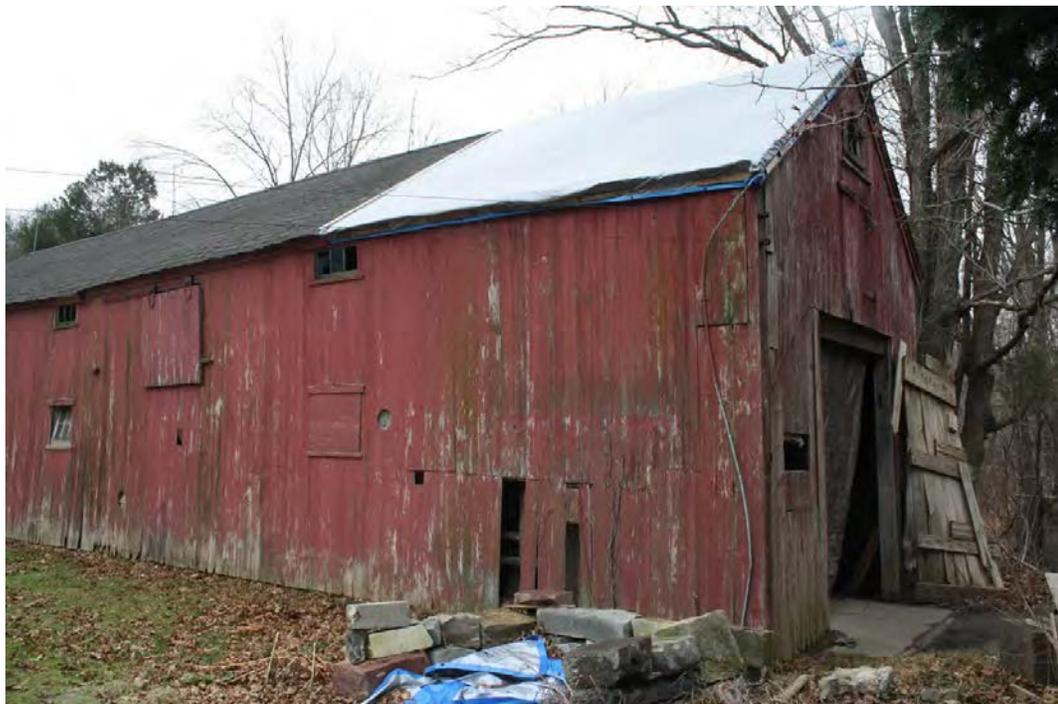
19. Northwest view of Barn II, camera facing southeast.

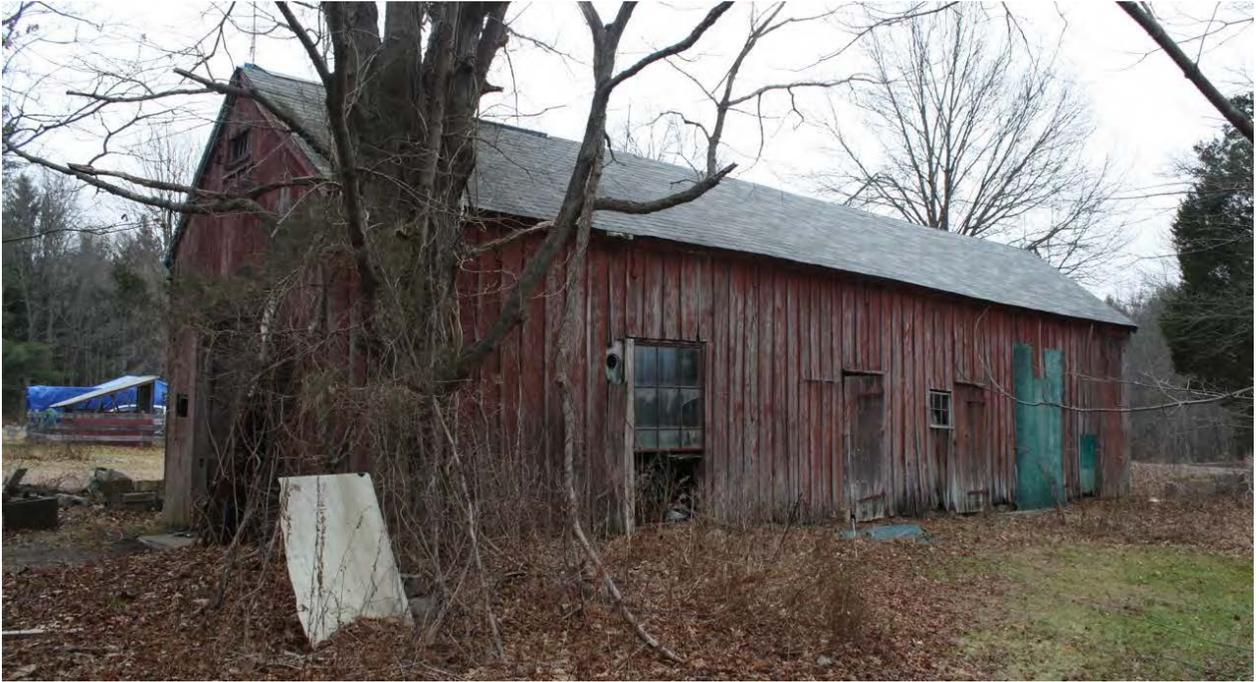
20. Southwest view of Barn II, camera facing northeast.

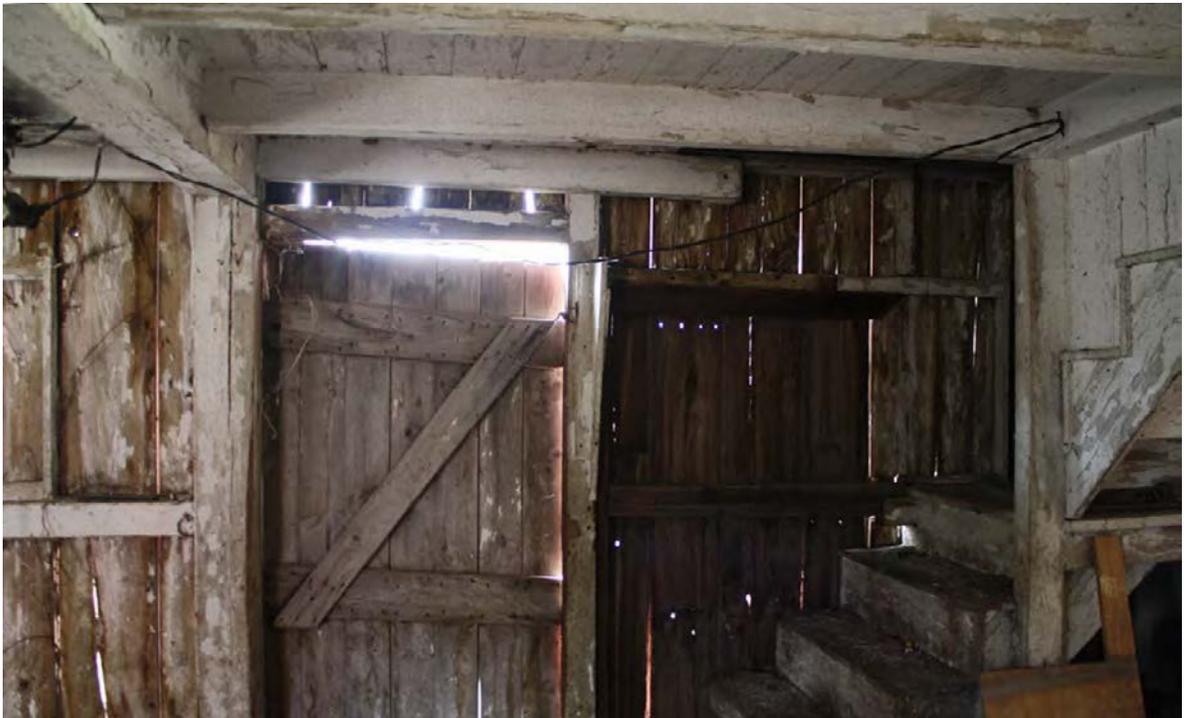
21. Interior view of Barn II ground floor south wall, camera facing south. At right is the stair to the loft.

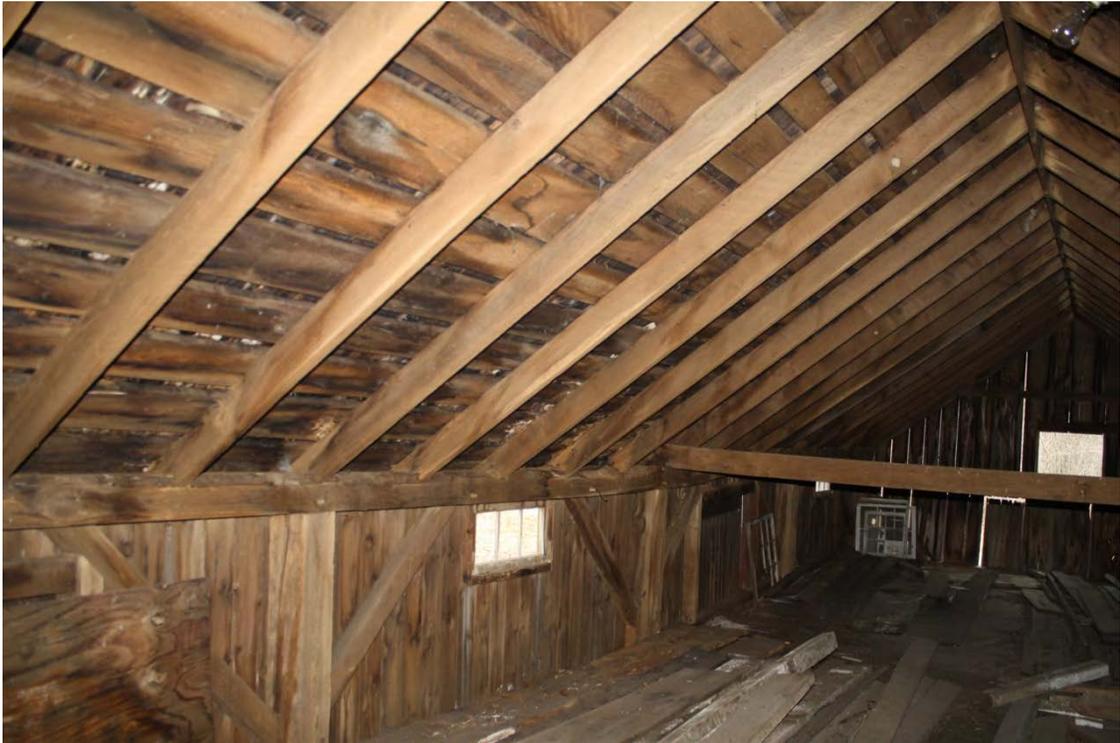
22. Interior view in loft level of Barn II, camera facing east. Note pegged post and beam frame with sawn rafters.

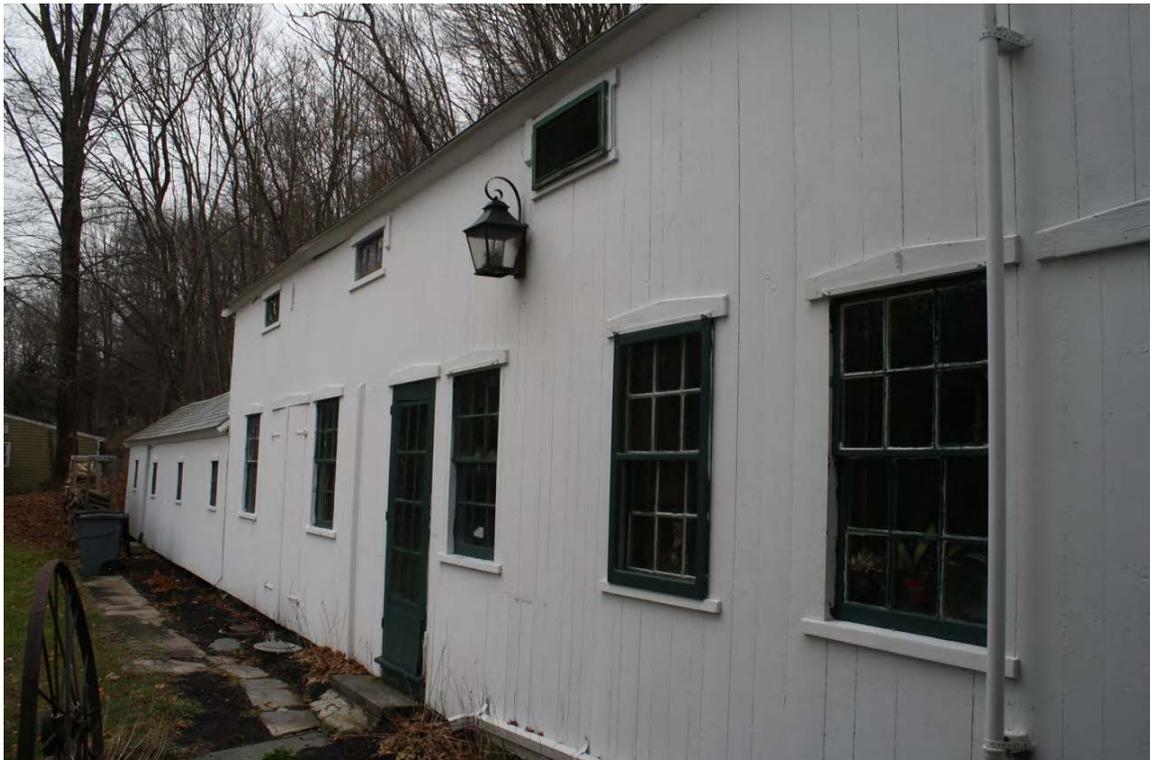
23. East eave-side of Barn III, camera facing south.

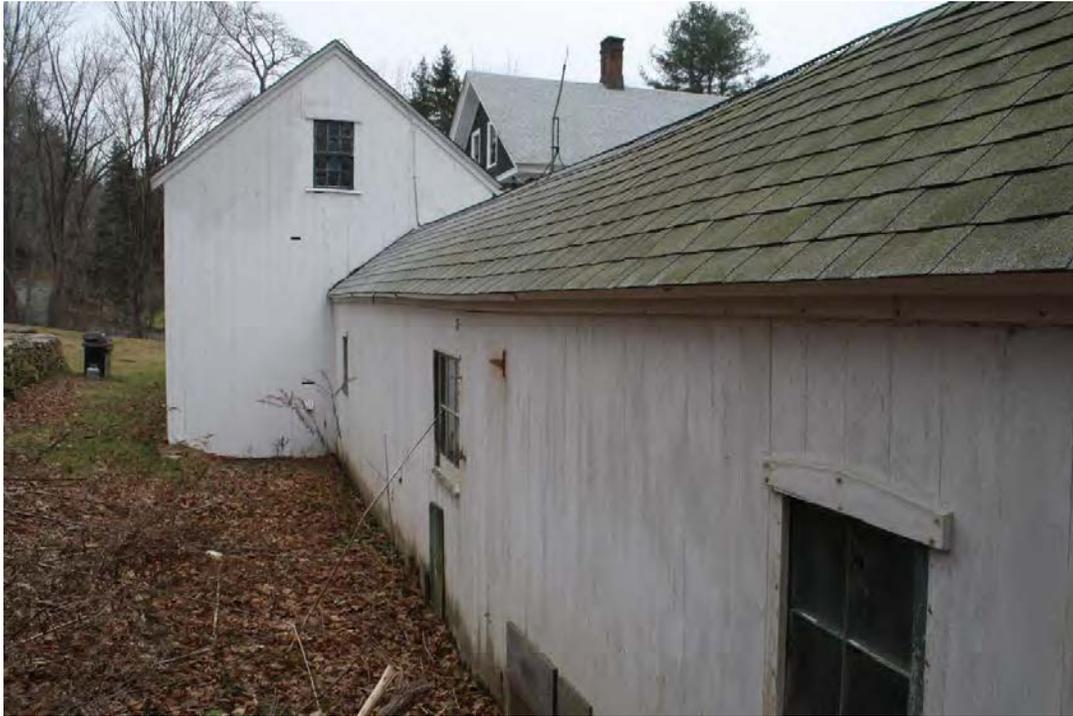
24. South view of Barn III with west side of 1-story wing in foreground, camera facing north.

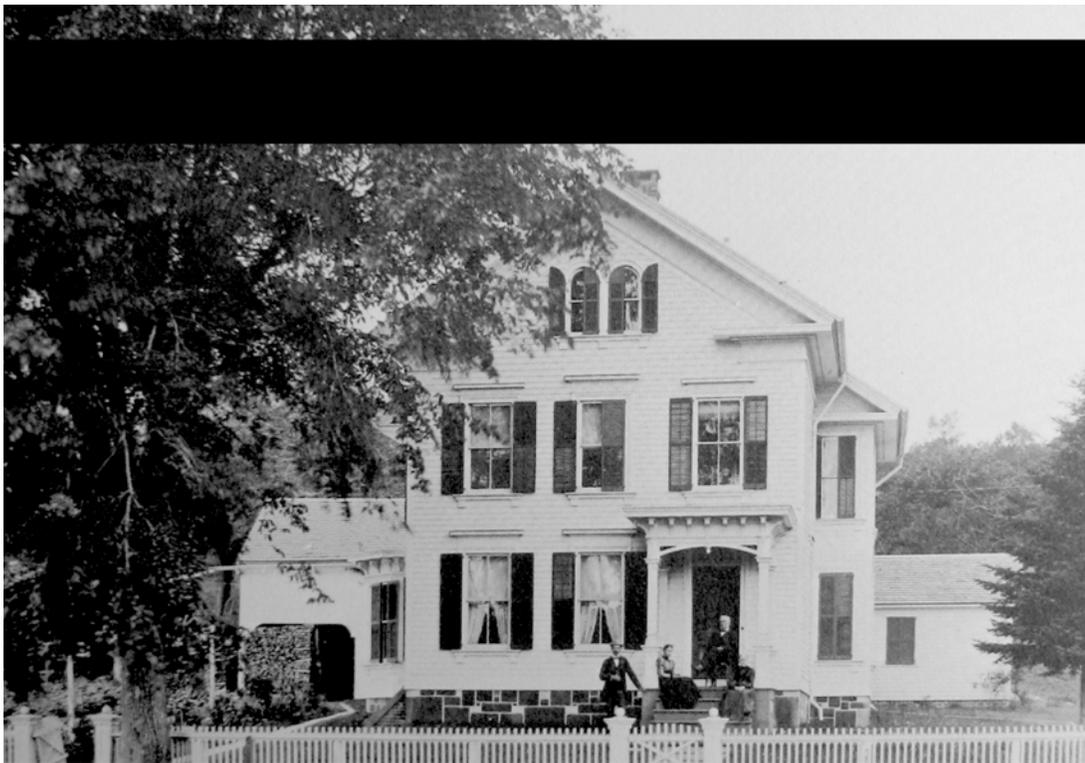
25. Historical east view of the Davidson House c. 1900 by George Levi Wooding. The family on the porch with Tyler Davison at left and S. G. Davidson seated (Bunton). The shed at left rear is smaller than at present.
