HISTORIC RESOURCES

BUILDING AND STRUCTURES

Building Name (Common) Cornwall Historical Society Record No. 34285
 Building Name (Historic) Andrews, John T., Carriage Barn
 Street Address or Location 7 Pine Street
 Town/City Cornwall Village Cornwall Village County Litchfield
 Owner(s) Cornwall Historical Society, PO Box 115, Cornwall CT 06753 Public Private

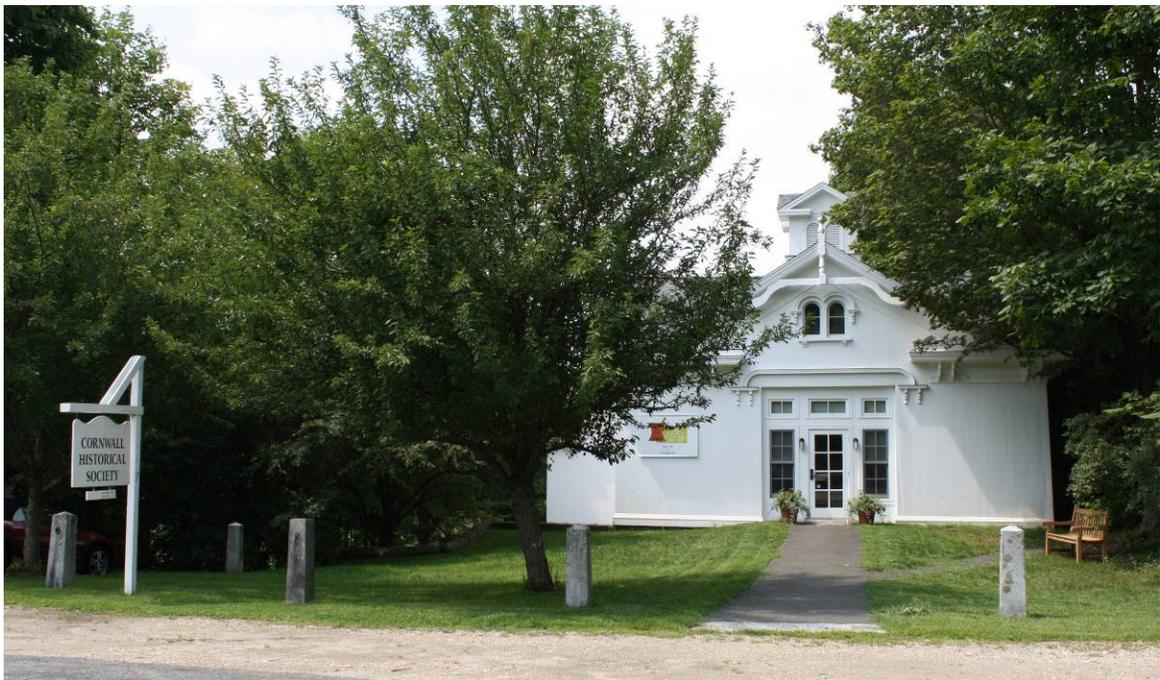
4. East view from Pine Street, camera facing west.

This is a 1 ½-story gable-roofed late 19th-century bank carriage barn. The original volume is a three-bay timber-framed 24- x 30-foot rectangle with a gable roof having its ridge-line oriented north-south parallel to Pine Street. A large cross-gable-roofed wall dormer is set into the east slope of the roof. In the mid-20th century, additions were built at the west side during conversion to a residence, including a shed-roofed addition across the northern two bays. The foundation of this formed the footprint of a 21st-century addition in 2006-8.

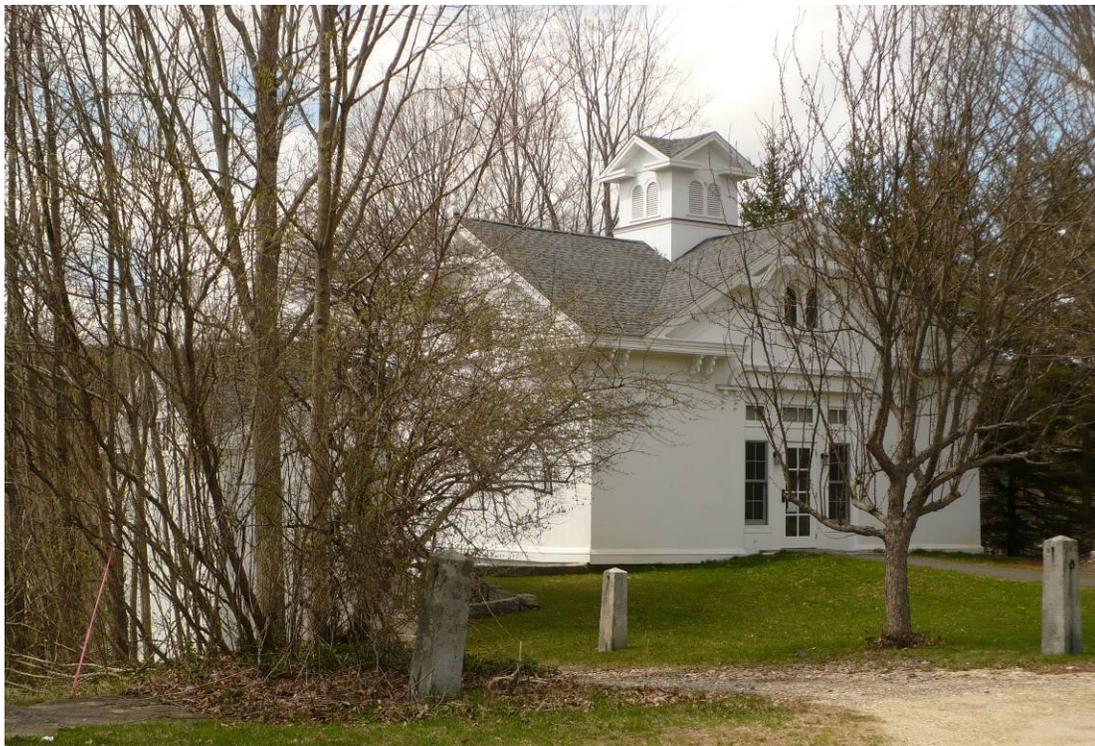
6. Southeast view of carriage barn, camera facing northwest.

The exterior is clad in vertical wood flush-board siding, painted white. The roof is gray asphalt shingles. At the center of the ridge-line is a square cupola. The cupola itself is cross-gabled and the design mimics that of the lower rooflines. Paired arched louvered vents are present on each of the four sides of this cupola. The cupola was removed and replaced by a brick chimney during the mid-20th-century and has been substantially restored in 2006-8. Details are modeled on a historic photograph, though with less extensive ornament.

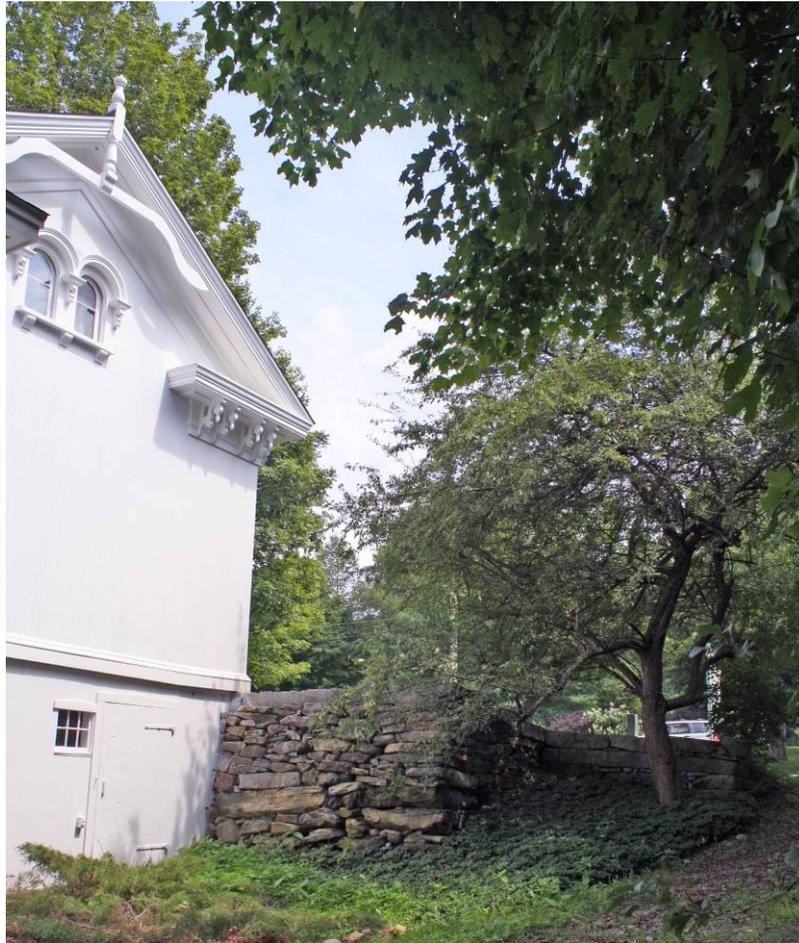
7. South gable-end view with fieldstone retaining wall, camera facing northeast.

The south gable-end has an exposed basement level. The decorative features of this side match those found on the east façade: wide projecting eaves and rakes with cornice returns, paired brackets, a pair of centered arched windows in the gable, and the truss and finial ornament. At the basement level two six-pane stable windows with beveled lintel trim are flanked by on the right (east) a plank door with iron strap hinges and on the left (west) a modern pass-through door with ten panes which is concealed behind a matching plank door when the building is locked. To the west is a projecting new addition constructed in 2008, a 1 ½-story gable-roofed wing.

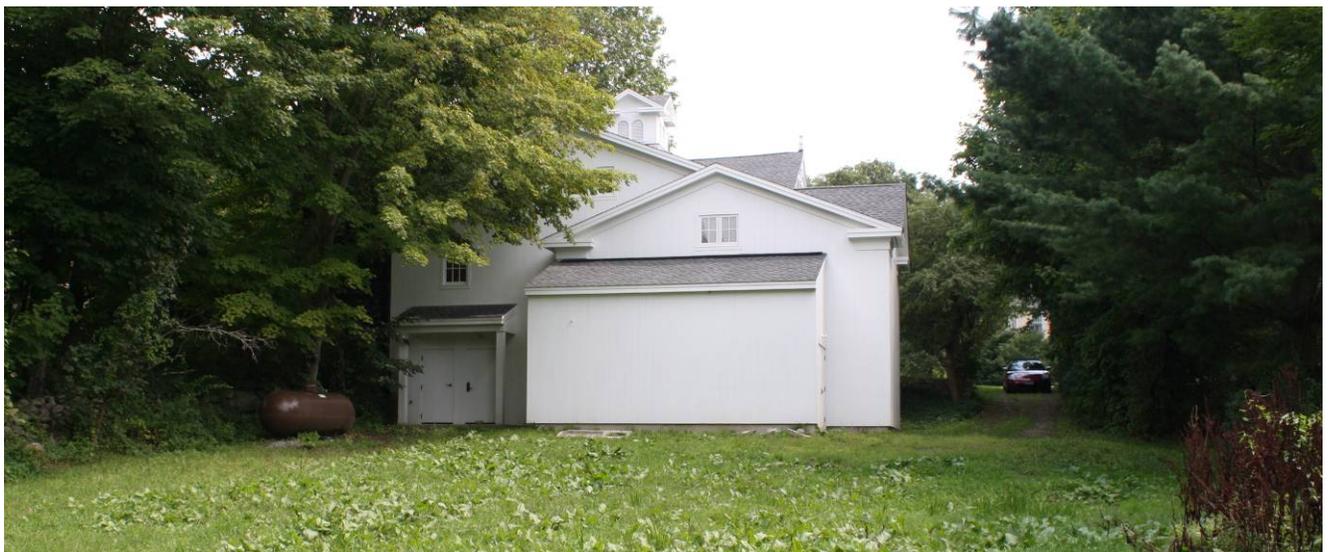
8. West view of rear addition, camera facing east.

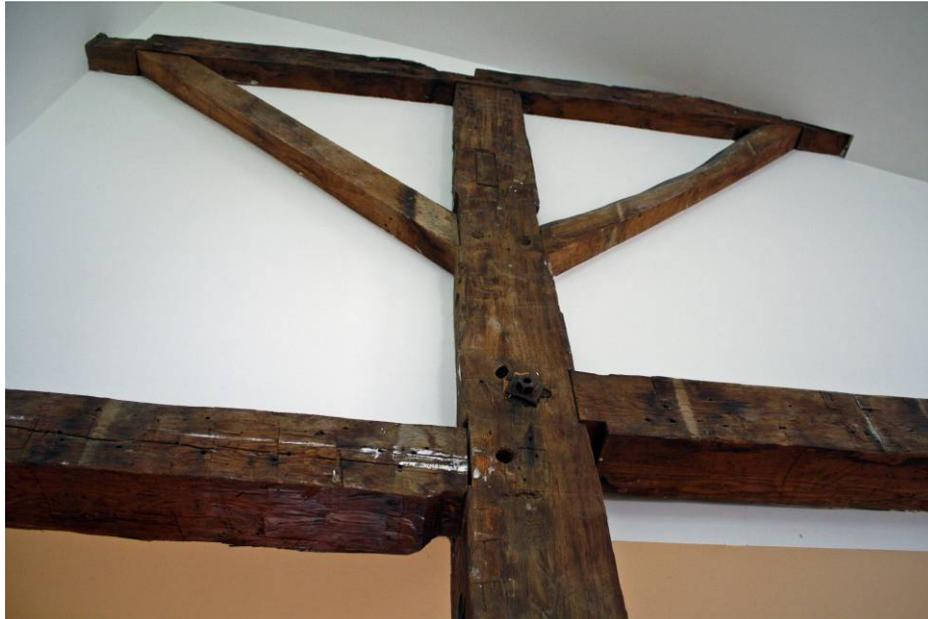
9. Interior view of exposed timber framing at west wall of barn, camera facing east.

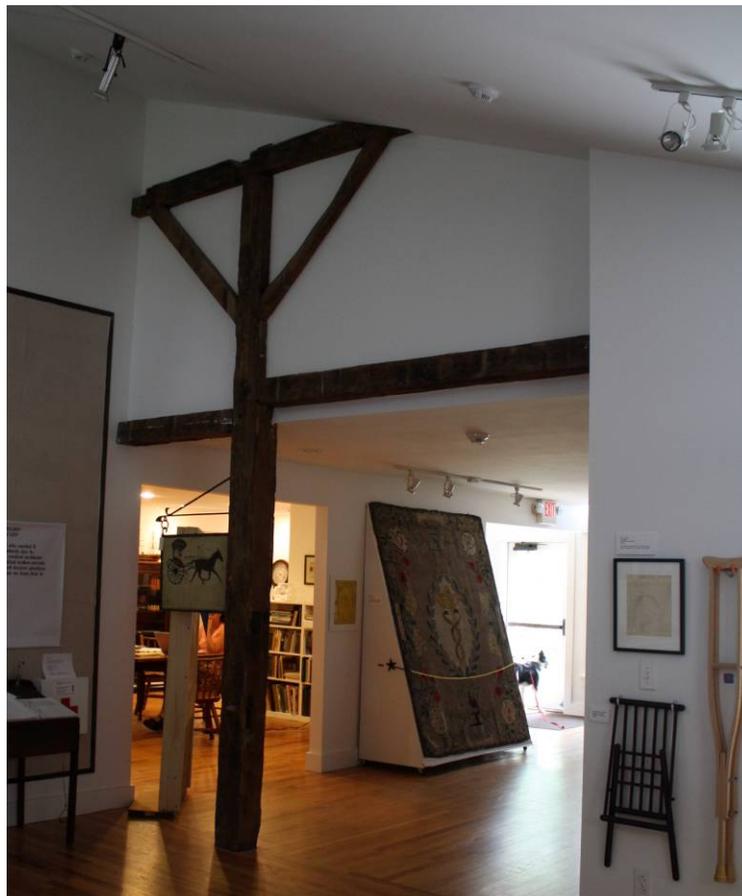
10. Interior view of exposed timber framing at west wall of barn, from southwest gallery, camera facing northeast.

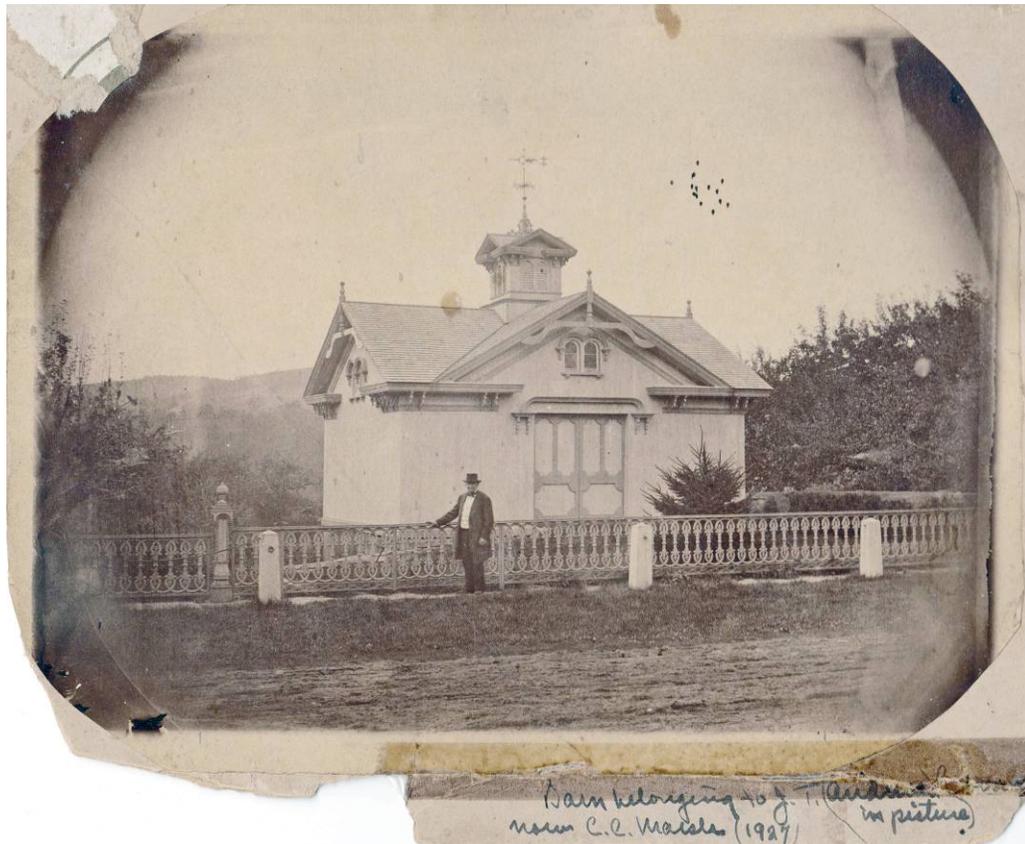
11. Historic photograph of 7 Pine Street, Cornwall Historical Society archives.
