HISTORIC RESOURCES

BUILDING AND STRUCTURES

Building Name (Common) Kaisen Barn and House Record No. 8129
 Building Name (Historic) Dudley, Jared, Farmstead
 Street Address or Location 241 Elm Street
 Town/City Guilford Village North Guilford County New Haven
 Owner(s) Kaisen, Gregory A. & Maria E., 241 Elm Street, Guilford CT 06437 Public Private

Style of building Two-bay English bank barn, Vernacular style Date of Construction 19th c.

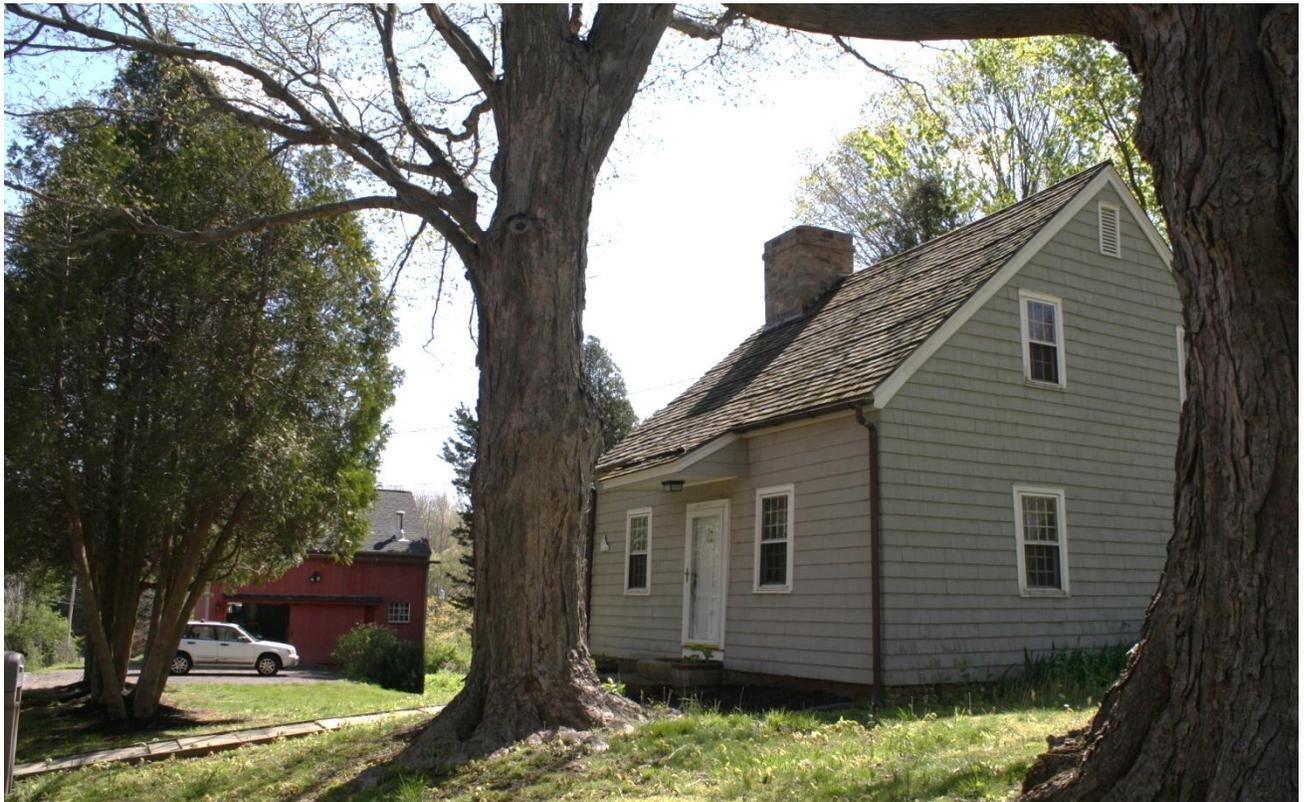
4. Northwest view of farmhouse with barn at left rear, camera facing southeast.

The east and west gable-ends have two twelve-over-twelve double-hung windows at the ground floor level and smaller two six-over-six double-hung windows in the attic level. The massive chimney has a mortared fieldstone exterior and is located against the east gable-end wall. Grade slopes down toward the east, partially exposing the mortared fieldstone foundation wall, which has a door into the cellar at the left (south) corner of the east wall. Siding is wood shingles painted gray with white wood trim. Roofing is wood shingles.

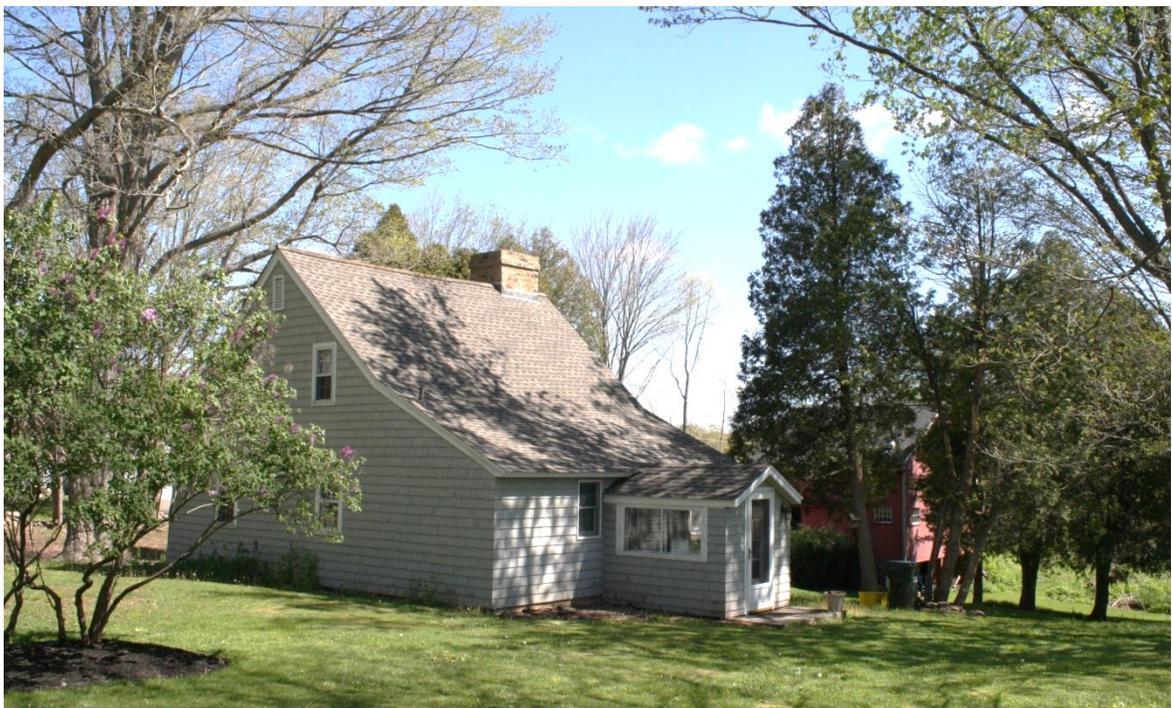
5. Southwest view of house, barn at right rear, camera facing northeast.

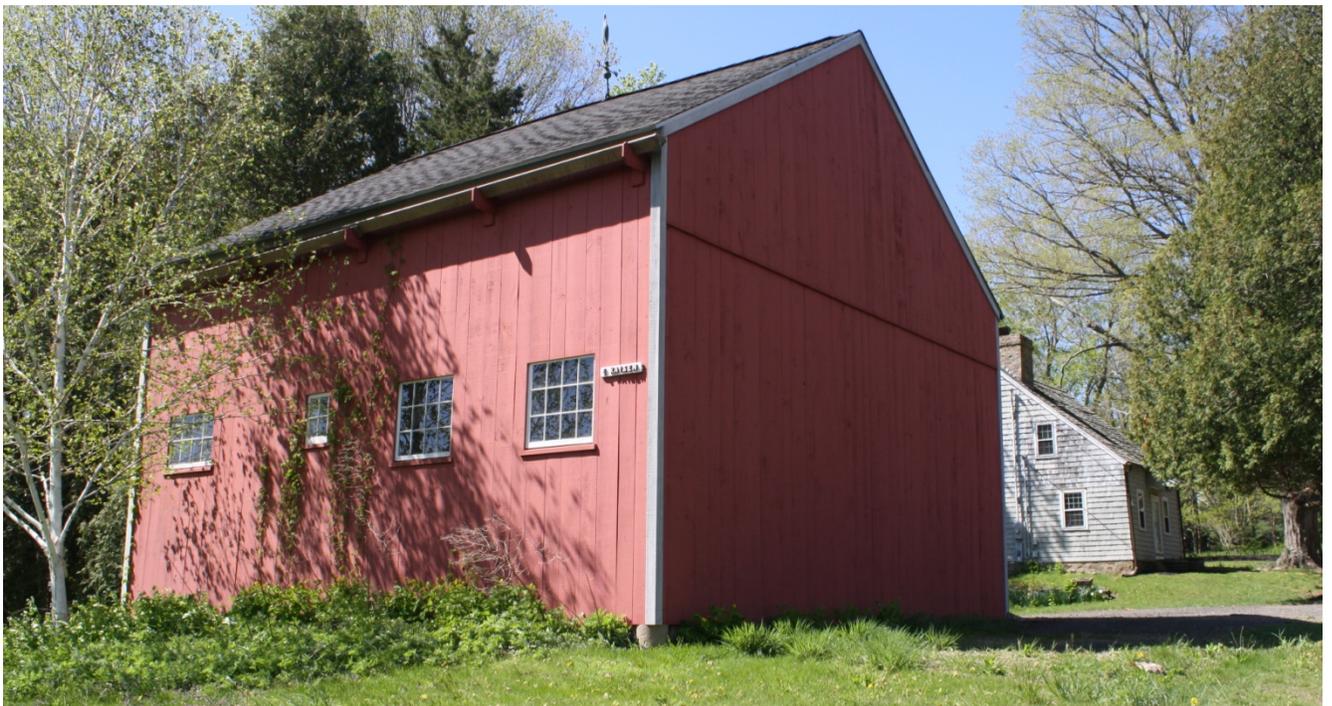
7. Northeast view of barn with house at right rear, camera facing southwest.

The north gable-end of the barn has no openings. At the northeast corner, a new concrete foundation pier has been added, with fieldstone foundation walling infill along both adjoining sides. The barn has vertical, flush-board siding painted red with white sash and gray corner boards. The foundation is mortared fieldstone. The roof has asphalt shingles. Traditional wood gutters have been installed along the eaves. A small wood sign with the letters “E KAISEN” is mounted on the east wall near the right (north) corner. On the ridge is a rooster weather vane.

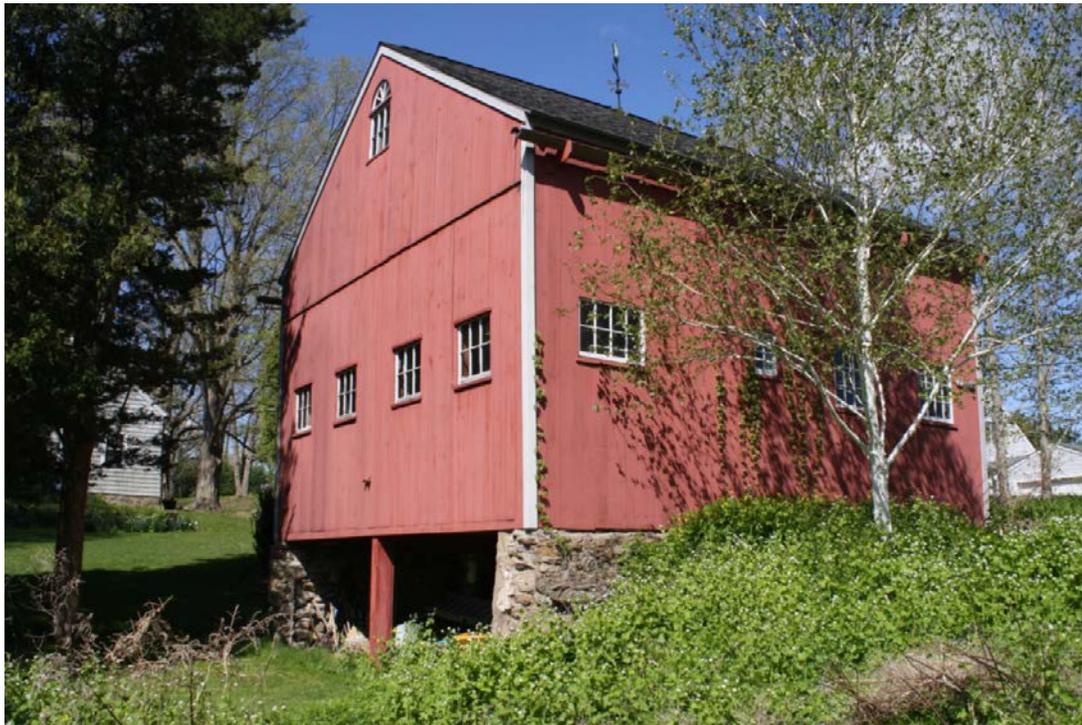
8. Southeast view of barn showing banked basement; farmhouse at left rear, camera facing northwest.

The main entrance is a sliding exterior door under a shallow wood-shingled hood, with access by a paved ramp. Beneath the south corner of the hood is a pass-through door. South of the ramp the grade declines sharply, revealing an exposed mortared fieldstone foundation. Toward the south corner of the eave-side wall is a stable window with twelve-pane sash. A metal stove pipe is located in the southwest corner of the roof.

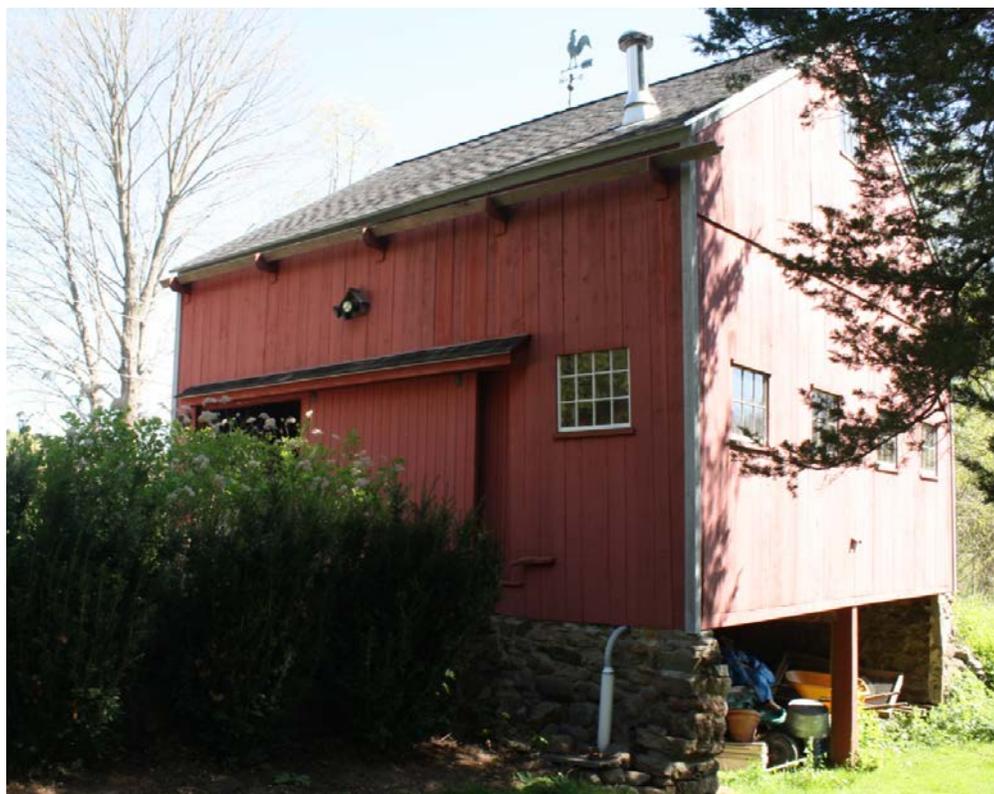
9. Southwest view of barn showing banked basement, camera facing northeast.

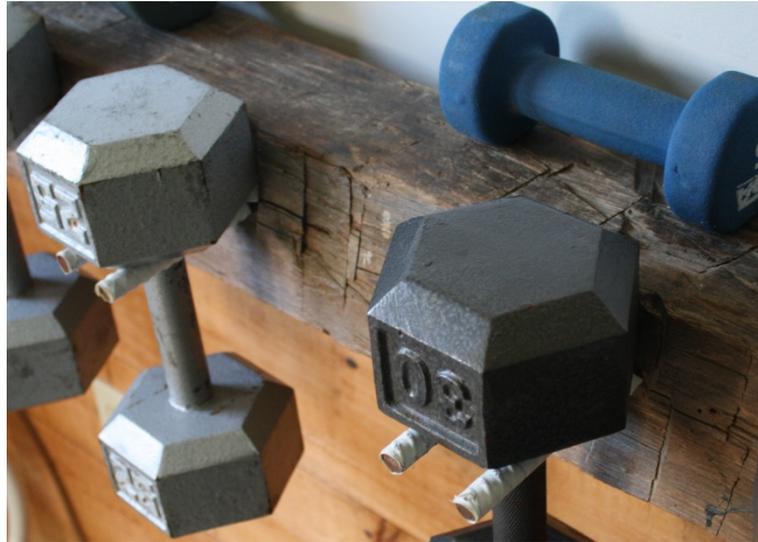
10. Interior view of hand hewn timber of center bent, in exercise room, camera facing southeast.

The interior now includes a finished exercise room in the northeast quadrant of the ground level, an insulated and finished workshop in the south bay, with a wood stove for heat, and a stair to the loft level storage area. The northwest quadrant of the ground level, accessed via the sliding barn door, is a parking space for a tractor. The basement remains open to the south; the floor framing of the main level is predominantly replacement construction during the renovation work.

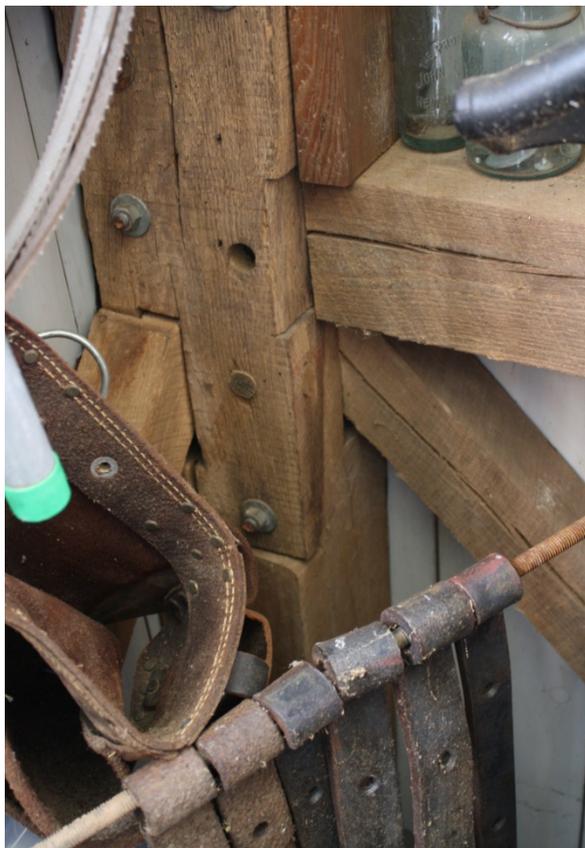
11. Interior view of south bent, in workshop, camera facing southeast, showing repaired post with scarf joint. The upper section is sash-sawn. Square rule framing is evident in the wall girt joint. At foreground are the iron hinges formerly on the hay doors.

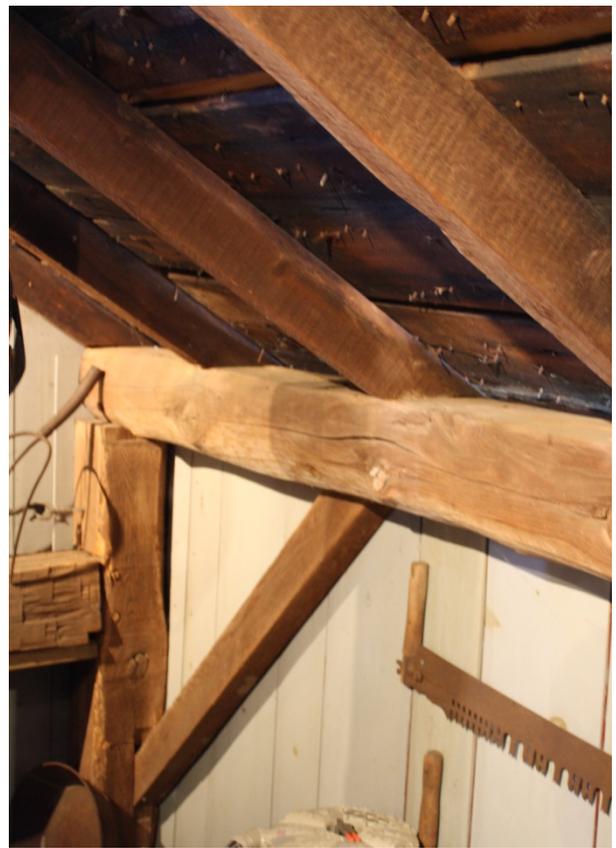
12. Interior view southwest corner of loft level showing dropped girt, plate, and rafters.

The rafters are of dimension lumber butted at the ridge without a ridge board, suggesting a mid- to late- 19th – century date; however it is often unclear whether the rafters are original or replacement work. The roof deck boards are wide random-width material, again indicating a mid-19th-century construction, or a re-use of old materials during later repairs.

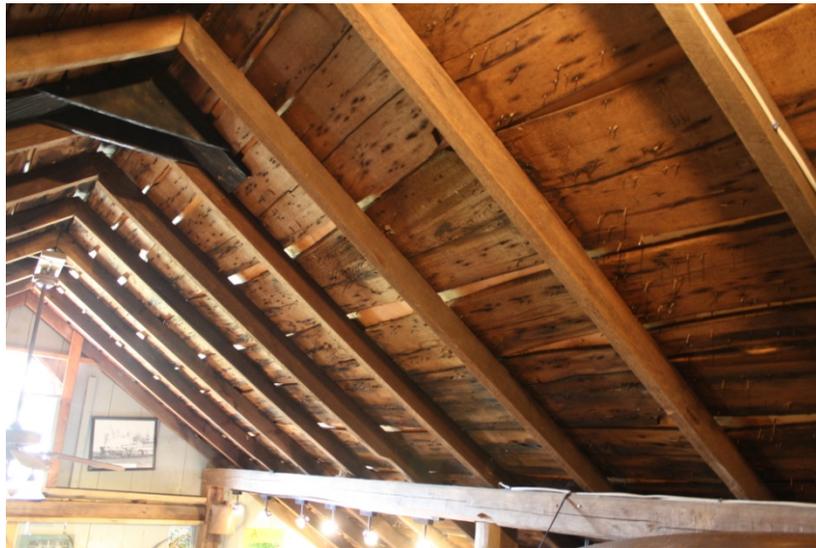
13. Interior view of roof framing and purlin, camera facing south.

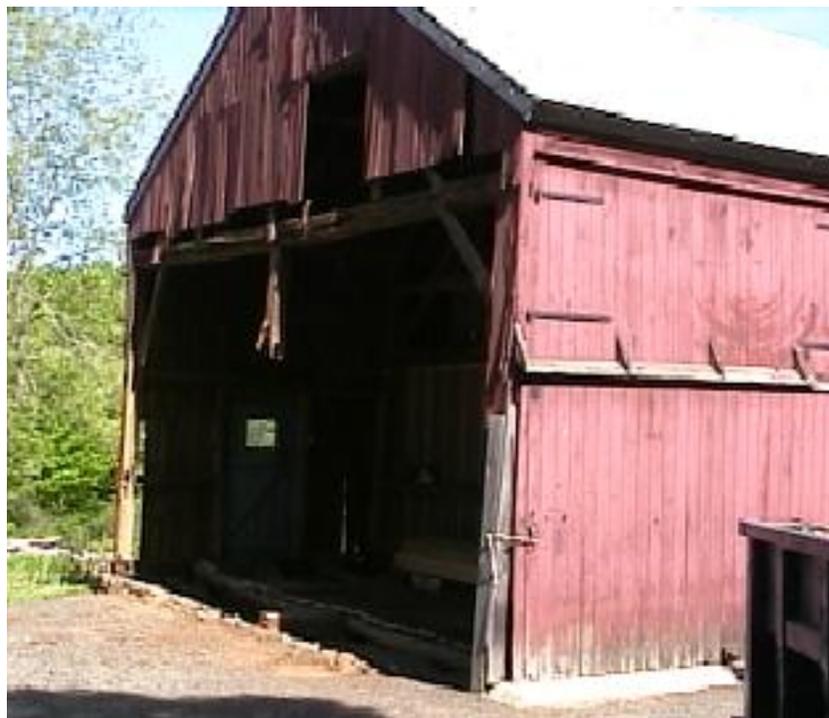
14. Northwest view during renovation, showing hay doors with iron strap hinges at right.

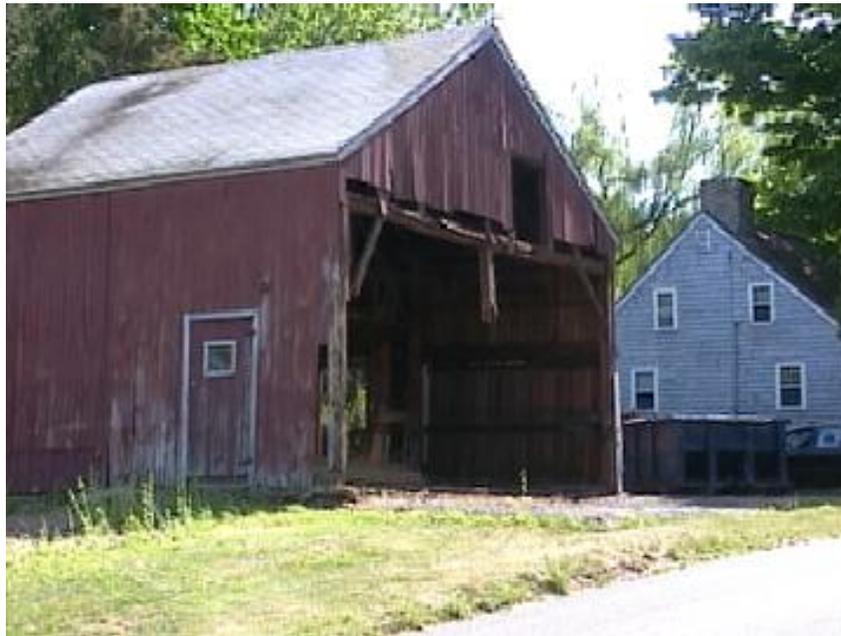
15. Northeast view during renovation, showing east side and extent of demolition at north.

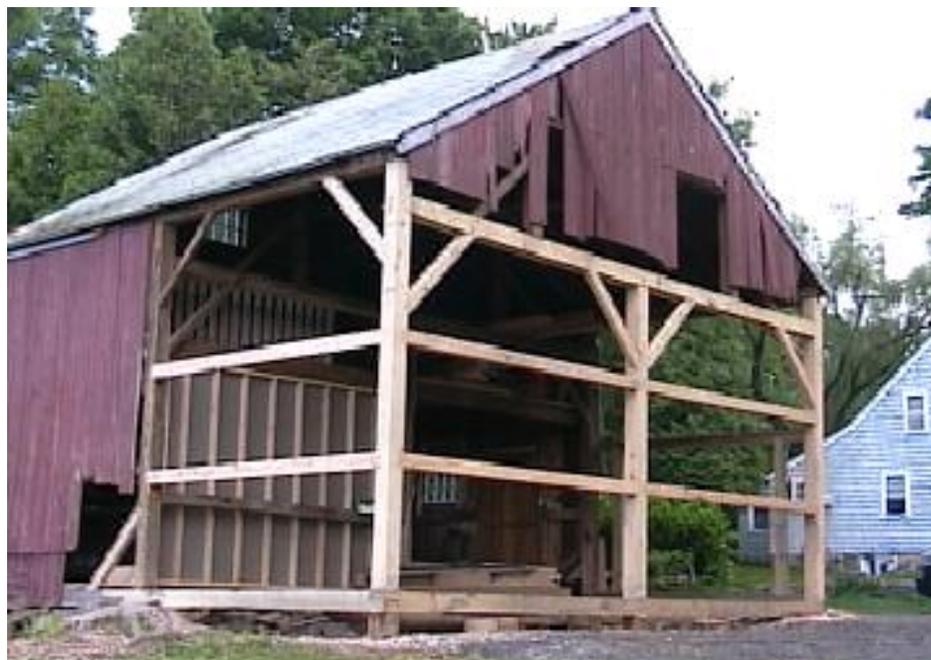
16. Northwest view during renovation, with new north bent prior to installation of siding.
