**HISTORIC RESOURCES**

**BUILDING AND STRUCTURES**

Building Name (Common) Parmelee, Chauncy and Jerusha, Farmstead Record No. 20613  
Building Name (Historic) Parmelee, Chauncy and Jerusha, Farmstead  
Street Address or Location 476 Route 81 (Higganum Road)  
Town/City Killingworth Village \_\_\_\_\_ County Middlesex  
Owner(s) Broach, Robert & Florence, 476 Route 81, Killingworth CT 06419  Public  Private

Style of building English barn, Vernacular style Date of Construction Late 18th c.

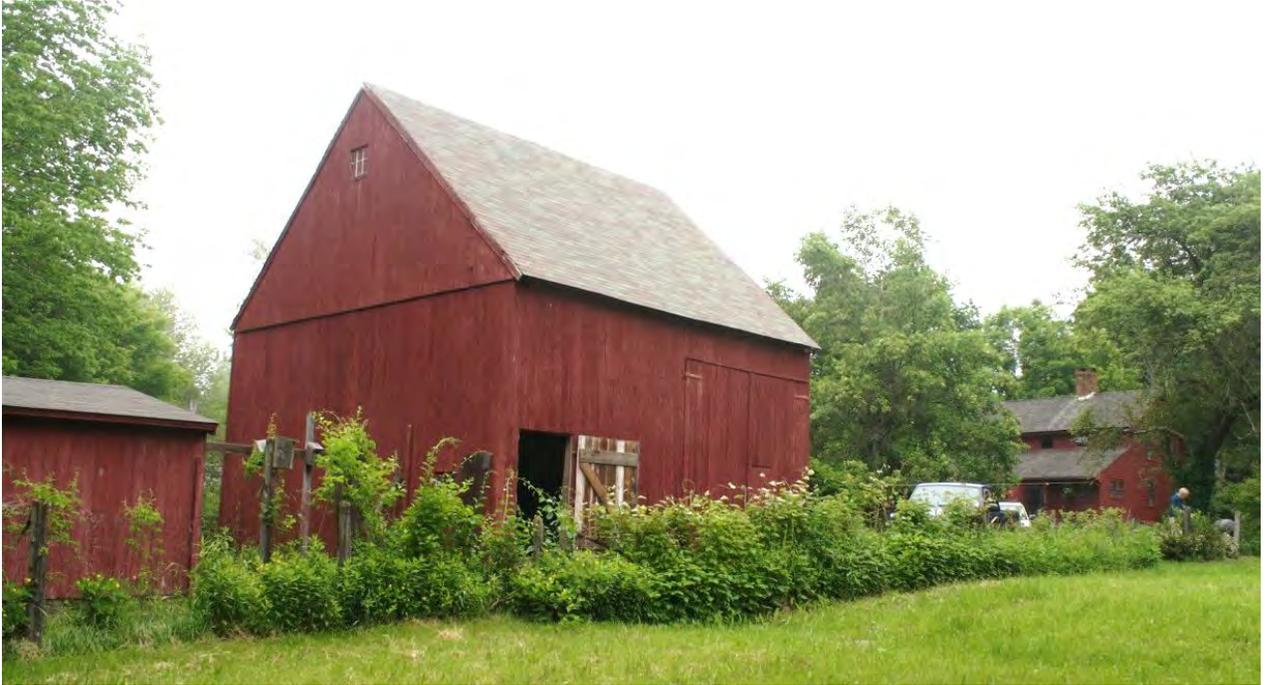
8. Southwest view of Barn I with Chicken coop at left, Farmhouse at right rear, camera facing northeast.

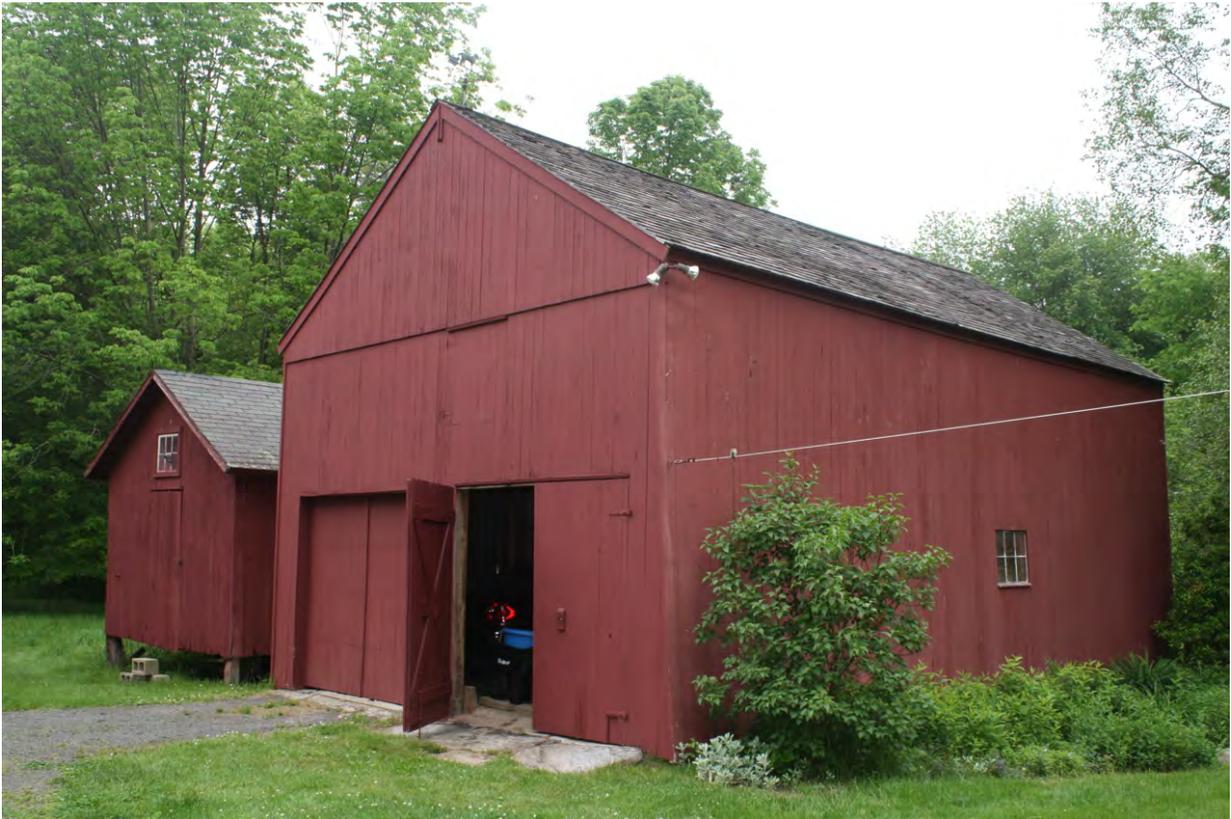
10. Southeast view of Corn crib (left) and Barn II (right), camera facing northwest.

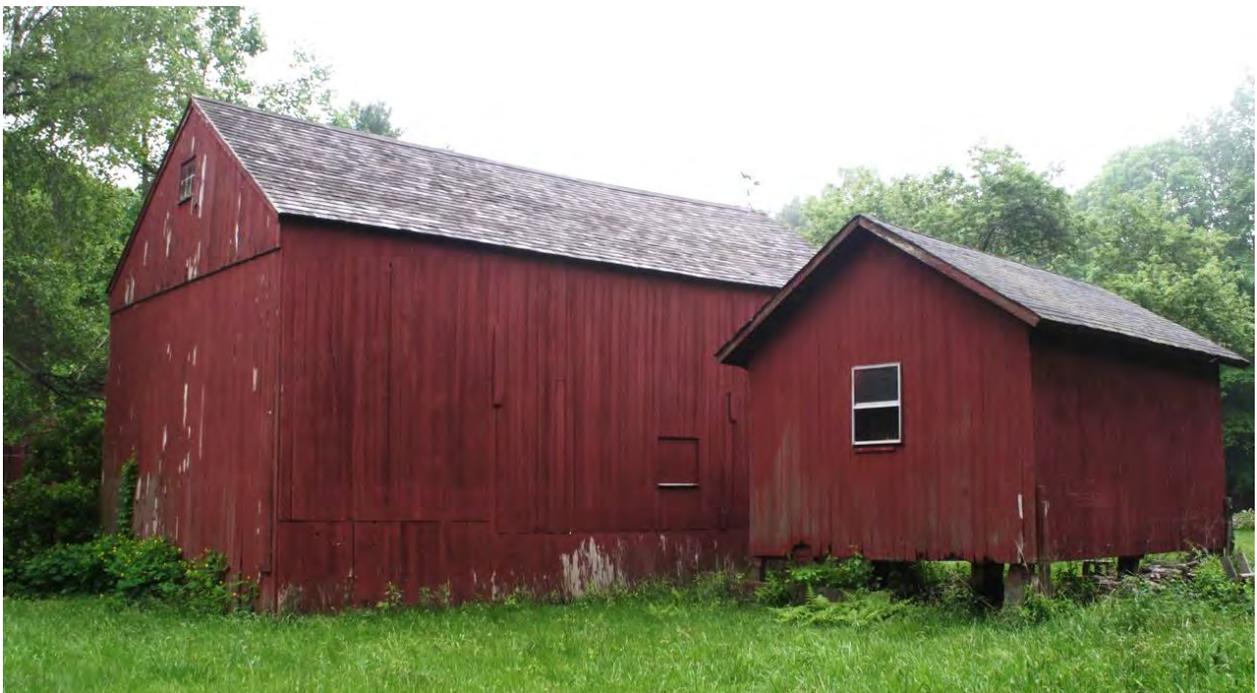
11. Northwest view of Barn II (left) and Corn crib (right), camera facing southeast. Note stone piers at Corn crib.

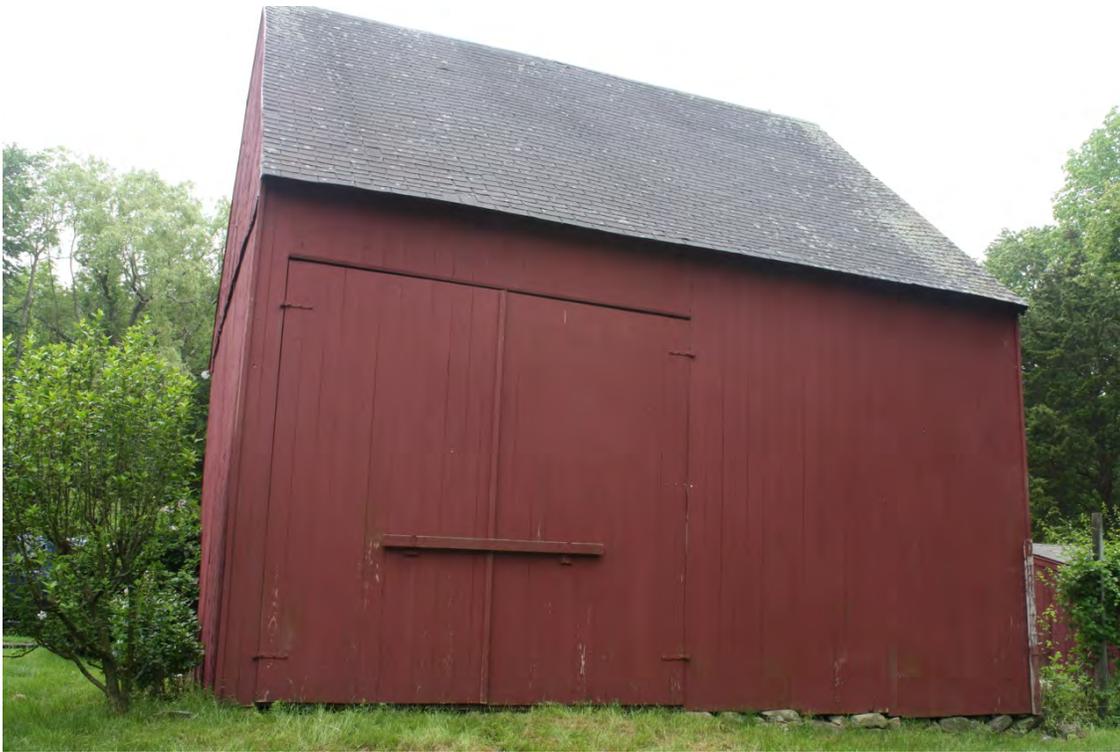
12. North view of Barn I, camera facing south.

The north eave-side has a pair of full-height hinged out-swinging doors in the left (east) bay, no openings in the right bay, and a small exposure of fieldstone foundation wall toward the right (west) corner; grade is sloped up to the door sill at the left bay. The east gable-end has no openings. The siding divide is at the eave line, signaling the tie girt in the plane of the plate in the framing. The roof has no overhang at the rake.

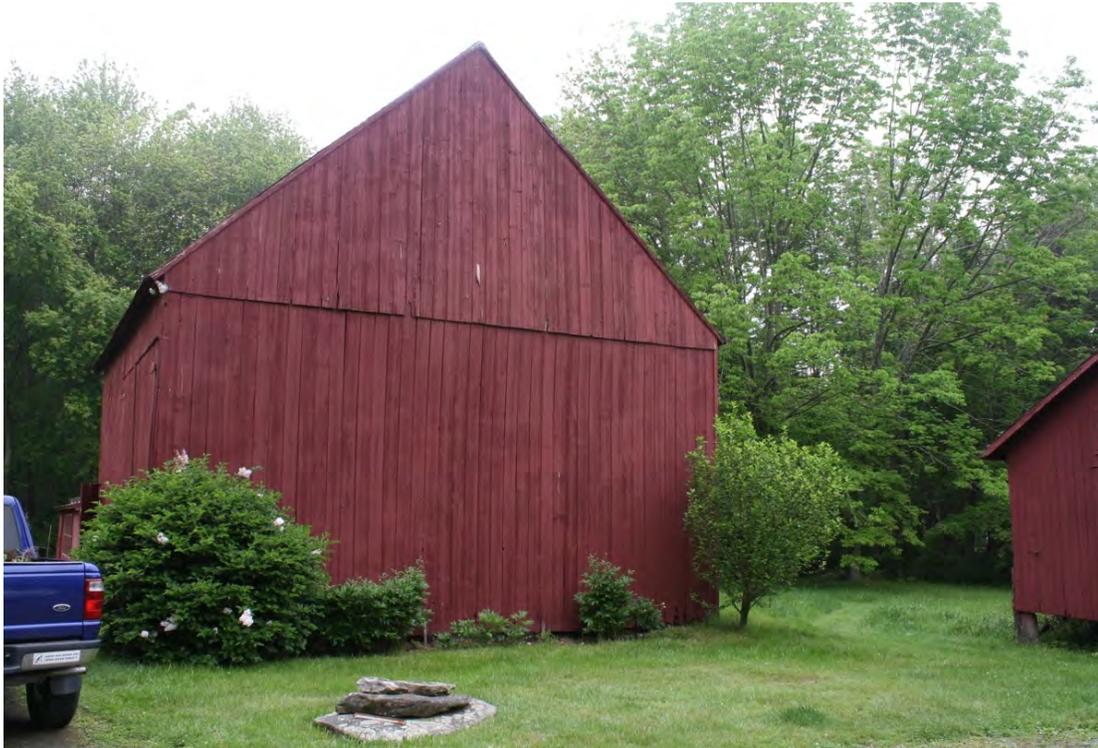
13. East view of Barn I, camera facing west. Corn crib is visible at right.

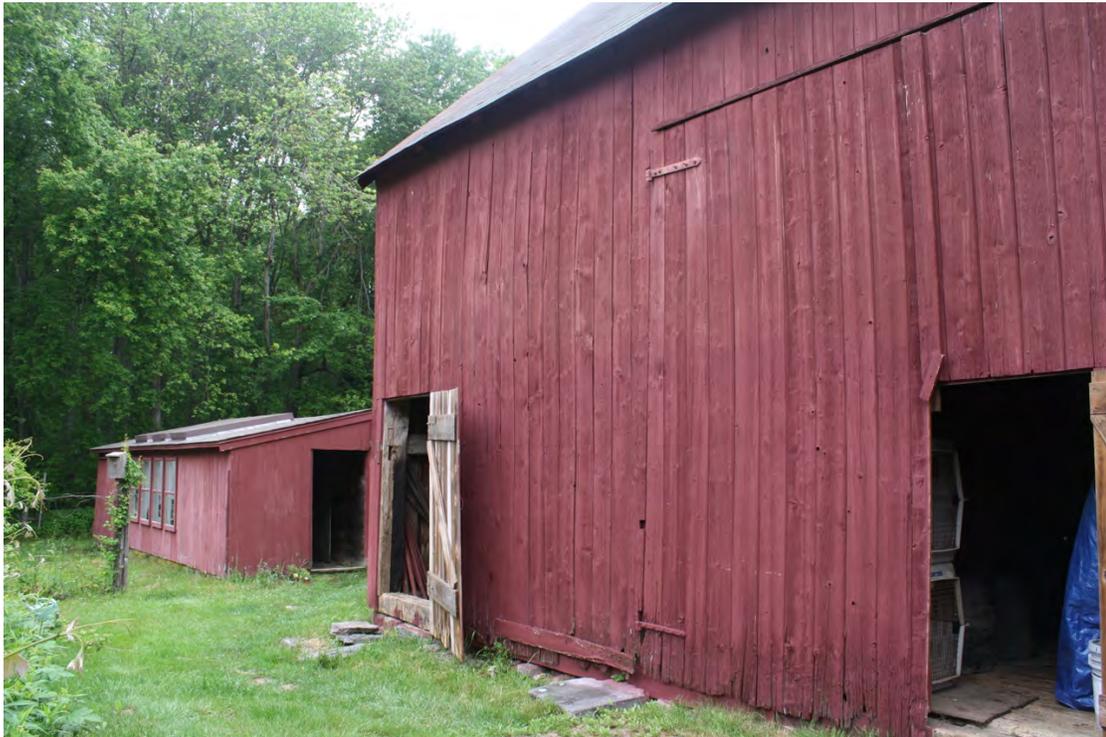
14. South view of Barn I showing hinged barn doors, weather door, pass-through door, and Chicken coop at left rear; camera facing northwest.

The south eave-side has a pair of hinged doors corresponding to the north, in the right (east) bay. These are similarly framed with z-bracing on the interior and vertical flush boards on the exterior and have iron strap hinges. A weather door is in the right leaf. At the left (west) corner there is a pass-through door that gave access to the cow stable area in the west bay of the barn. The west gable-end has a single six-pane stable window in the right (south) half at grade level and a small six-pane attic window near the peak. Approximately a foot of foundation wall is exposed below the siding on this side. The eaves have a very slight overhang, while the rakes are flush, with a narrow rake board over the siding. Siding is vertical boards painted red. The steeply-pitched roof has asphalt shingles.

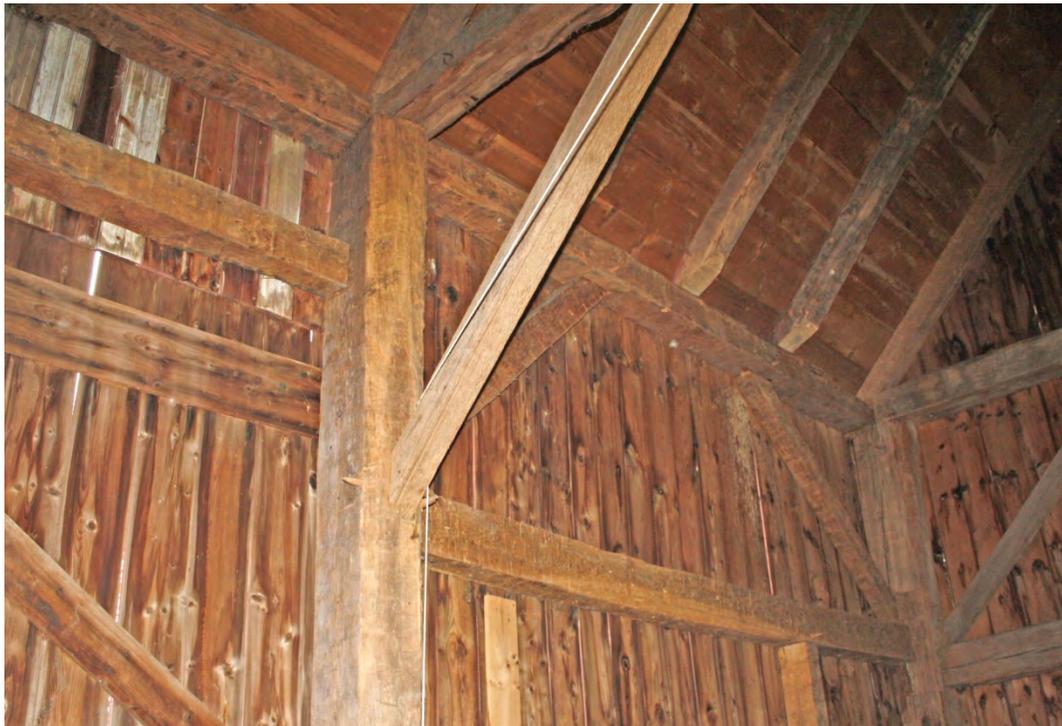
15. Interior view of Barn I, southwest corner; camera facing southwest. Note tie girl joining into plate at the top of posts – gunstock shape visible in corner post.

This barn is highly significant for its apparent early date and type of construction. A number of characteristics point to an 18<sup>th</sup>-century date, including: the steep, medieval-style roof pitch, gunstock corner posts with tie girts joined at the plate elevation, scribe rule framing, hand hewn rafters half-lapped at the ridge, and the unusual full-height center posts with longitudinal braced tie. Much of the original fabric remains and has been maintained in good condition.

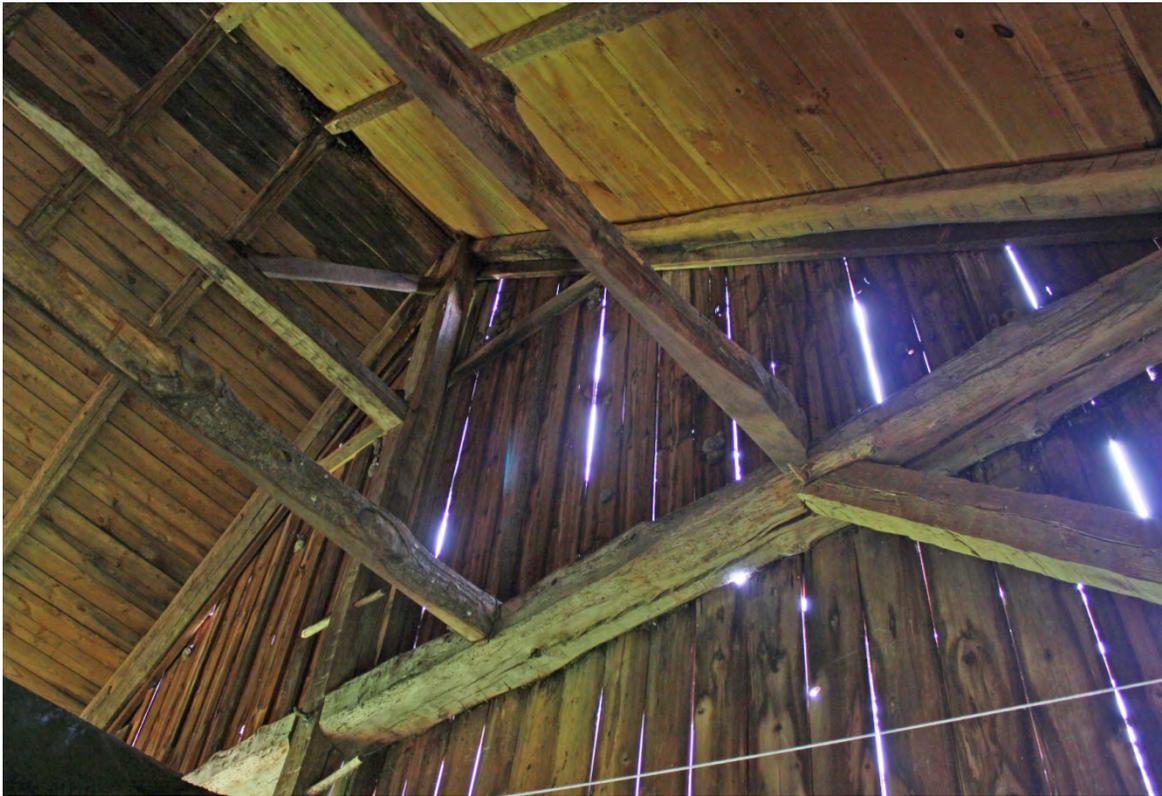
16. Interior view of Barn I east wall, camera facing northeast. Note full height center post up to roof peak.

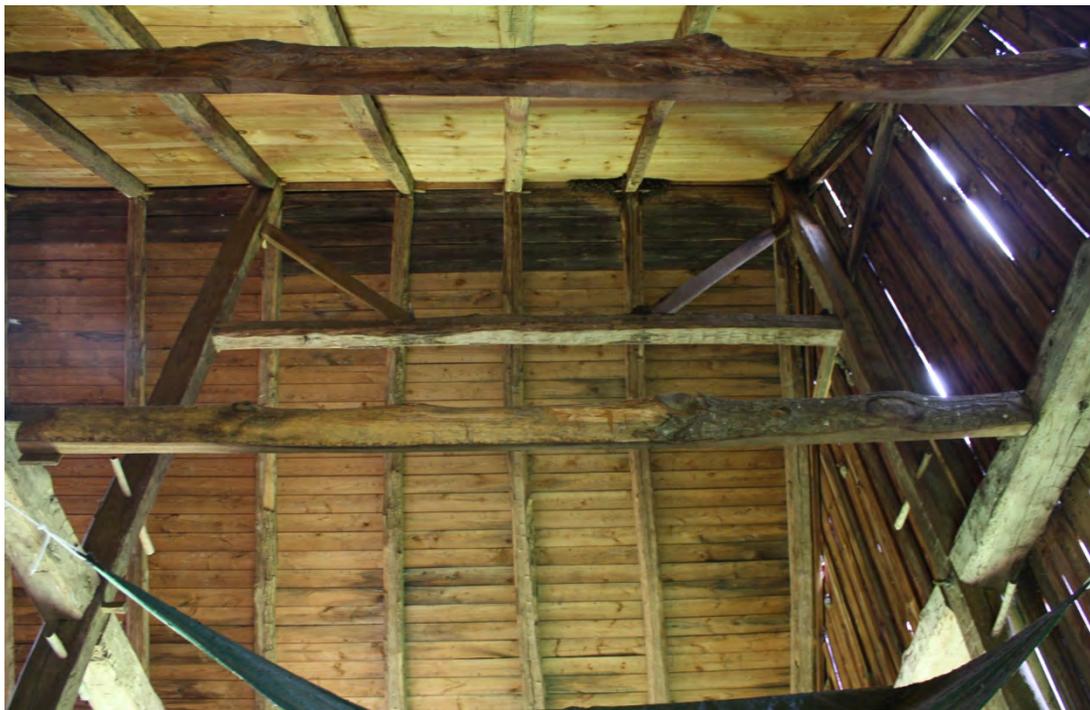
17. Interior view looking up toward roof peak in east bay, camera facing north. Note longitudinal tie member and angle braces between two full-height center posts.

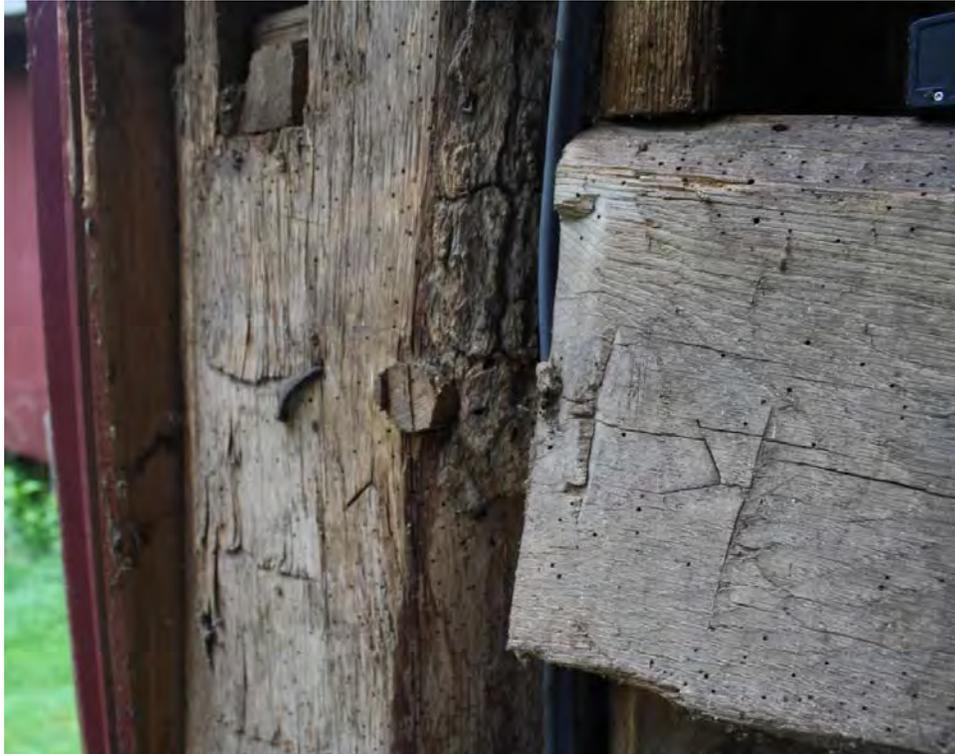
18. Interior detail view of Barn I showing scribe rule marriage marks and hewn timbers.

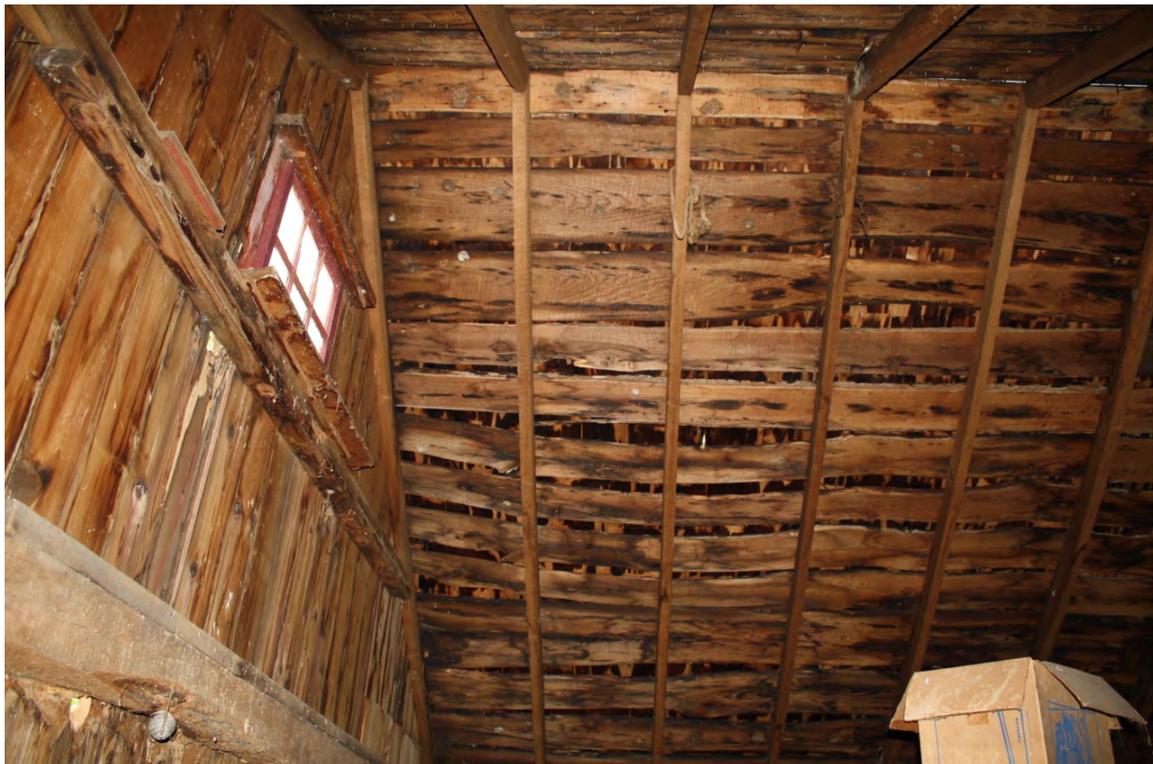
19. Interior of loft at Barn II, showing sawn rafters and random spaced decking planks; camera facing east.

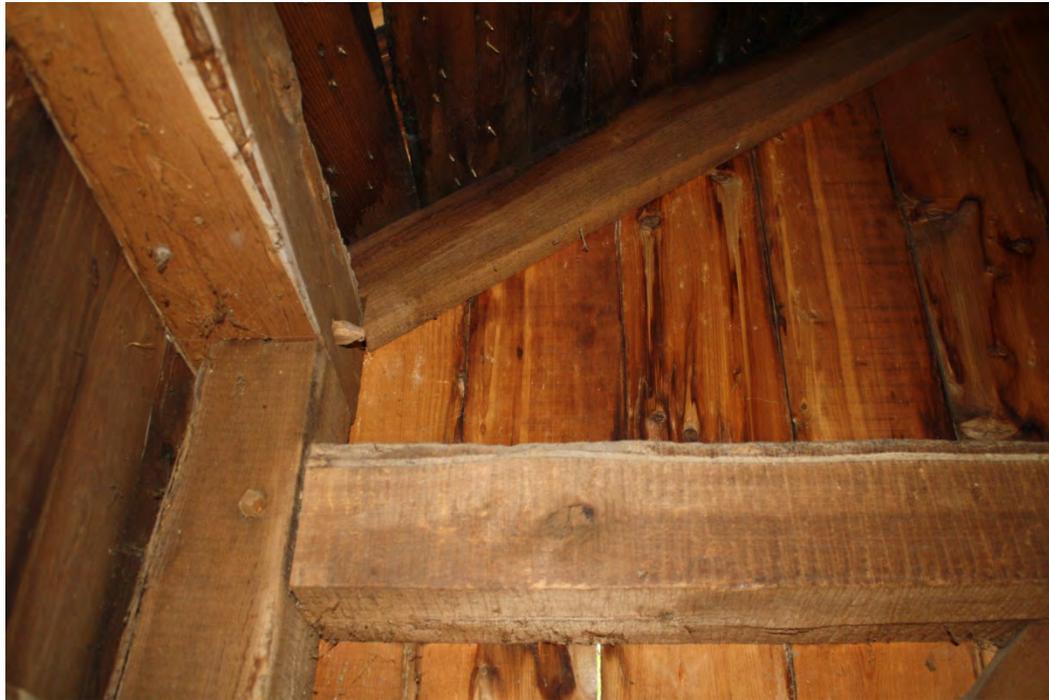
20. Interior detail view of Barn II framing at northwest corner ladder opening, showing dropped girt, saw kerf marks; camera facing north.
