HISTORIC RESOURCES

BUILDING AND STRUCTURES

Building Name (Common) Barn Hill Studio & Gallery Record No. 38462
 Building Name (Historic) Gray-Hurd Farmstead
 Street Address or Location 20 Barn Hill Road
 Town/City Monroe Village _____ County Fairfield
 Owner(s) Dohanos, Linda & Gilchrist, Timothy, 20 Barn Hill Road, Monroe CT 06468 Public Private

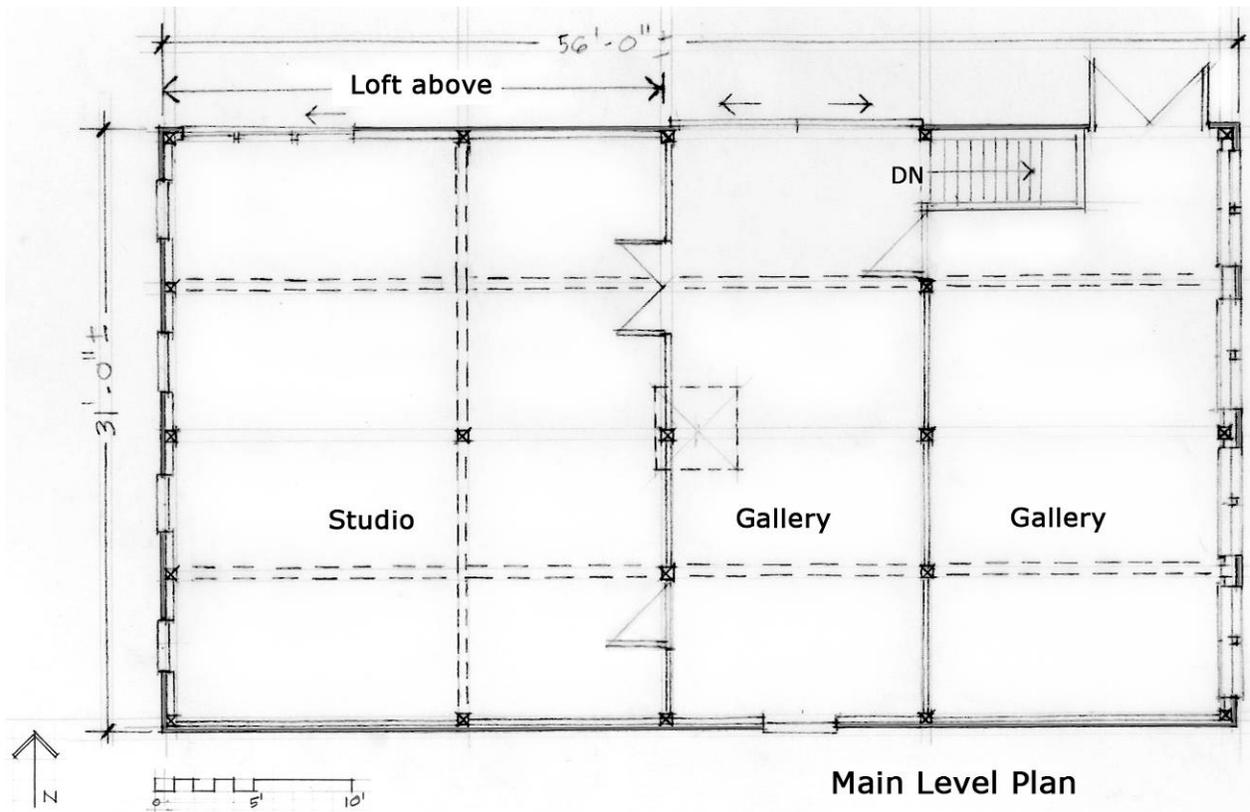
Main Level Plan
Gray-Hurd Barn
20 Barn Hill Road, Monroe CT

5. Plan sketch – main level.

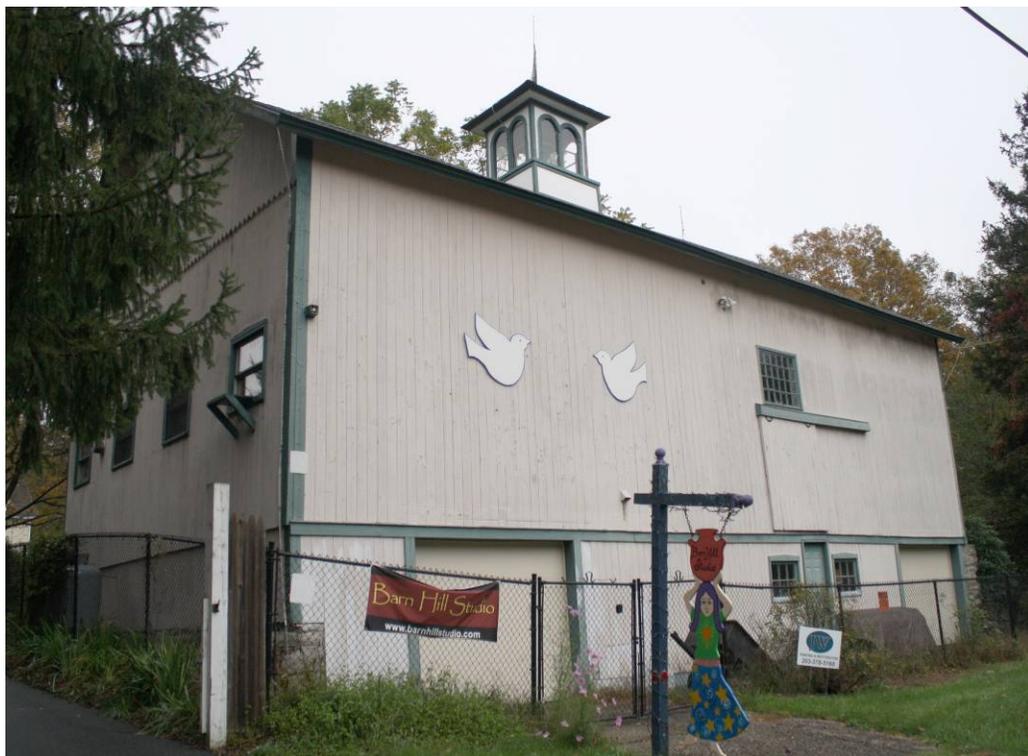
7. Southwest view, camera facing northeast.

The south eave-side of the barn has a horizontal trim course separating the bank level from the main level above. The basement wall has vertical wood siding, and the interior is accessed by two over-head garage doors – one towards the left (west) and the other towards the extreme right (east). These have replaced sliding doors, as evidenced by grooves in the siding above. A modern pass-through door located in the second bay from the right (corresponding to the threshing floor bay above) is flanked by a six-pane window with frame on each side. At the main level above, an exterior-hung sliding hay door is at the first floor level, above the pass-through door. A twenty-four pane window is centered above the sliding hay door. A pair of ornamental wood cutouts of doves is mounted on the upper wall of the western bays.

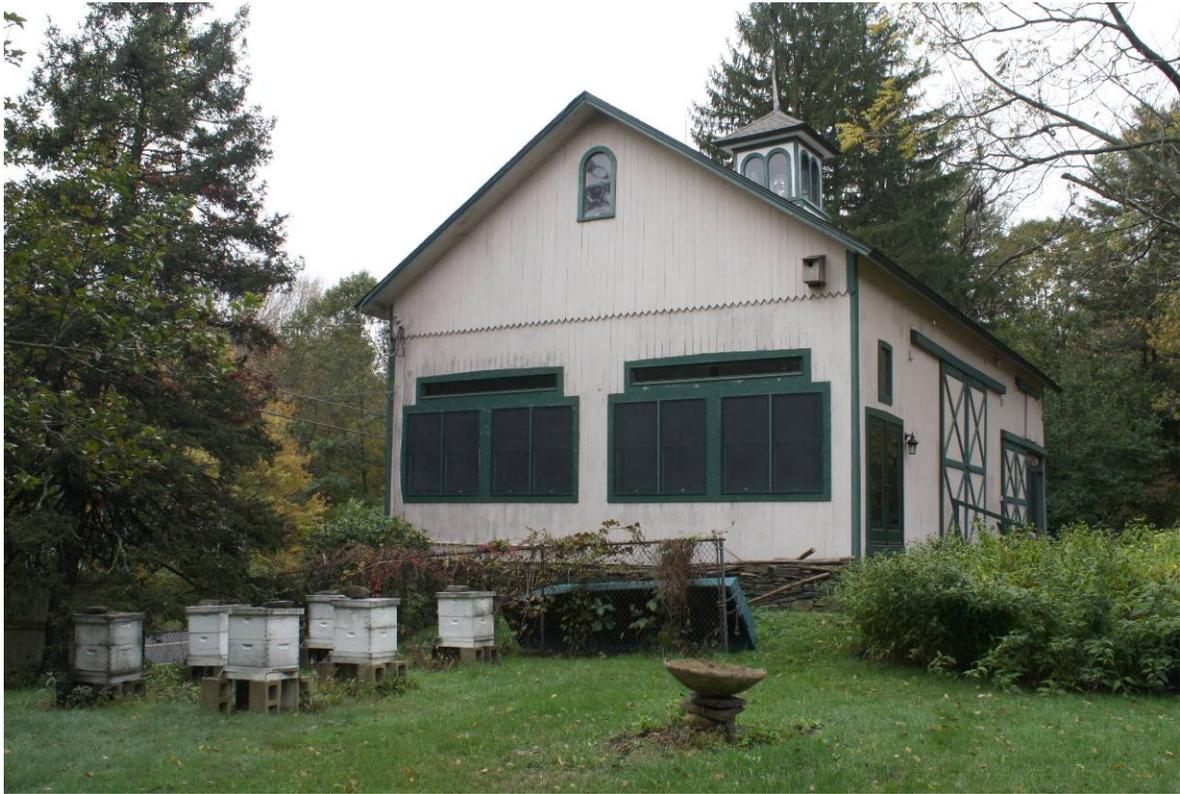
8. Northeast view, camera facing southwest.

The grade level along the east gable-end of the barn slopes down from north to south, partially exposing the unmortared full-height fieldstone masonry foundation wall. The masonry projects out beyond the plane of the wall above. The main floor level of the east gable-end has eight modern one-over-one double-hung windows. These are grouped into two panels of four, with a horizontal transom above each of the two panels. The gable attic matches the east end.

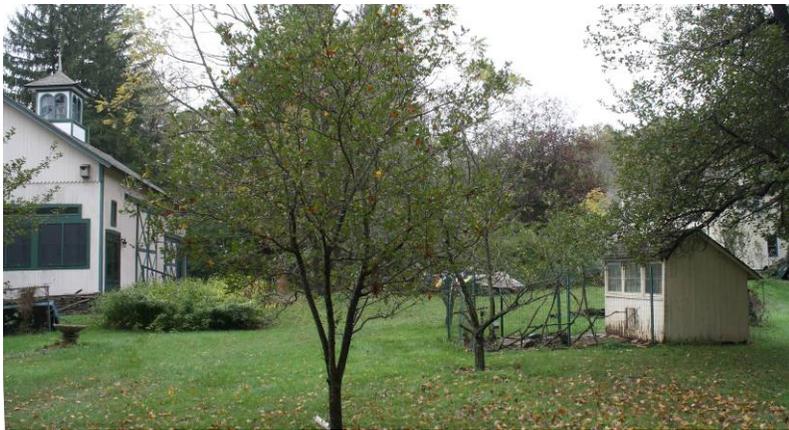
9a. Southeast view of chicken coop, camera facing northwest.

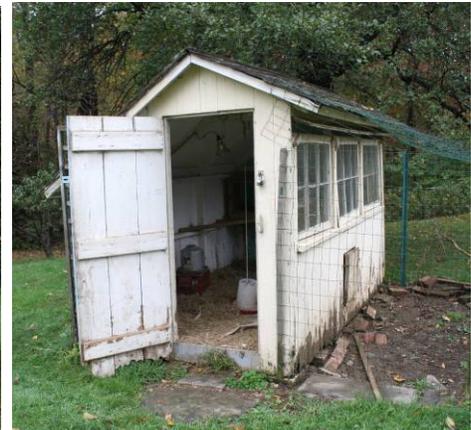
9b. Southwest view of coop.

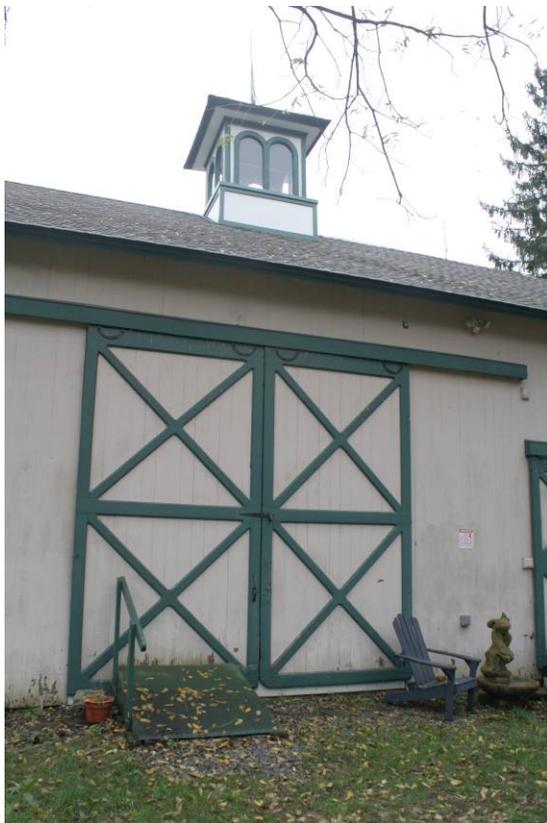
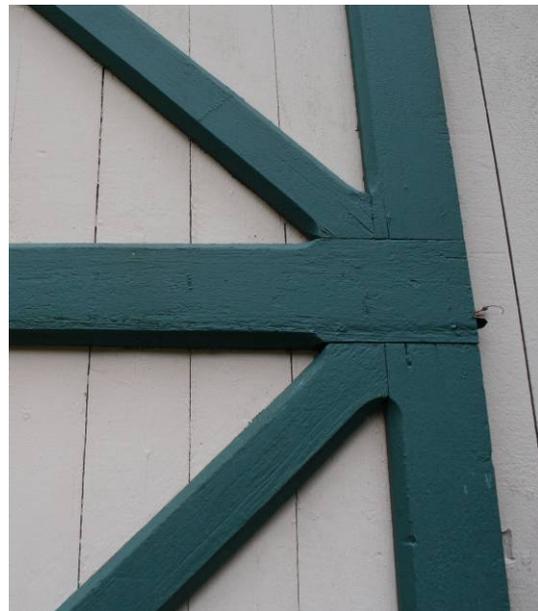
11a-b. Details of barn doors and cupola, camera facing south.

The main entrance is in the second bay from the east through a pair of tall exterior-hung X-braced sliding barn doors. The doors' exterior bracing system has ornamental detailing including beveled edges and eased corners; vertical boards make up the solid panels behind the bracing members. To the left (east) a modern pair of French doors and a single-pane stained glass window in the upper wall, have been added. To the right (west) in the end bay a shorter double sliding exterior door matches the main doors in style, and slides to the left (east) to reveal a modern triple glass sliding door infilling the barn door opening and providing entry into the studio space. Above these doors is a smaller sliding hay door, also in the rightmost bay and surfaced with vertical siding. All three barn doors have shallow hoods covering the track mechanisms. A fieldstone retaining wall extending in line with the

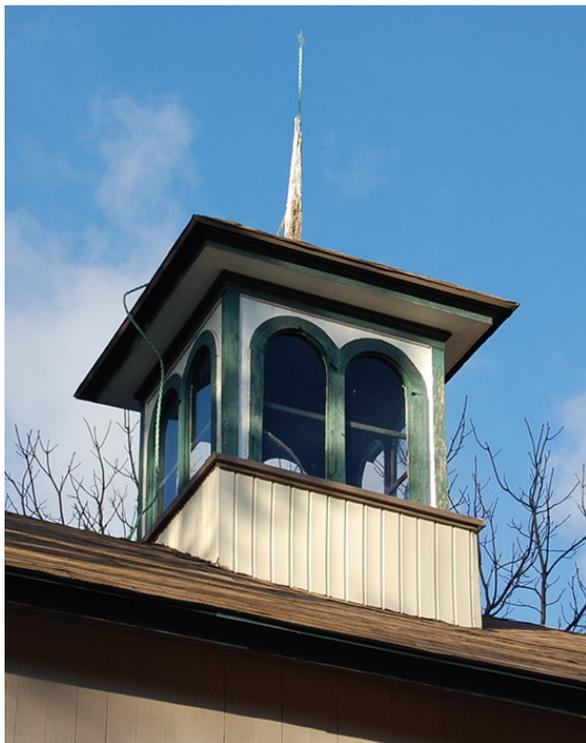
12a. Cupola detail, camera facing north.

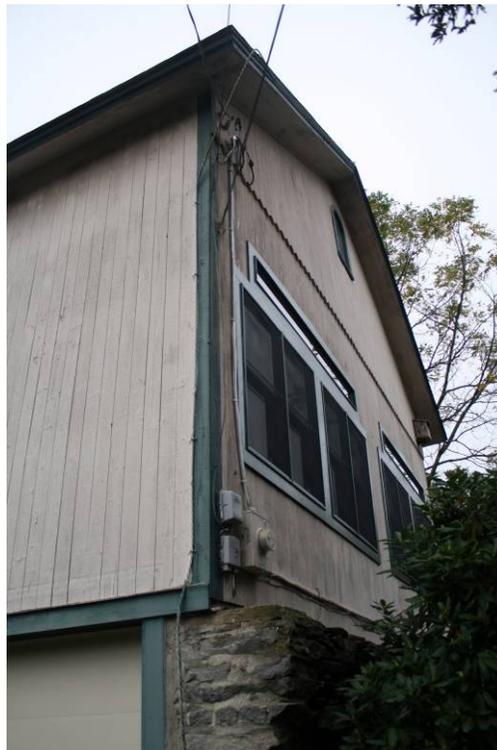
12b. Southeast corner detail, camera facing north.

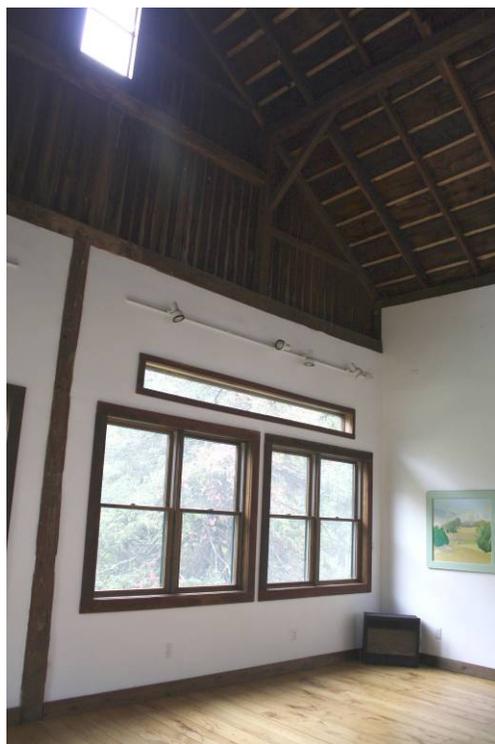
13a. Interior view of southeast corner.

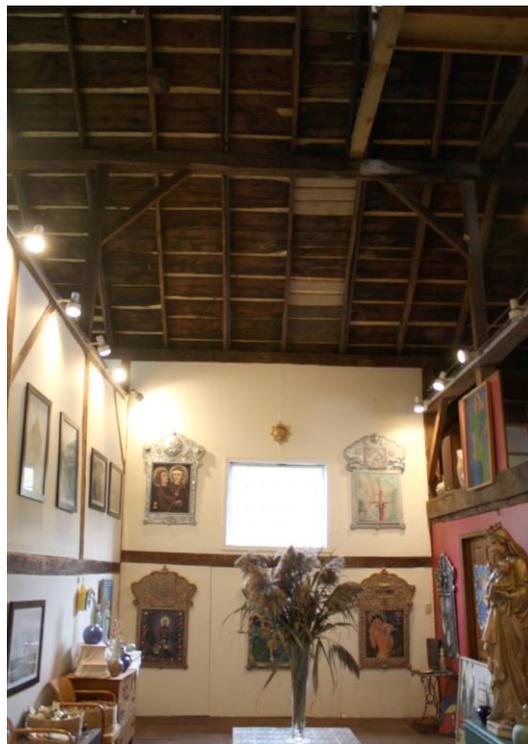
13b. Interior view of threshing bay gallery, camera facing south.

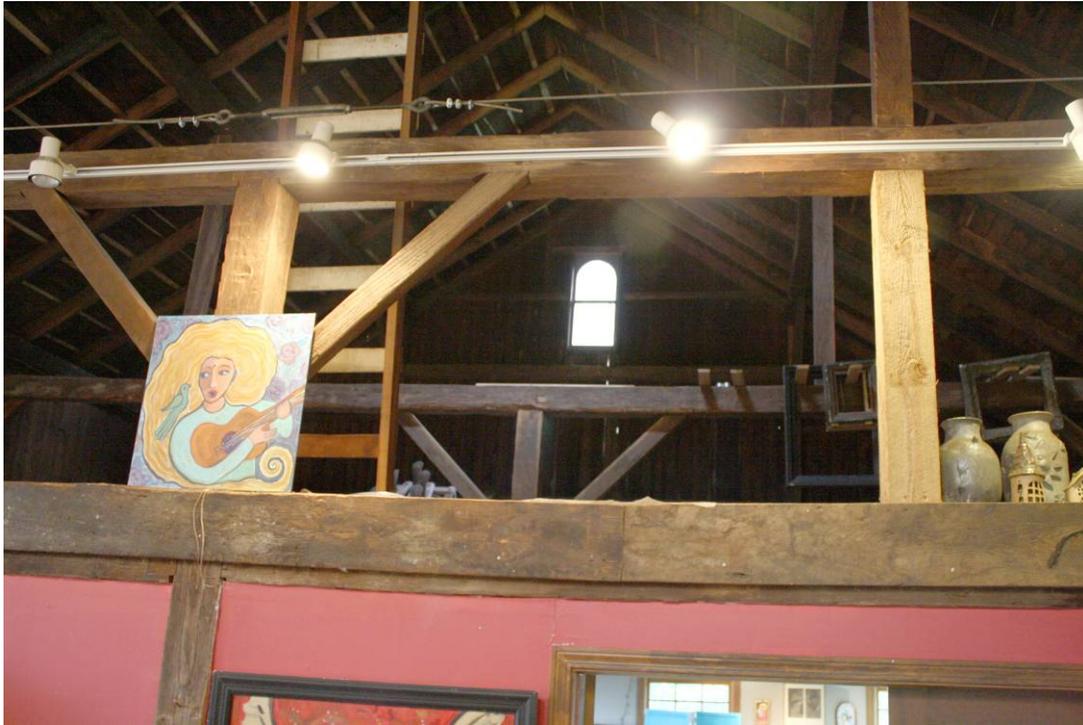
14. Interior of loft level, camera facing west.

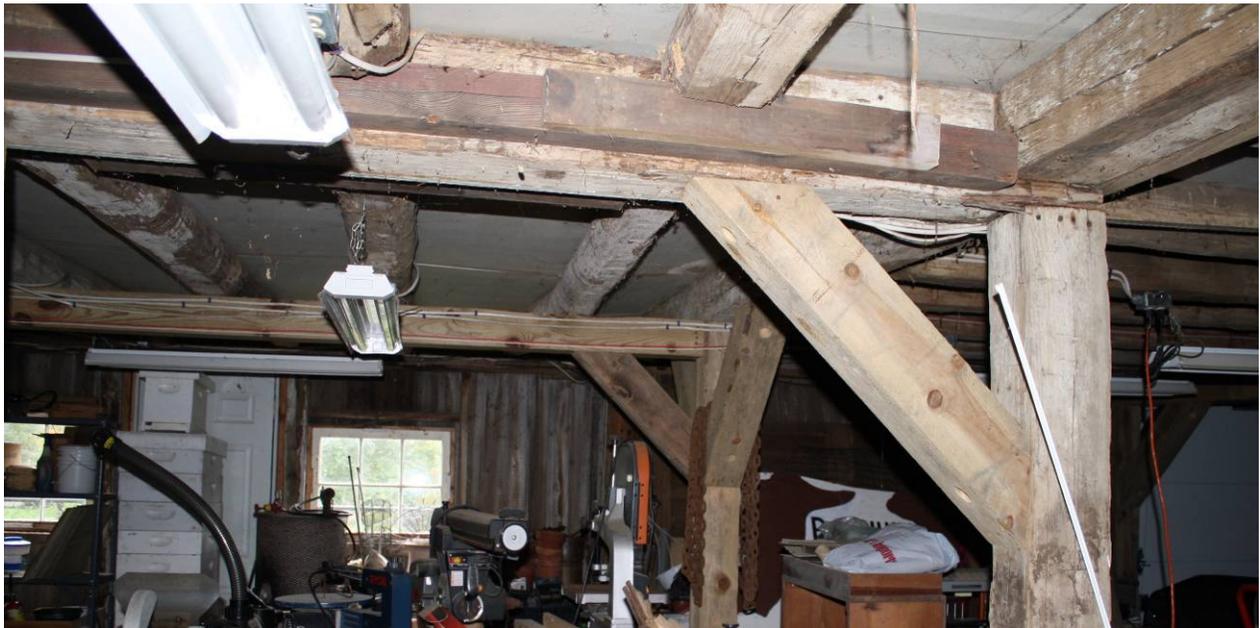
15. Interior of basement below threshing bay, camera facing south.
Note change of joist direction in adjacent bay to right (west).

At the basement level, recent stabilization has supported the old framing by placing new timbers below the originals, leaving the old fabric extant and visible. The north and east foundation walls are full-height fieldstone, mortared on the interior. The west foundation is a half-height fieldstone wall with wood framing above up to the main level plate. The eastern bay has joist framing above to support the main floor, running east-west and consisting of a mix of hand-hewn squared members, round poles with the upper and lower surfaces hewn, and modern dimensional lumber. New plank flooring has been cut from trees on the site for the Gallery floor above. The second bay, where the big barn doors above indicate the threshing floor, are framed with a series of girders running east-west and joists oriented north-south. These are mainly hewn squared timbers mortised into the girders. The next bay to the west and the far western bay resemble the eastern bay, with the joists spanning east-west. The third bay has mainly square-hewn joists while the fourth bay has mainly round poles hewn flat on their upper and lower surfaces. Some of the heavy timber posts in this area exhibit unused mortises, suggesting the possibility that they were recycled from an earlier structure. A stair has been inserted at the northeast corner connecting to the main level above.
