*Agricultural Heritage Multiple Property Submission - State Register*

**BUILDING AND STRUCTURES**

Building Name (Common) Hallmark Hill Condominium Barn Record No. 52421  
 Building Name (Historic) \_\_\_\_\_  
 Street Address or Location 35 Hallmark Hill Drive  
 Town/City Wallingford Village \_\_\_\_\_ County New Haven  
 Owner(s) Prime Property Management, PO Box 6208, Hamden, CT 06517  Public  Private

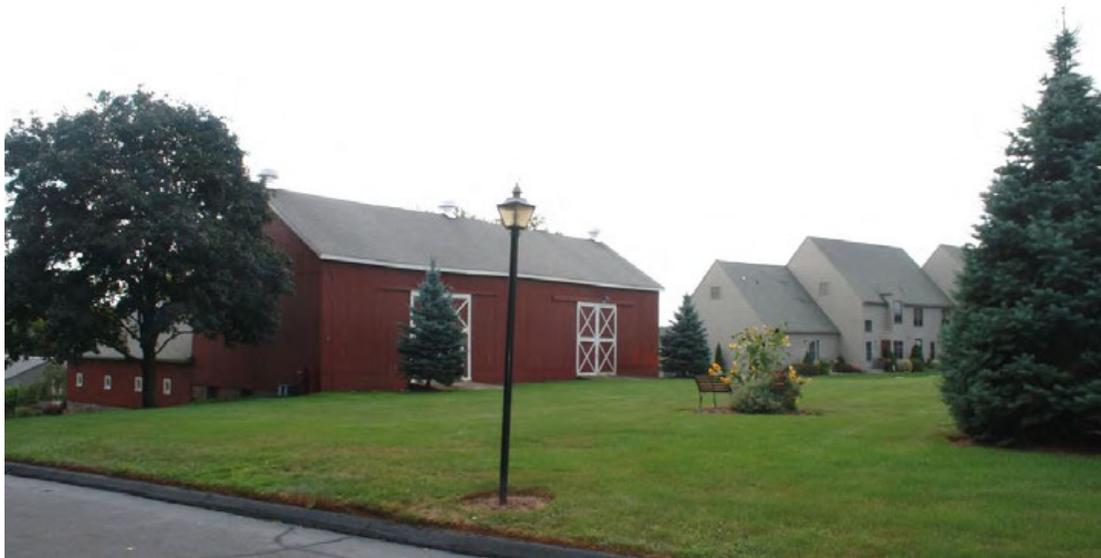
5. Northwest view of Barn, Addition I (to the right), and Addition II (behind to the left). Condominium units are to the right.

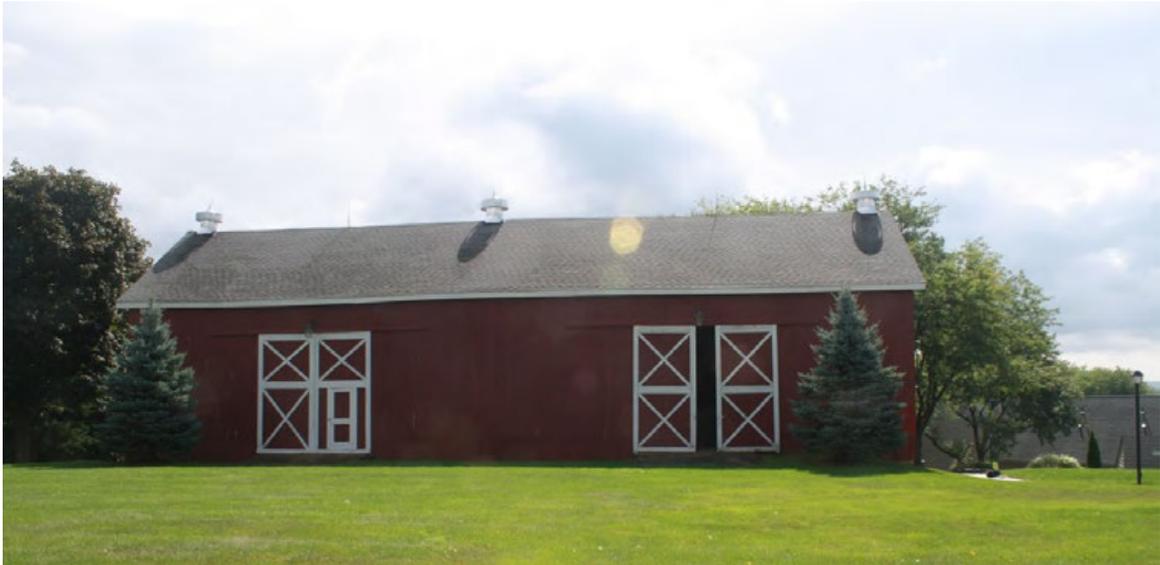
6. West eave-side view of Barn and Addition I, camera facing east.

The main entry into the barn is in the west eave-side, a pair of full-height exterior sliding doors in the center of the three original bays of the barn (Bay 2). The doors have x-braces and a weather door in the south leaf. A nearly identical pair of exterior sliding doors are found in Bay 5. The other bays are blank. Concrete ramps lead to the two door openings. The date “Jan, 18, 32” is inscribed in the concrete in front of the Bay 5 entry. The grade declines at the south corner of the structure from west to east, resulting in an exposed mortared fieldstone foundation and banked basement level. A set of concrete stairs built into the hill descends from main grade to the basement level along the south gable-end.

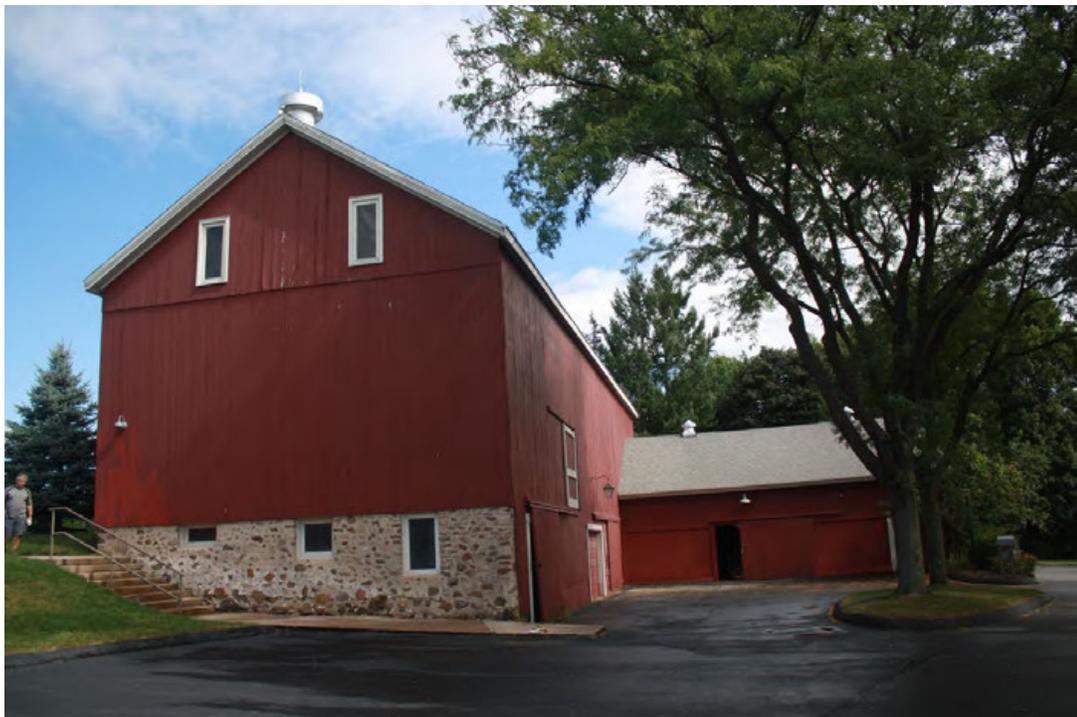
7. South gable-end view of Addition I and south eave-side of Addition II, camera facing north.

The south gable-end of Addition I has modern replacement windows of different sizes at the basement level. In the gable attic are two modern replacement windows widely spaced just above the dropped girt line siding divide.

The south eave-side of Addition II has a centered exterior sliding door with a hay door above, just beneath the eave. A pass-through door is found at the east (right) corner. The grade at the east gable-end of Addition II is at the lower level, revealing several courses of the mortared fieldstone foundation. The east gable-end of Addition II has two modern windows in the main level and a third centered in the gable attic above the dropped girt line siding divide. The north eave-side of Addition II has a series of four small single-pane stable windows with trim. A vent is at the east corner of Addition II. A pass-through door is at the corner of the addition where it meets the main barn.

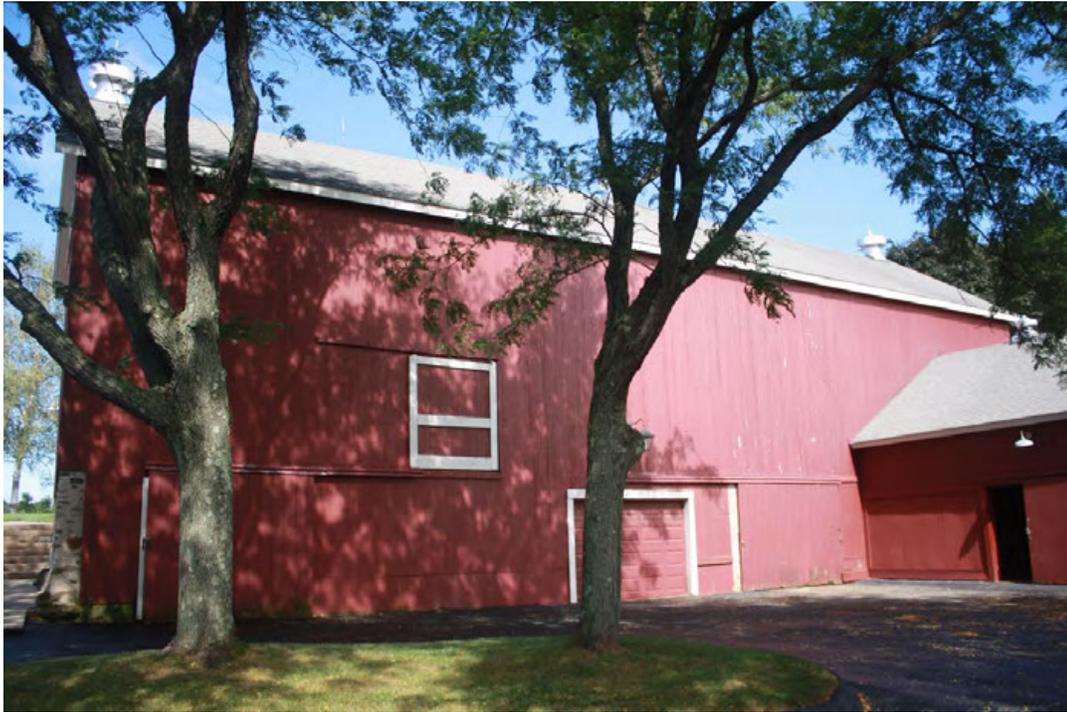
8. East eave-side view of Addition I, main Barn, and Addition II (to right), camera facing west.

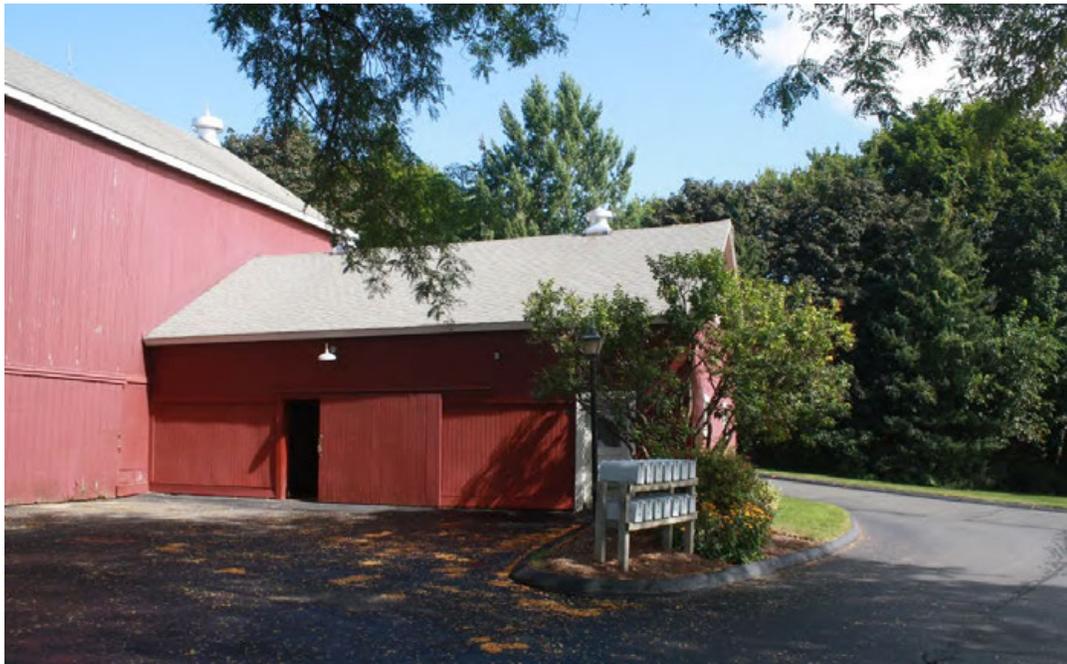
9. South eave-side view of Addition II and east eave-side of Barn, camera facing north.

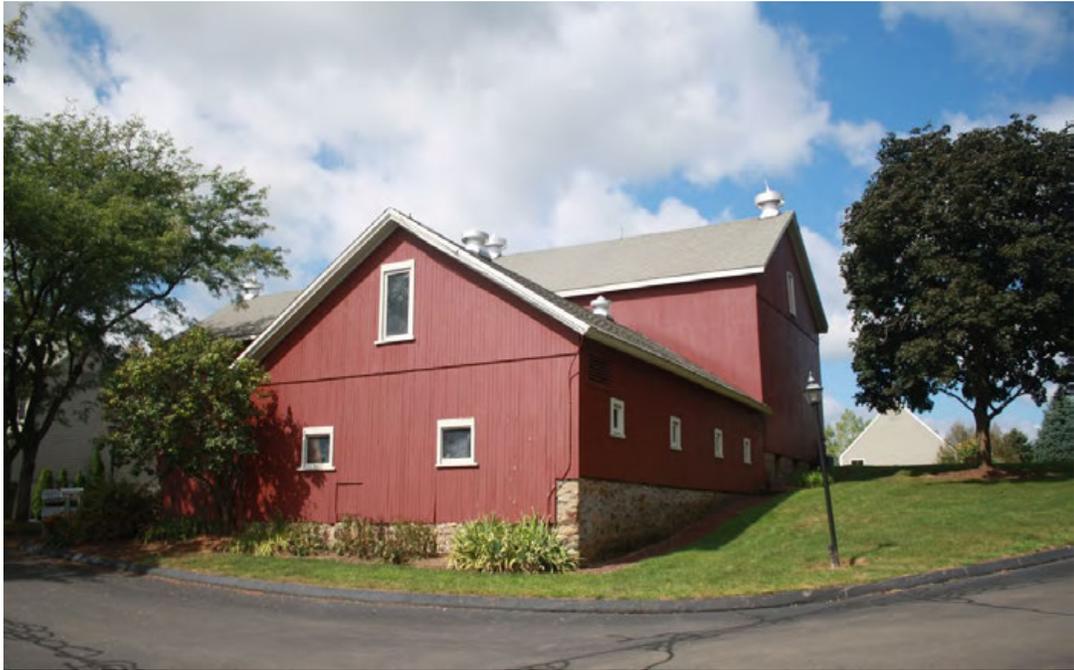
10. East gable-end and north view of Addition II with main Barn at rear, camera facing west.

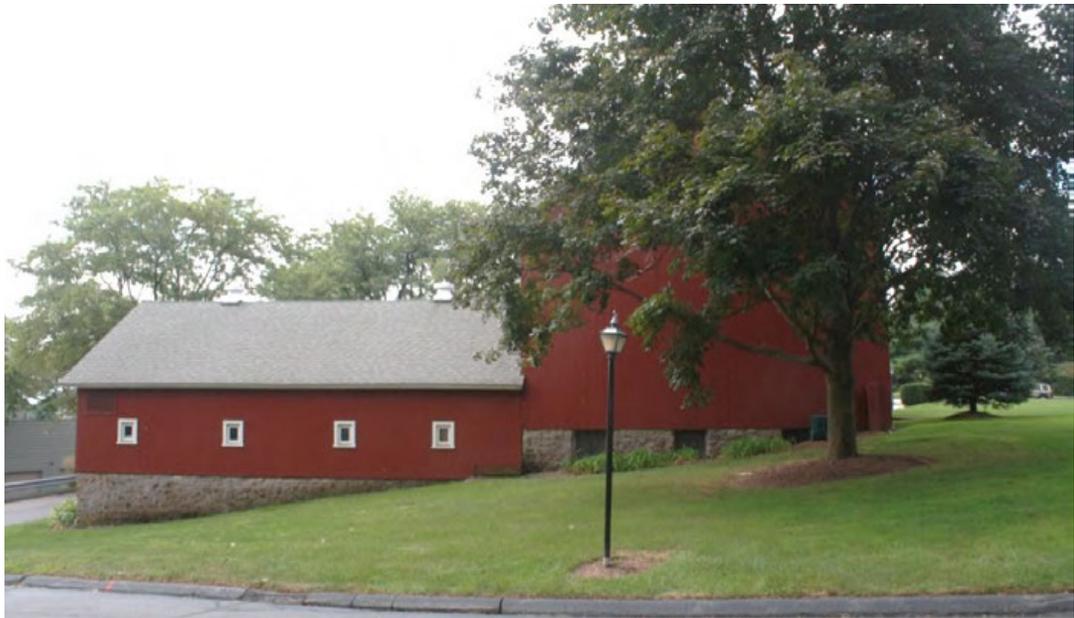
11. North view of main Barn (right) and north eave-side of Addition II (left), camera facing south.

The north gable-end of the barn is flush with the north eave-side of Addition II. Although the grade inclines from east to west, the mortared fieldstone foundation and part of the basement level on the barn are exposed. There are three windows in the basement level. There is a modern replacement window in the gable attic.

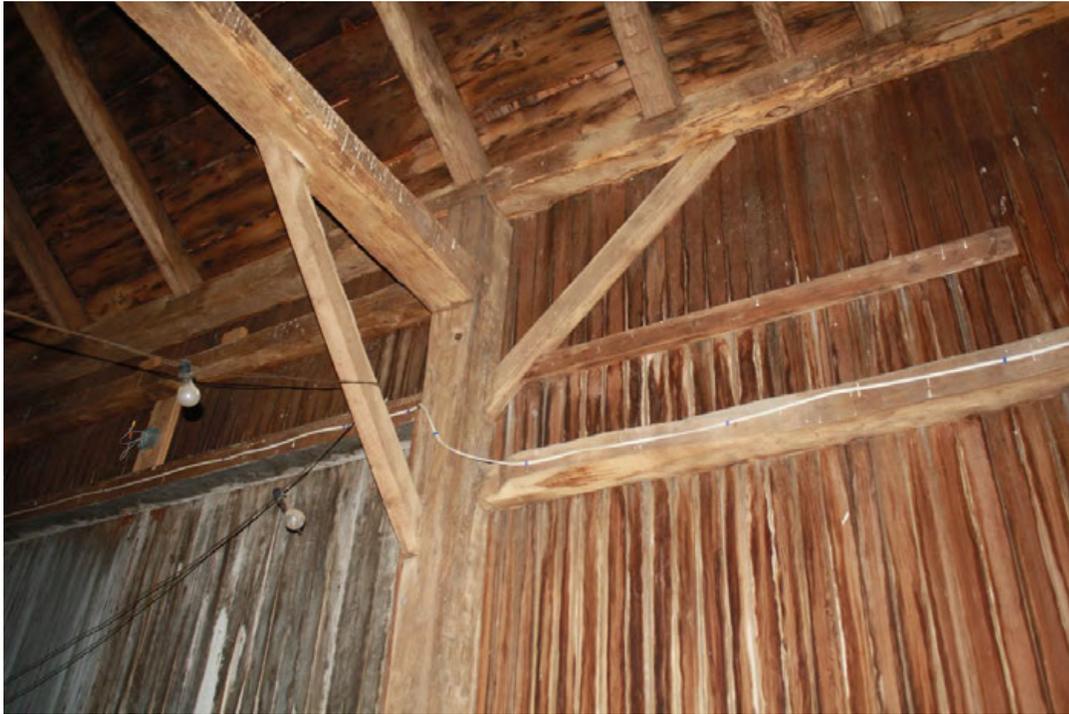
12. Detail of the interior of main Barn, showing hand-hewn post and beam frame with dropped tie-girt, camera facing west.

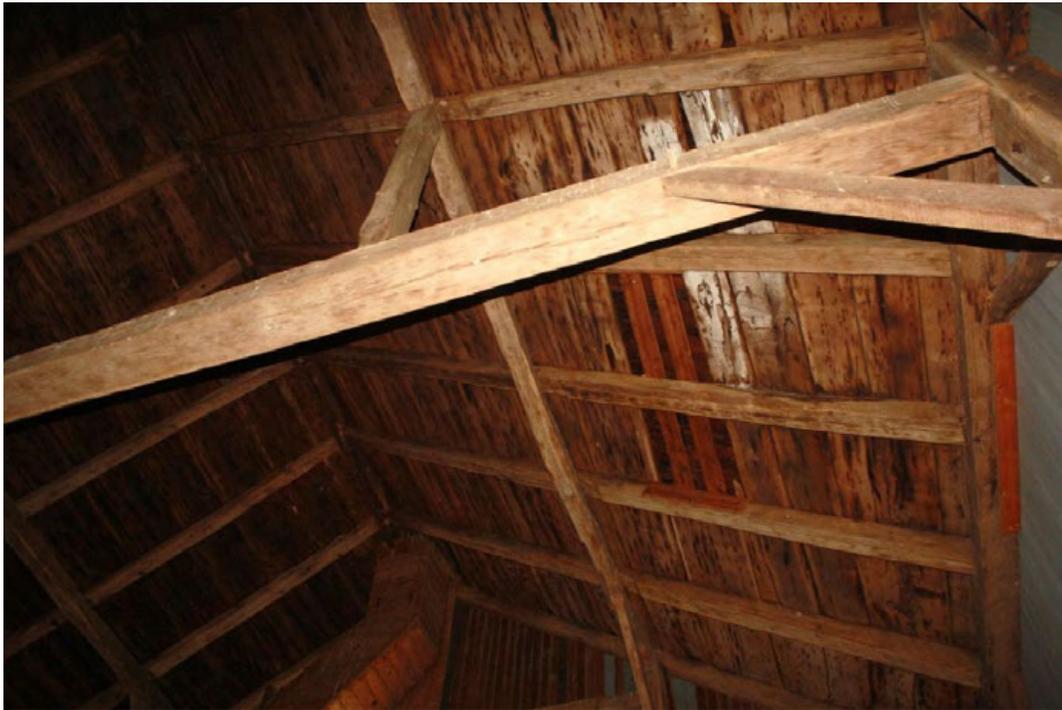
13. Detail of the interior of main Barn, showing hand-hewn purlin plate and queen post, camera facing north.

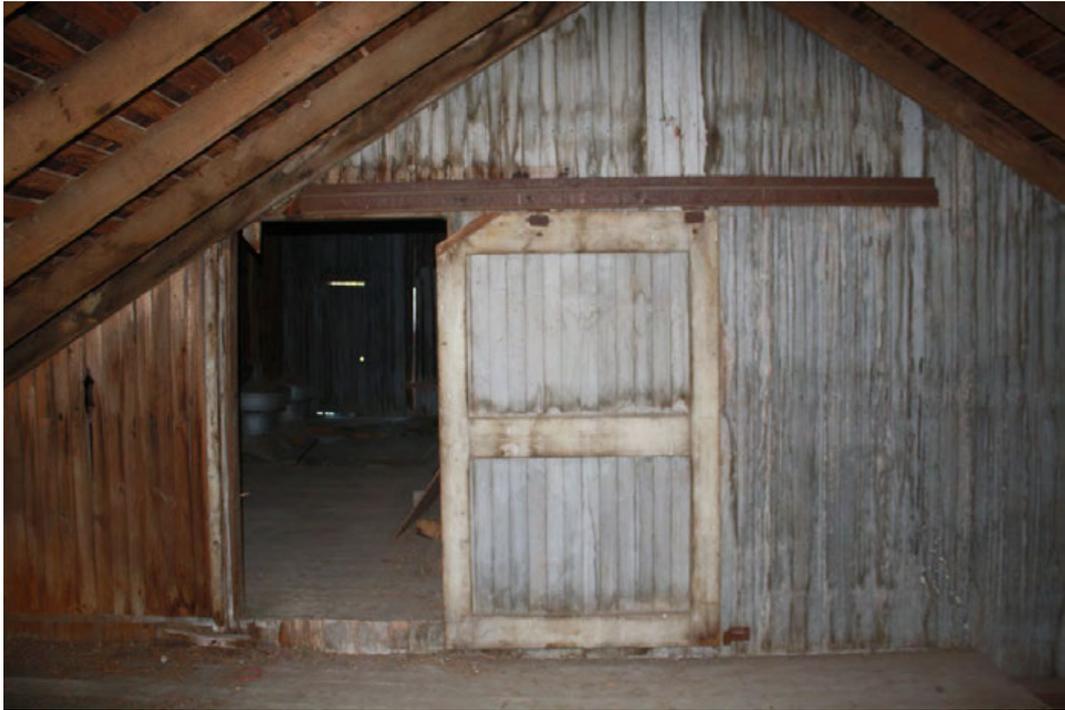
14. Detail of the interior of main Barn from the loft of Addition II, showing a hay door originally on the exterior of Barn I, camera facing west.

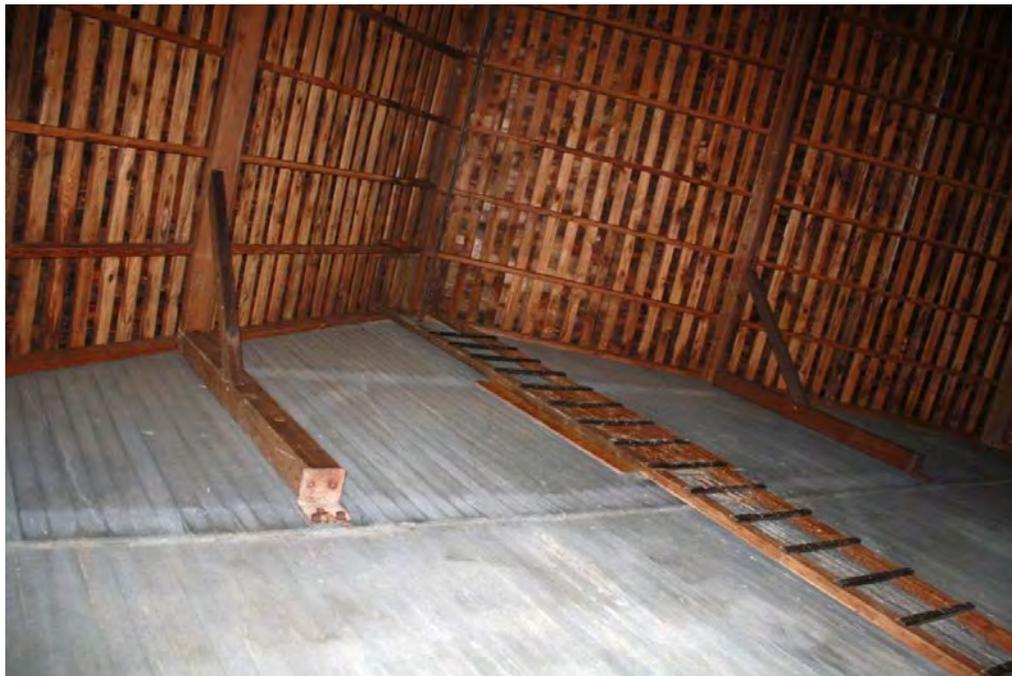
15. Detail of the interior of main Barn from Addition I, south gable-end showing the original exterior wall, camera facing north. Note the L-bracket supports posts in place of a lateral tie-girt which appears to have been removed.

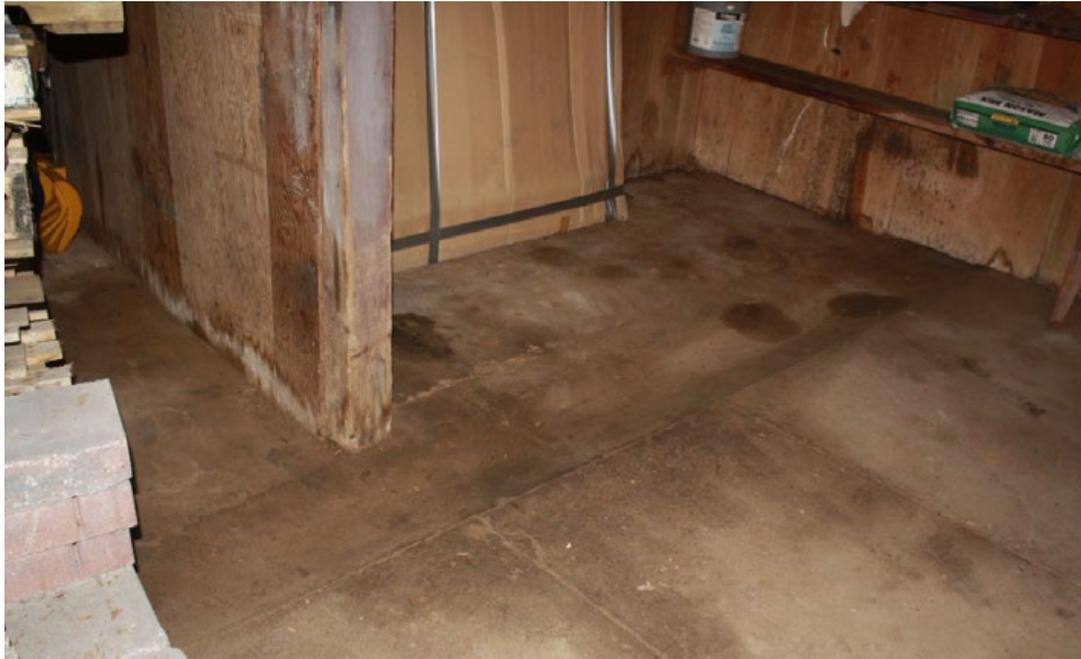
16. Detail of the interior of Addition II showing infilled manure gutter, camera facing north.

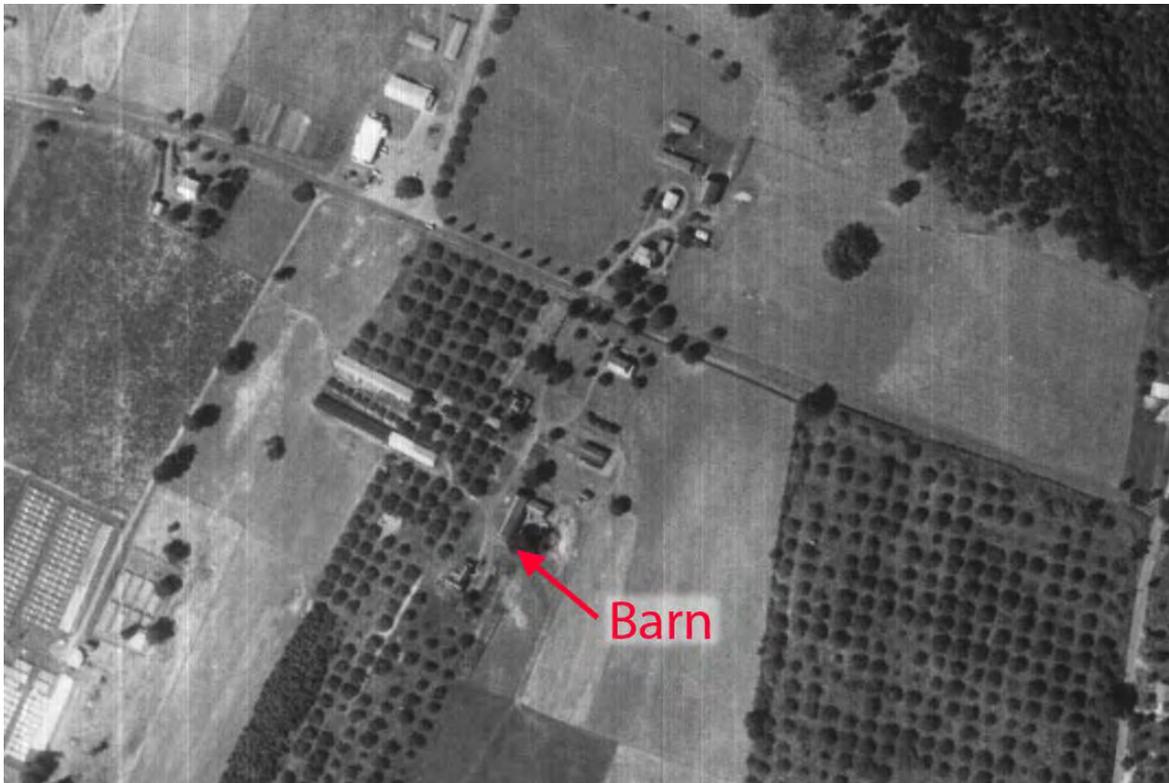
17. Aerial photograph of the site taken in 1951, UConn MAGIC archive. Note the extensive complex of outbuildings surrounding the subject barn including what appears to be a farmhouse to the north near Cook Hill Road. Much of the surrounding area was planted in orchard trees.
