**HISTORIC RESOURCES**

**BUILDING AND STRUCTURES**

Building Name (Common) Luddy/Taylor Tobacco Museum & Archives, Northwest Park Record No. 53463  
Building Name (Historic) Lang, Jacob and Dona, Farmstead  
Street Address or Location 135 Lang Road (Tobacco museum), 145 Lang Road (Northwest Park)  
Town/City Windsor Village Rainbow County Hartford  
Owner(s) Town of Windsor, 275 Broad Street Windsor, CT 06095 (continued page 2)  Public  Private

HISTORIC RESOURCES INVENTORY FORM – BUILDING AND STRUCTURES continuation sheet

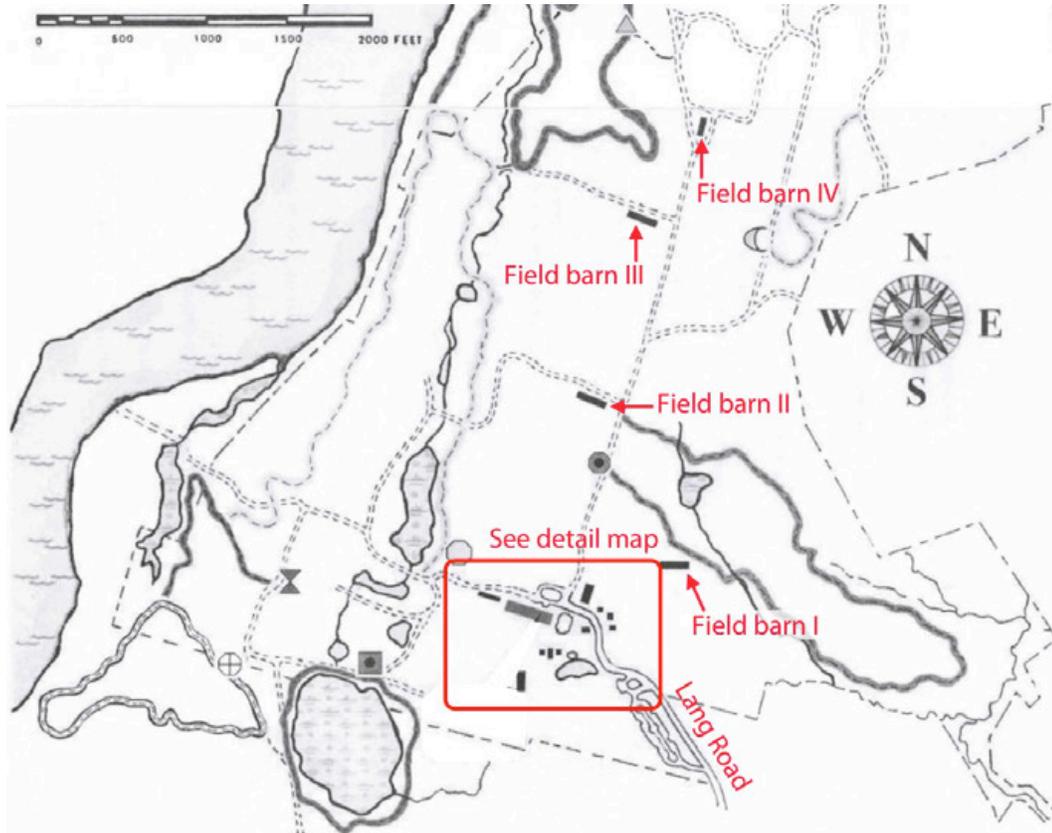
4. Map of Northwest Park with contributing resources indicated – base map courtesy of Northwest Park.

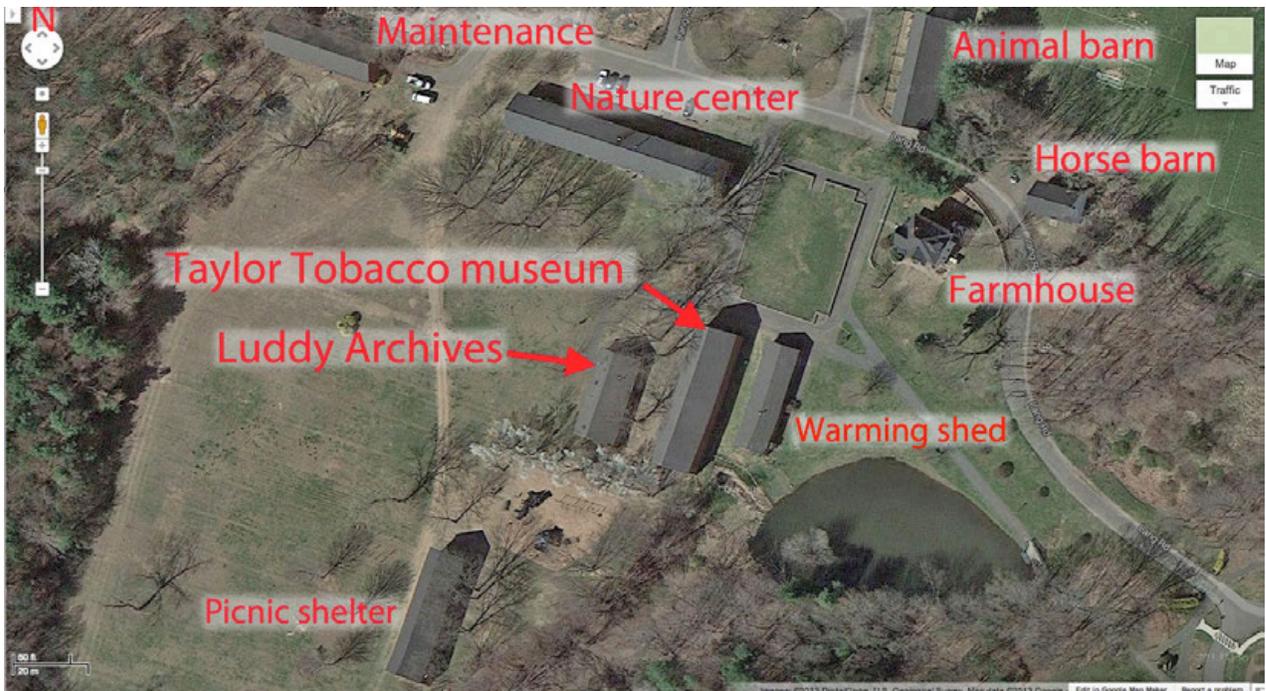
5. Detail Site Plan showing contributing resources in the central area.

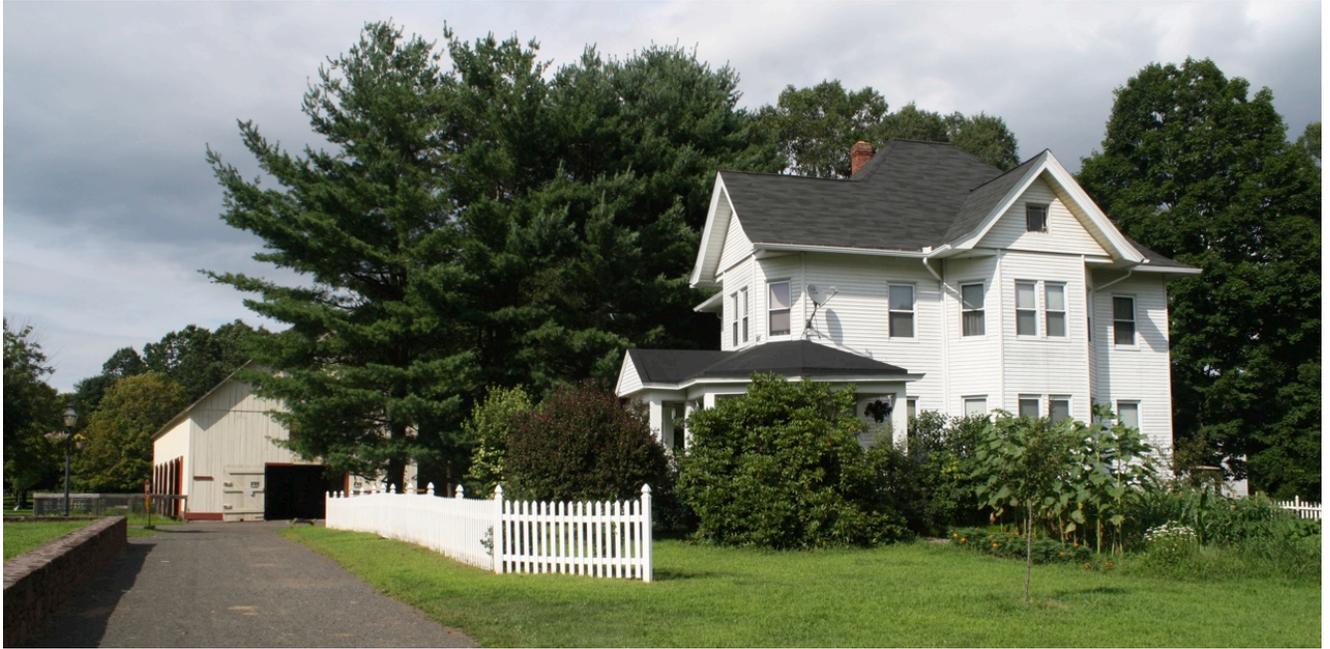
6. South view of Farmhouse, camera facing north. Animal barn is at left rear.

The Farmhouse is a 2 ½-story vernacular Queen Anne-style building with a steeply-pitched hip roof and projecting gable-roofed bays on the west and south sides. A wrap-around porch shelters the entry on the west side. Lang Road formerly ran along the south and west sides of the house, ending as a farm road extending northward. It has been re-routed around the east and north sides, so that today the west front façade faces a green space forming a courtyard for the nature center and museum. The Farmhouse has been re-sided with vinyl siding, and is used as staff housing.

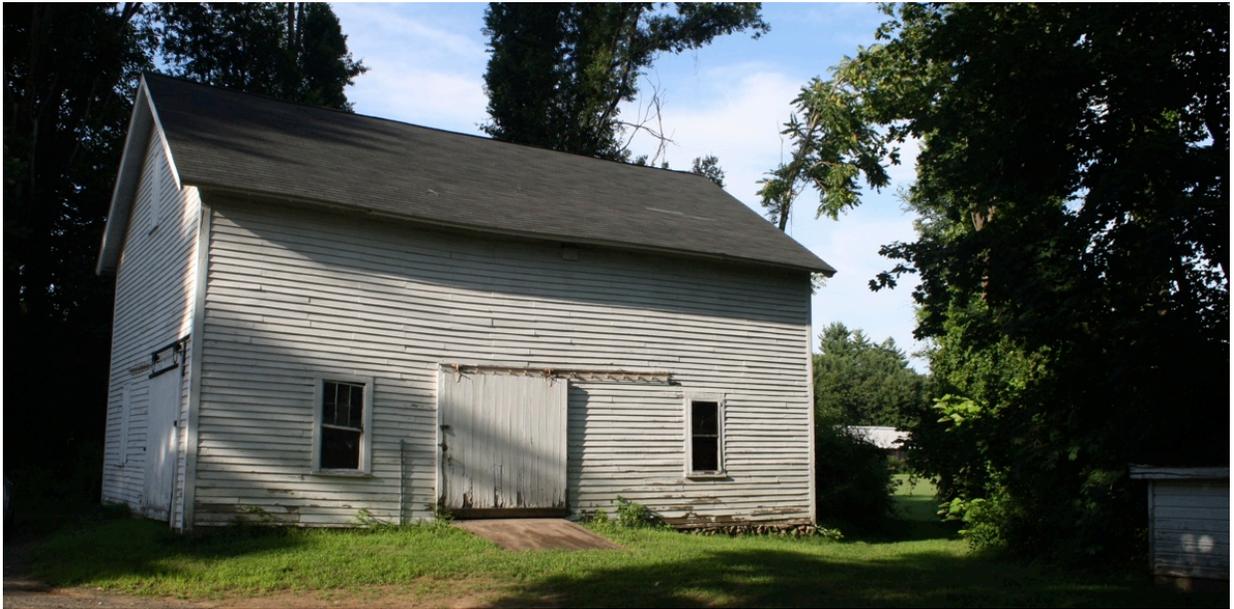
8. Southwest view of Horse barn, camera facing north. Field barn I (Tobacco shed) is partially visible at right rear. A small structure, possibly a springhouse, is at the far right.

Northeast of the Farmhouse is an English barn which appears to have been a horse barn or carriage barn for the farm family. It is a 1 ½-story three-bay gable-roofed structure with its ridge-line oriented east-west. A sliding door in the center bay of the south side is typical for an English barn. Another sliding door is off-center to the right (south) in the west gable-end. There is a pass-through door in the east gable-end and several window openings which appear to have had double-hung sash. Siding is wood clapboards with corner board trim, roofing is asphalt shingles, and the foundation is cobblestone masonry. To the southeast is a small low hip-roofed structure that appears to have been a springhouse. North of the Farmhouse and west of the English horse barn is the modern maple sugar house, a gable-roofed board-and-batten structure.

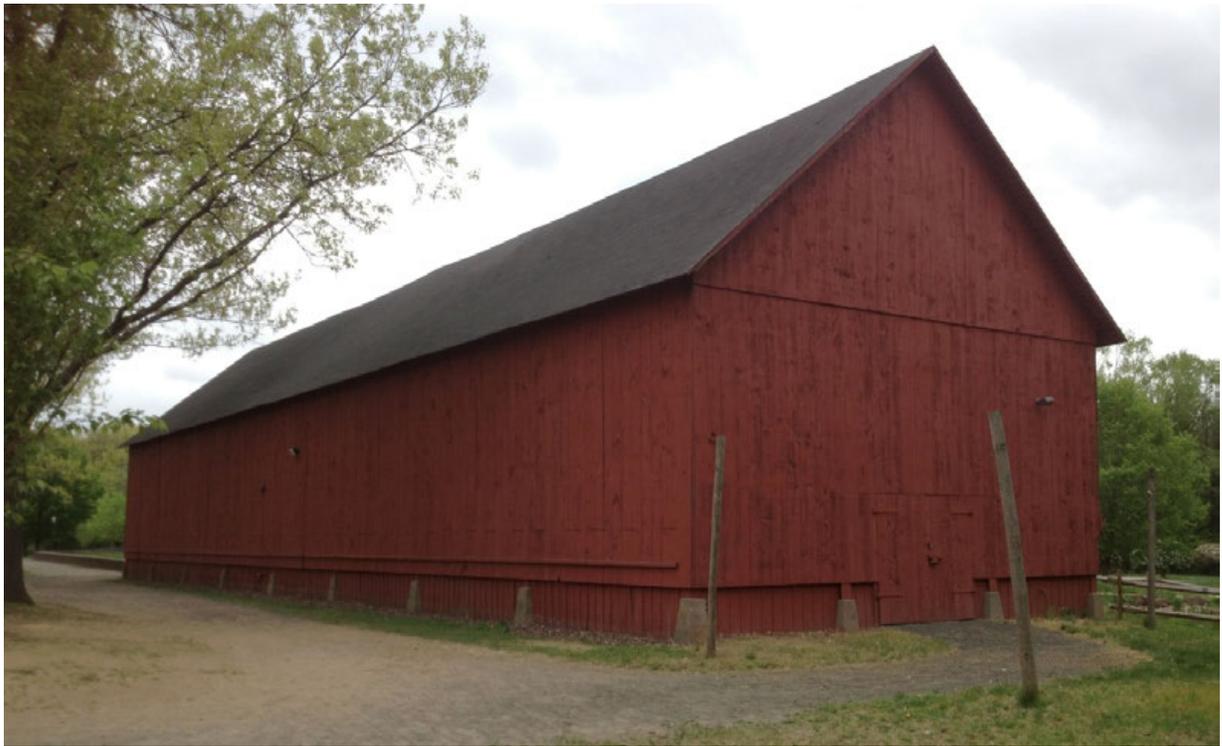
11. Southwest view of Taylor Tobacco museum, camera facing northeast.

This shed is an eight-bay three-aisle gable-roofed structure with its ridge-line oriented north-south. It has been converted to a seasonal museum displaying exhibits on historical tobacco farming. The vertical wood siding has been replaced and secured, but the long iron hook and eye fasteners and the horizontal battens for tilting open groups of alternate boards to ventilate the shed, have been re-installed. Along the lower edge between the truncated pyramidal concrete foundation piers, narrow vertical siding has been infilled for weather-tightness where originally the spaces would have been open or had top-hinged shutters. In each of the north and south gable-ends a pair of hinged doors provides access to the museum, and is similar to the original type of wagon doors, though not as wide or tall. Siding is painted red. Roofing is asphalt shingles.

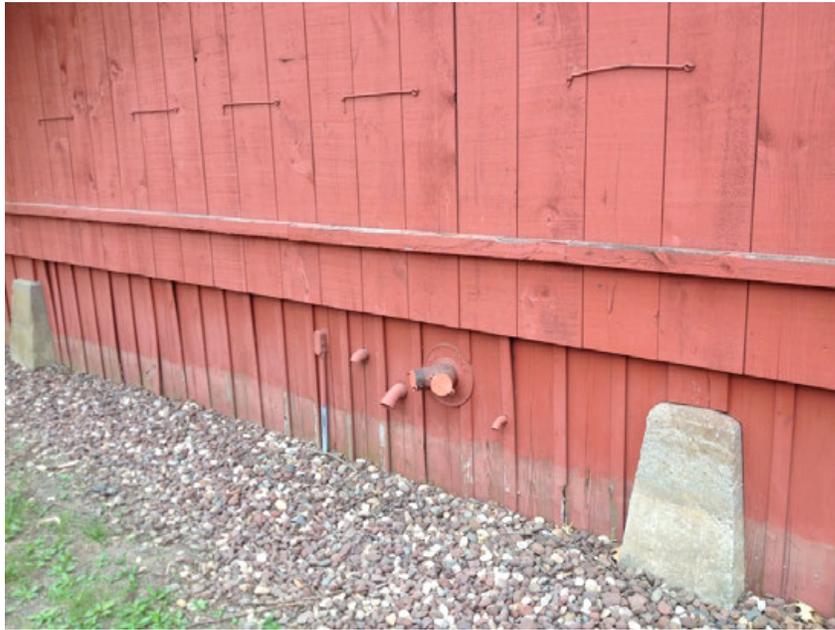
12. West detail view of Taylor Tobacco museum, camera facing northeast. Note horizontal battens for operating vents, and hooks for closing vents.

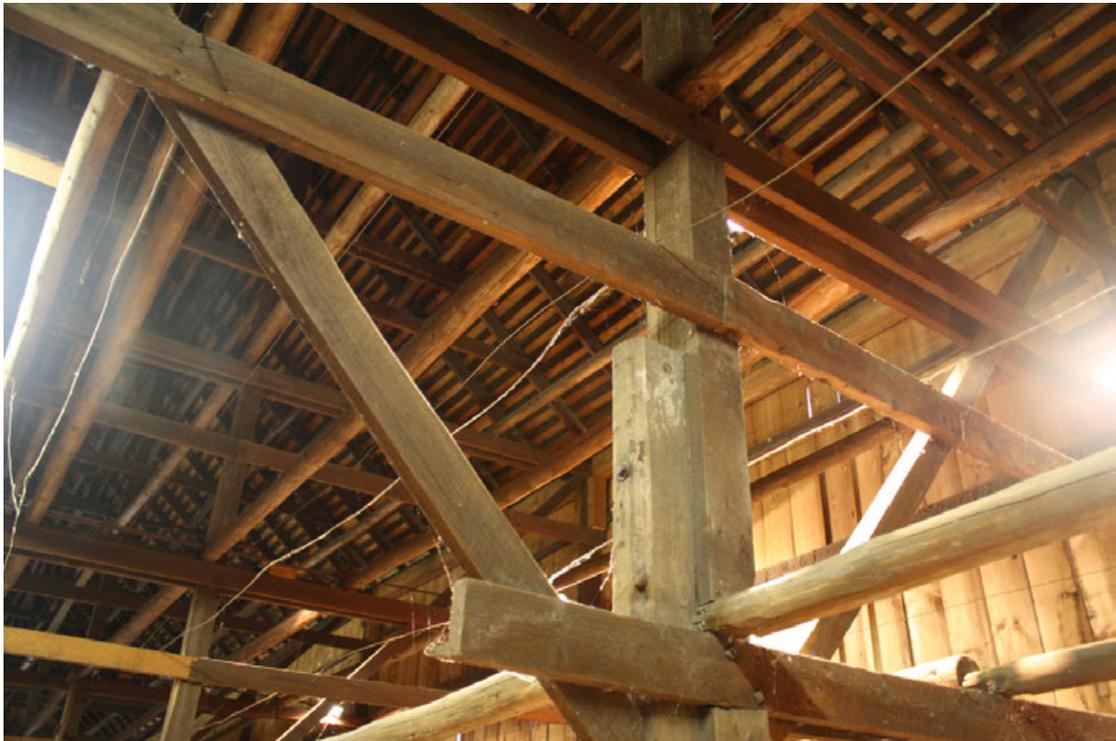
13. Interior detail view of Taylor Tobacco museum, showing nailed and bolted connections.

The interior is a typical early 20<sup>th</sup>-century type of timber frame structure with two interior posts at each bent and a network of tie-girts and diagonal braces of dimension lumber secured with bolted or nailed connections. The multiple horizontal ties also function as supports for the rails upon which the tobacco leaves were hung to cure. Lighting and a concrete slab floor have been installed for the display area.

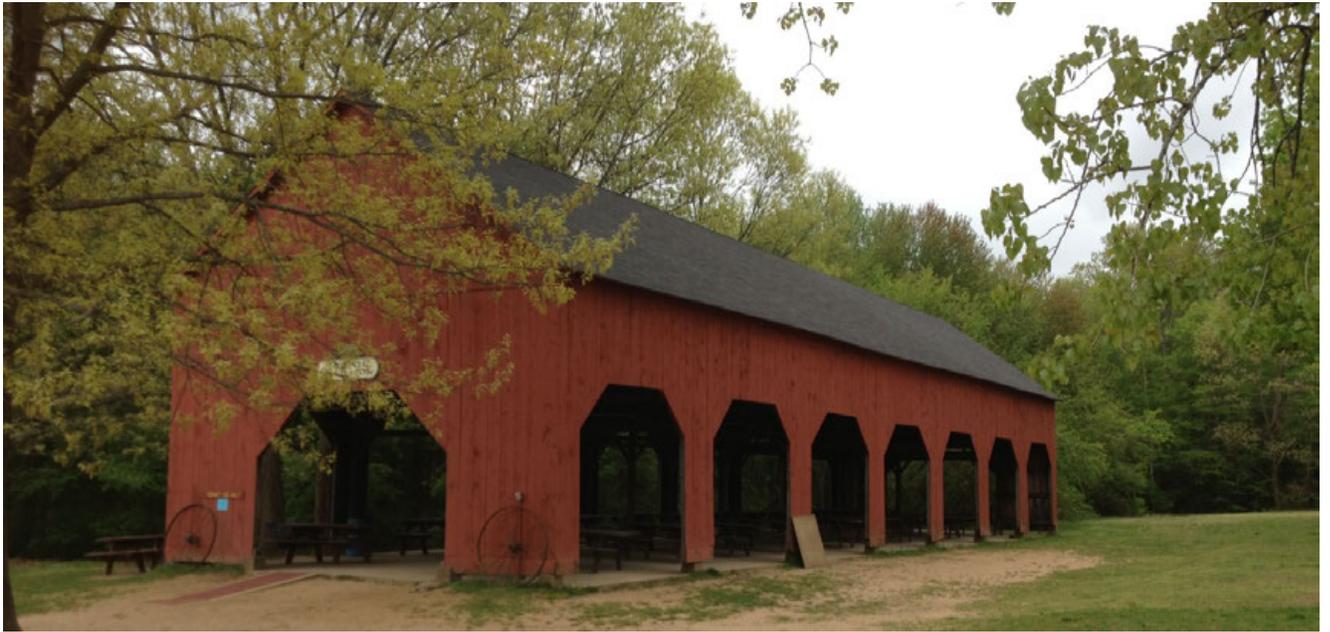
16. Northwest view of Picnic pavilion, camera facing southeast.

This shed, located south of the Museum, is a seven-bay three-aisle tobacco shed structure with its gable roof oriented north-south and with truncated pyramid concrete foundation piers. The typical structure is similar to the museum shed. The side walls have openings cut into each bay with chamfered top corners, forming an open-sided picnic shelter. Similar openings at the gable-ends have taken the place of doors. Siding is vertical boards painted red and roofing is asphalt shingles.

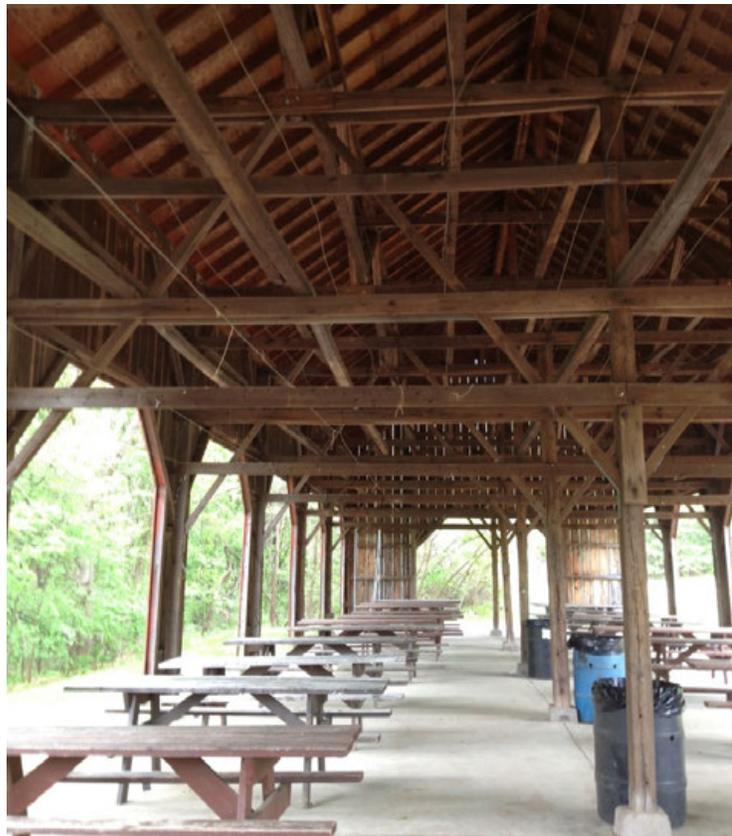
17. Interior view of Picnic pavilion, camera facing south.

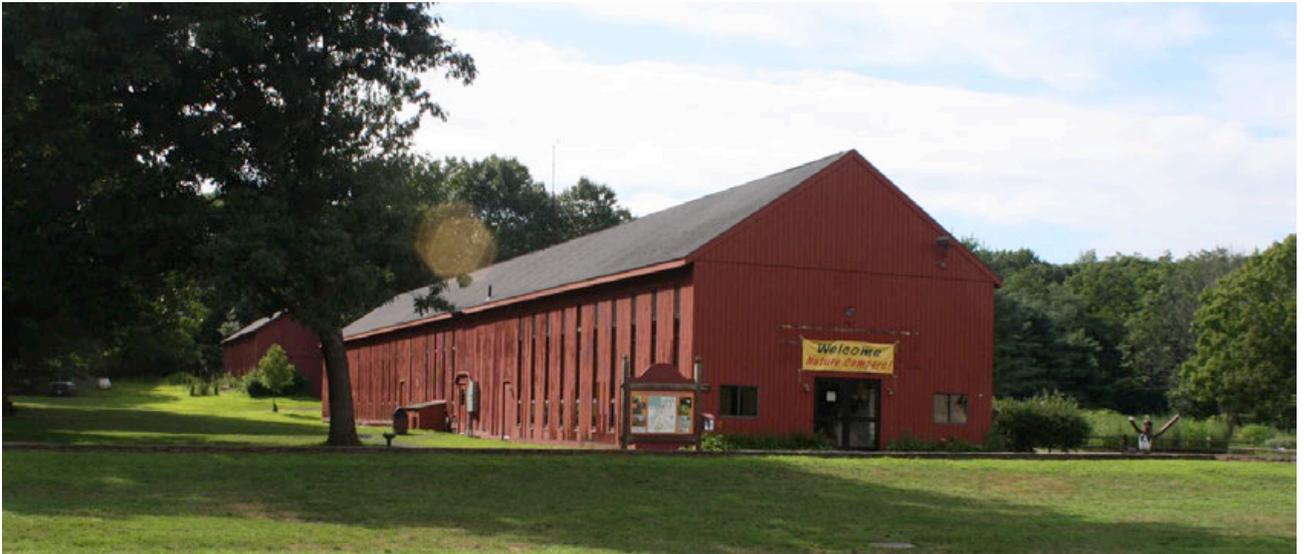
18. Southeast view of Nature center, camera facing northwest.

This shed, converted to a fully finished building, is oriented east-west, and has a modern glazed entry in the east gable-end. Along the eave-sides, tall narrow glazing panels are reminiscent of the narrow vent panels of the historic tobacco sheds. Vertical wood siding is painted red. Roofing is asphalt shingles.

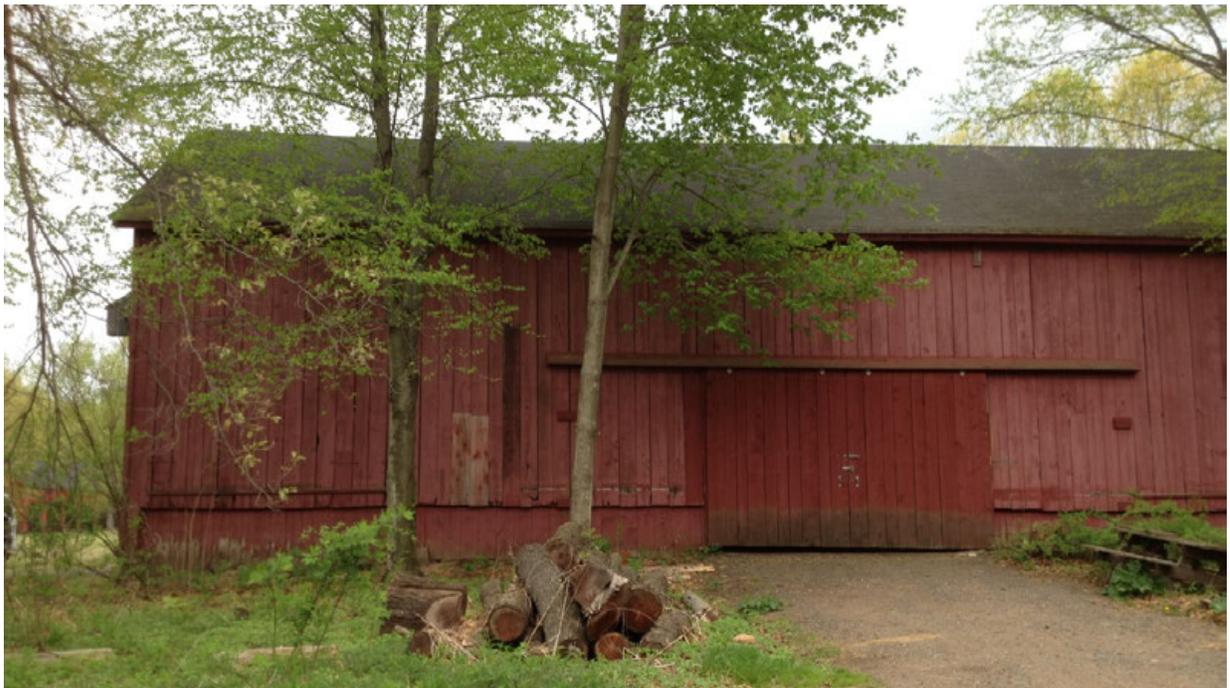
19. North view of Maintenance shed, camera facing south.

This shed is located west of the Nature center and is a six-bay three-aisle shed structure with its ridge-line oriented east-west. The structural elements are typical, similar to the Museum shed. The lower skirt below the siding has been filled in with vertical board siding; the upper siding has been partially replaced but in some areas the original horizontal battens for opening the vents are still in place. The main entry to the shed is a sliding door in the north

side. A secondary doorway is in the east gable-end, off-center toward the right (north). This shed has asphalt shingle roofing and the siding is painted red. The interior floor is gravel.

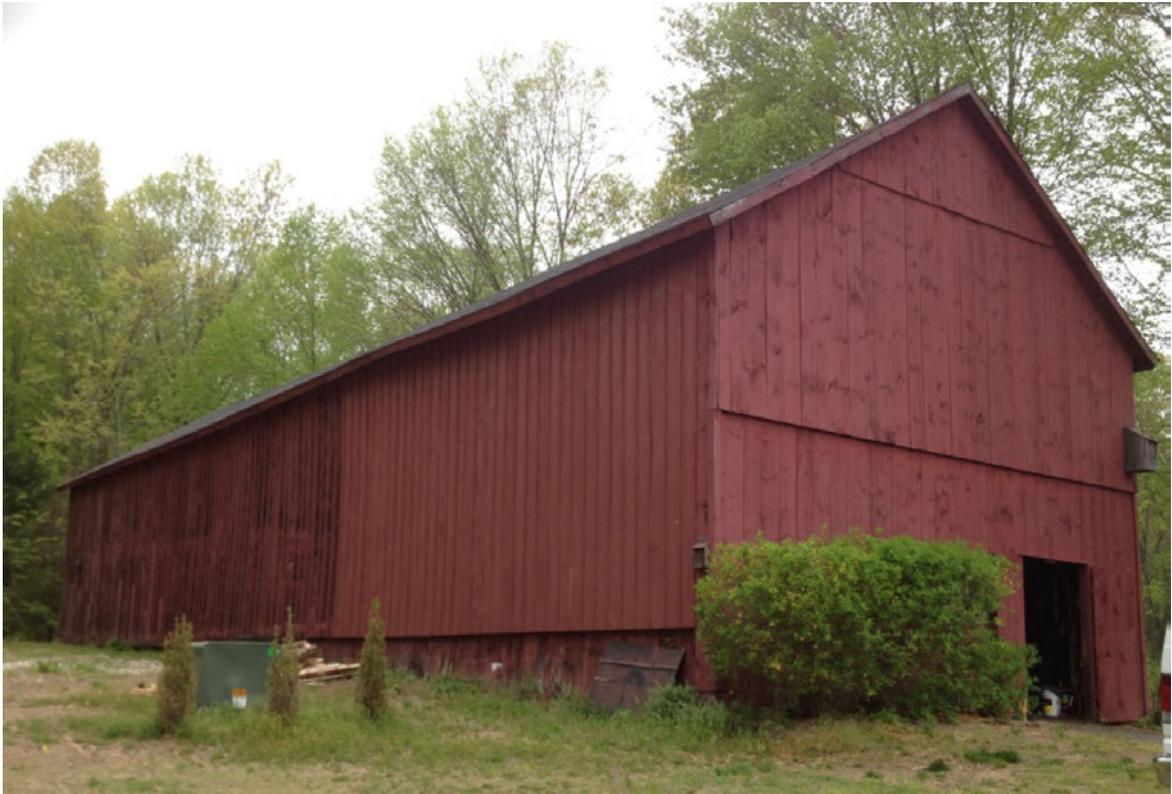
19. Southeast view of Maintenance shed, camera facing northwest.

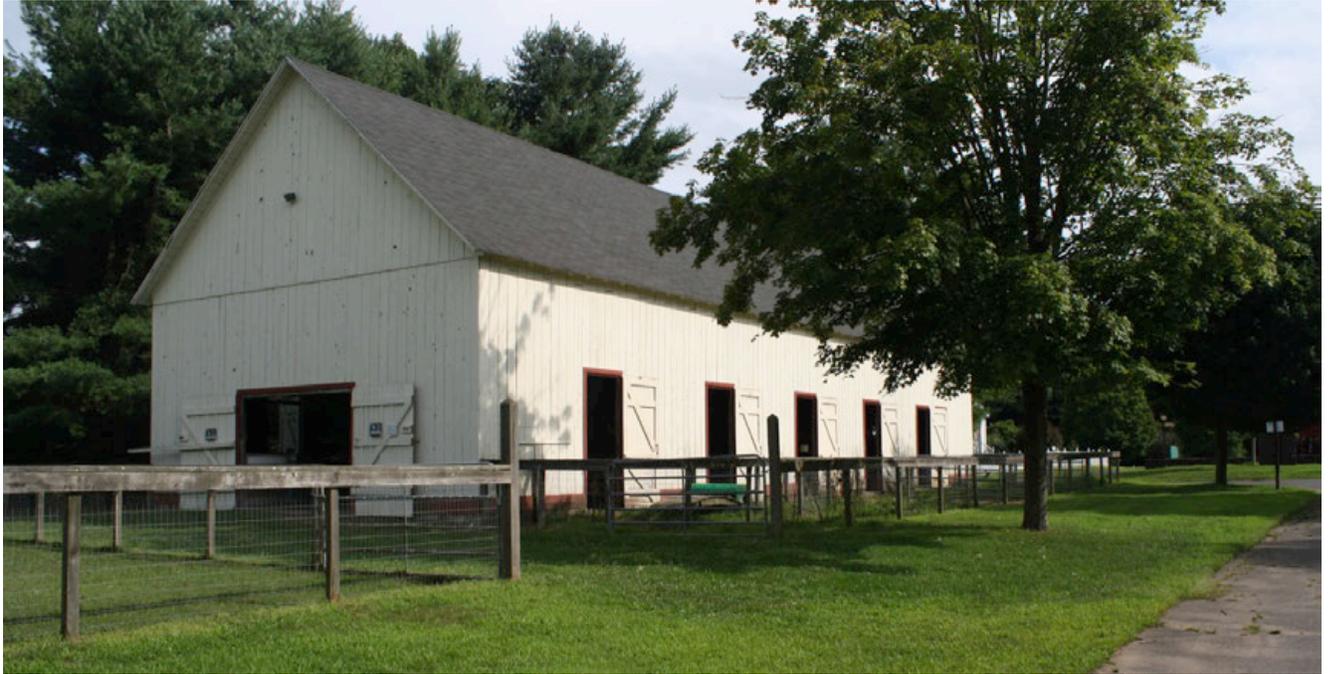
21. Northwest view of Animal barn, camera facing southeast.

This is a six-bay three-aisle gable-roofed shed with its ridge-line oriented north-south, and it is located north of the Farmhouse. The eave-side walls have been modified with five tall hinged doors in each side corresponding to livestock stalls inside and pens outside. The north and south gable-ends have pairs of hinged doors the full width of the center aisle. The south end has a hay door above, with a pointed top. The shed structure is standard and similar to the other sheds. The center aisle has a concrete slab floor. Several bays near the south end are enclosed for storage. The exterior is painted cream with barn red trim. The roof is asphalt shingles.

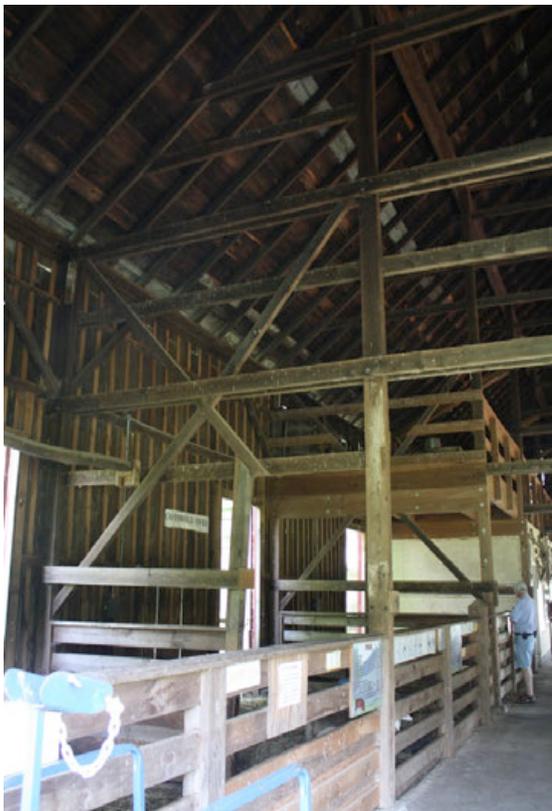
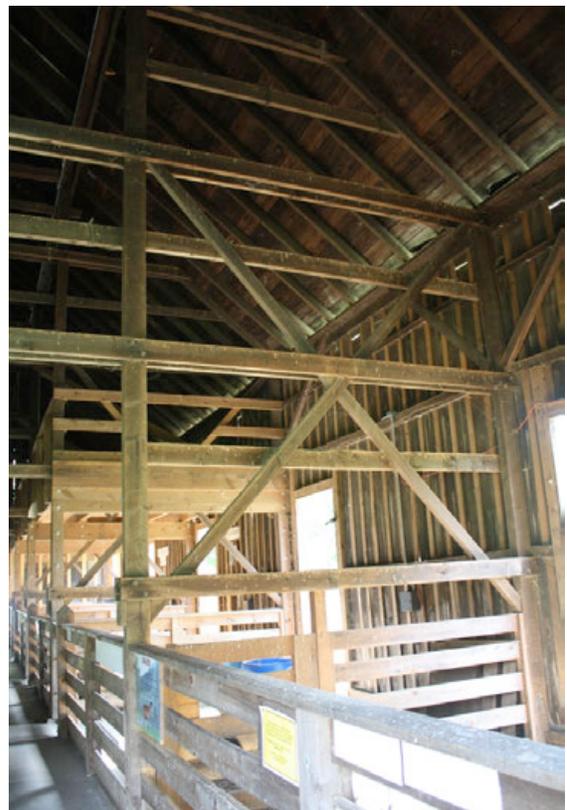
22a-b. Interior views of Animal barn, camera facing south.

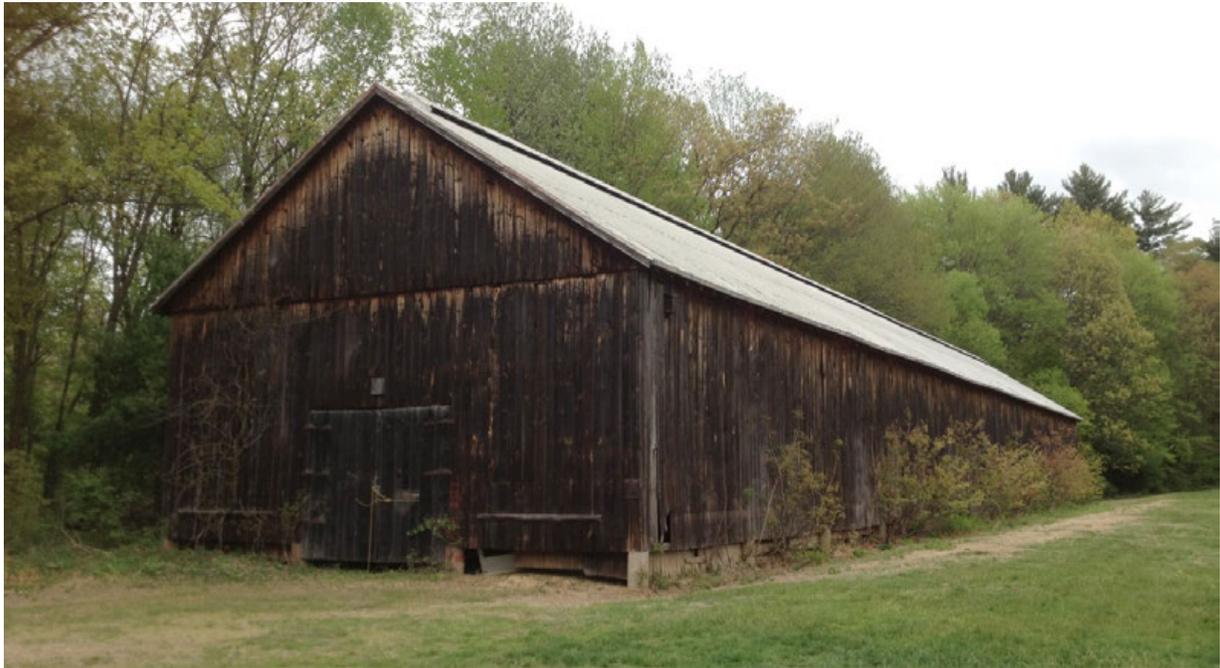
23. Southwest view of Field barn I (Tobacco shed), camera facing northeast. Note the metal roof with continuous ridge ventilator.

This shed, located along the north edge of the soccer field, is a 12-bay three-aisle gable-roofed tobacco shed with its ridge-line oriented east-west. Its concrete foundation piers are cylindrical, suggesting construction using cardboard tube formwork which may indicate a later date of construction than the other sheds. The frame is typical, similar to the Museum shed. A pair of hinged doors with iron strap hinges is in each gable-end. Roofing is metal panels. The interior floor is dirt.

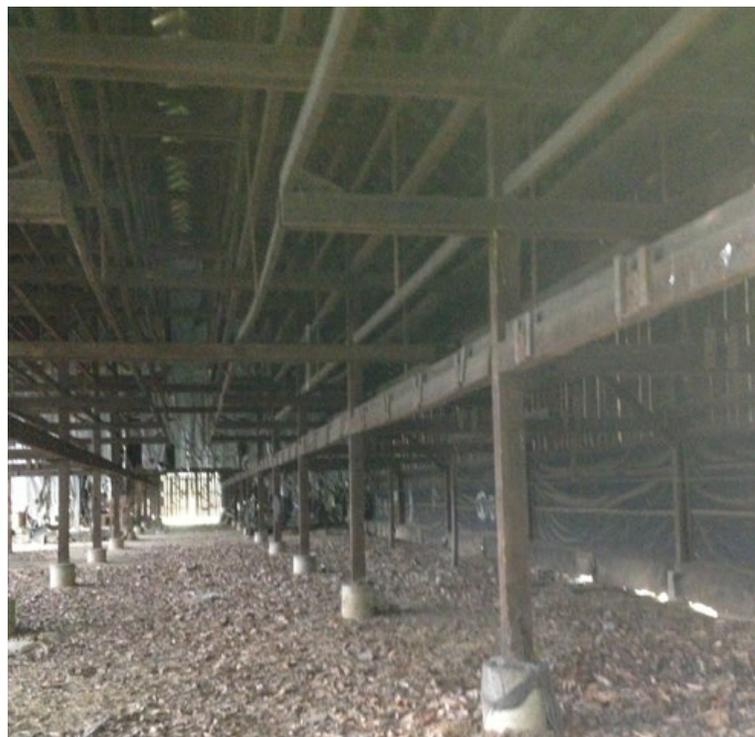
24. Interior view of Field barn I, camera facing west.

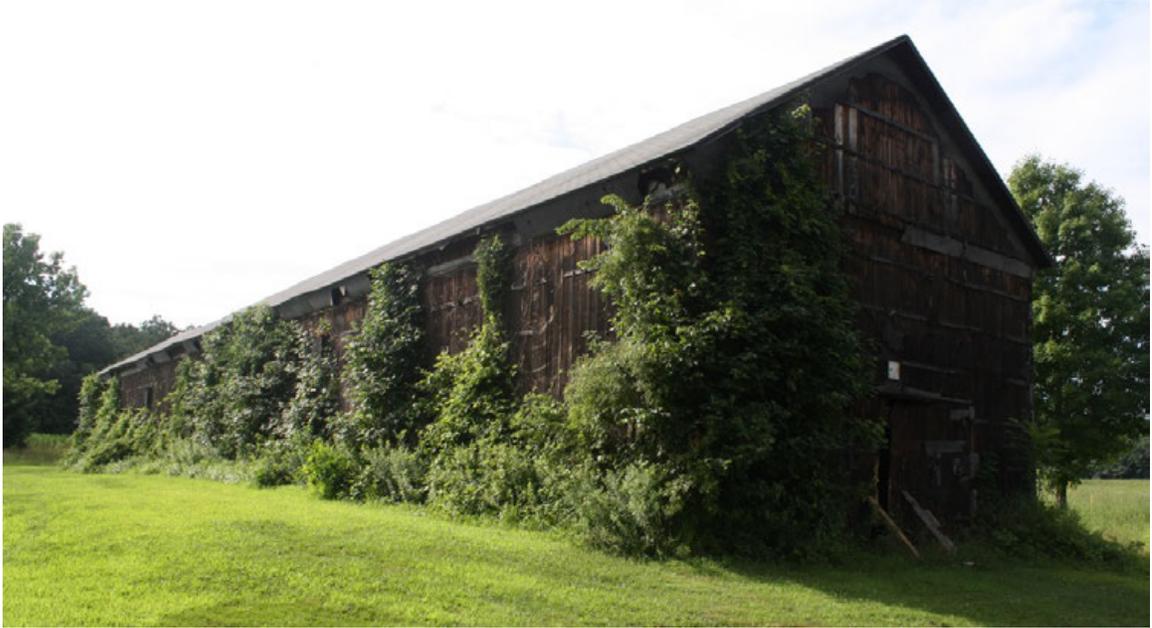
25. Southeast view of Field barn II, camera facing northwest.

This shed is located in a mowed field (formerly a tobacco field) along the northern extension of Land Road, near the Brookside trailhead, and has its ridge-line oriented east-west. It is a ten-bay two-aisle shed, with a single interior post at each bent. A pair of hinged doors is located in each gable-end. Roofing is asphalt shingles. The vertical wood siding and eaves have been covered with tar-paper or a similar sheet material; this has mostly worn away. The interior floor is dirt.

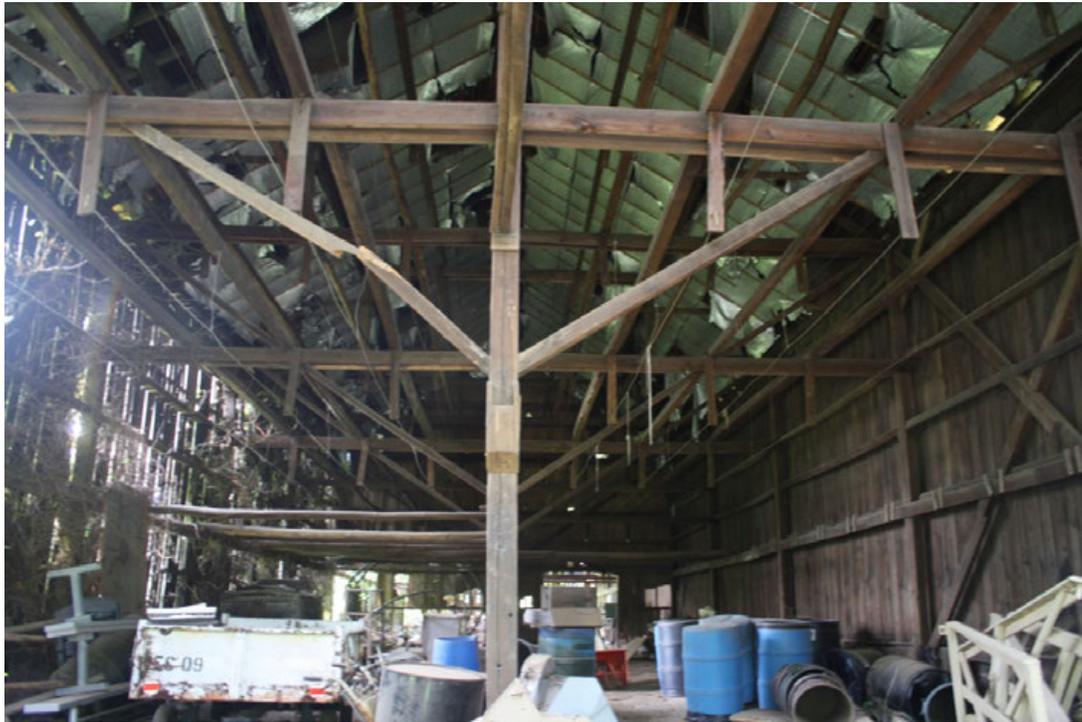
27. Interior view of Field barn II, camera facing west.

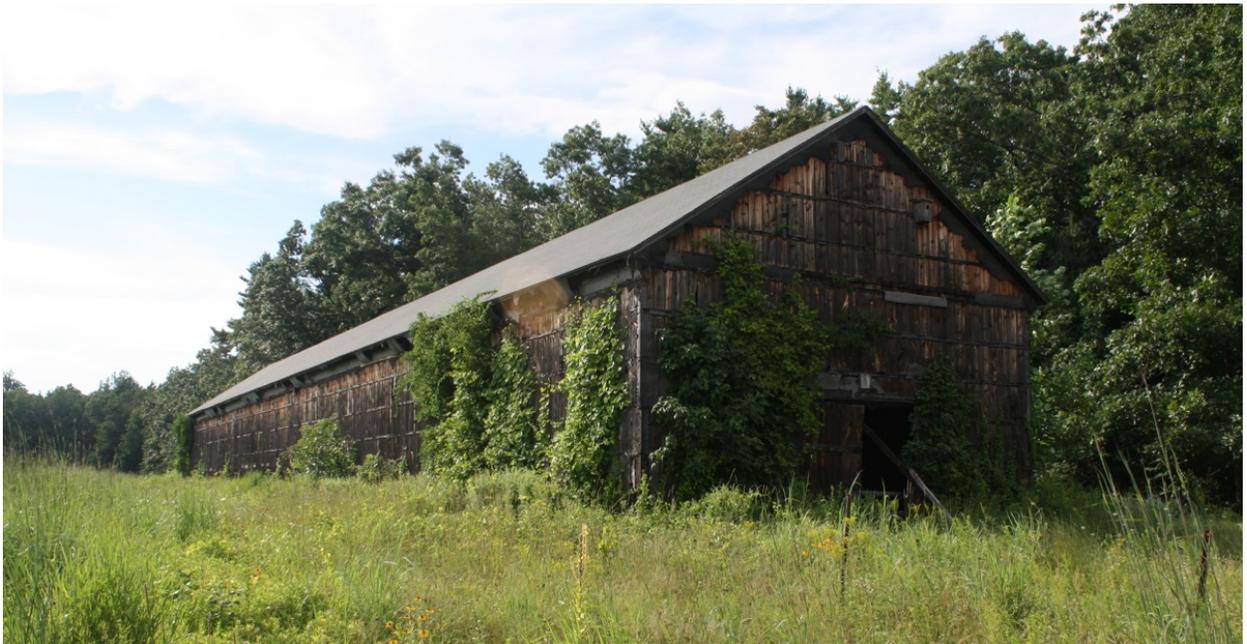
28. Southeast view of Field barn III, camera facing northwest.

This shed is located in a mowed field (formerly a tobacco field) along the northern extension of Land Road, near the Softwood trailhead, and has its ridge-line oriented east-west. It is a twelve-bay two-aisle shed, with a single interior post at each bent. A pair of hinged doors is located in each gable-end. Roofing is asphalt shingles. The vertical wood siding and eaves have been covered with tar-paper or a similar sheet material; this has mostly worn away. The interior floor is dirt.

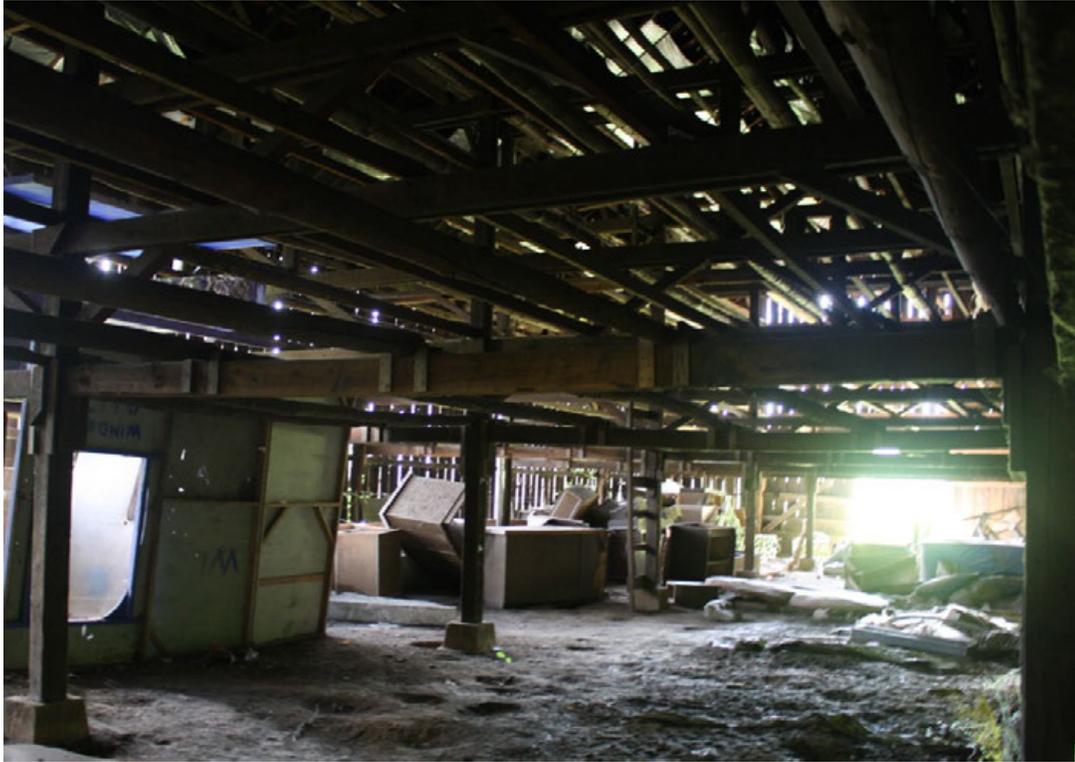
29. Interior view of Field barn III, camera facing southwest.

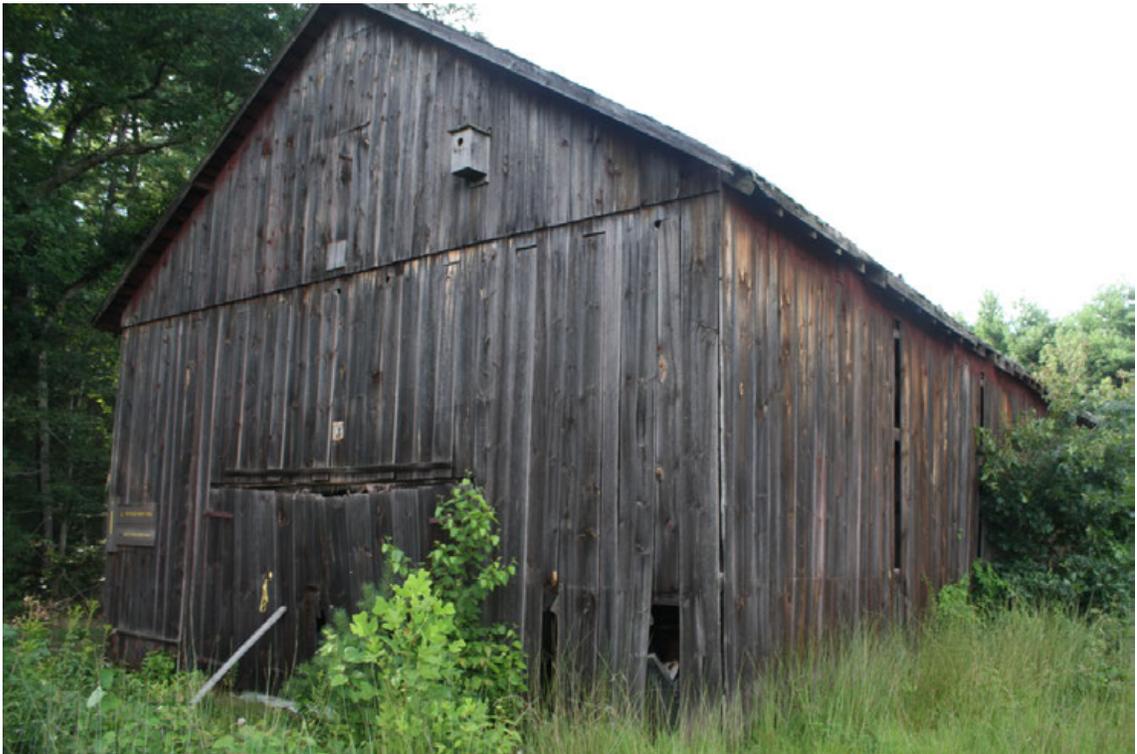
30. Southeast view of Field barn IV, camera facing northwest.

This shed is located further north of the previous pair and sits with its ridge-line oriented north-south at the edge of a wooded area so the east eave-side faces an open field and the west and north sides are adjacent to woods. It is an eleven-bay two-aisle shed structure with truncated pyramidal concrete foundation piers. The framing is typical. Large openings in the east side and the north gable-end no longer have doors extant. The vertical wood siding, formerly painted but faded except for traces of paint on the west side, has extant hinges and fasteners for its venting system, of the top-hinged vertical slat type. Roofing is an old type of interlocking asphalt shingle, with some missing sections. The interior floor is dirt.

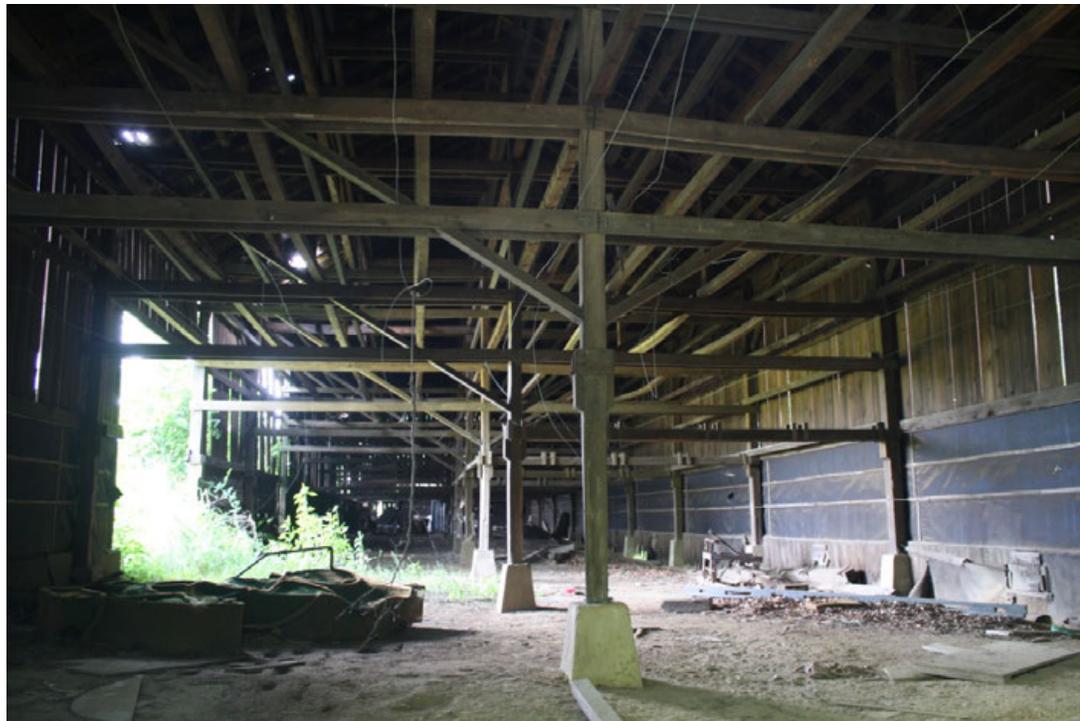
31. Interior view of Field barn IV, camera facing south.

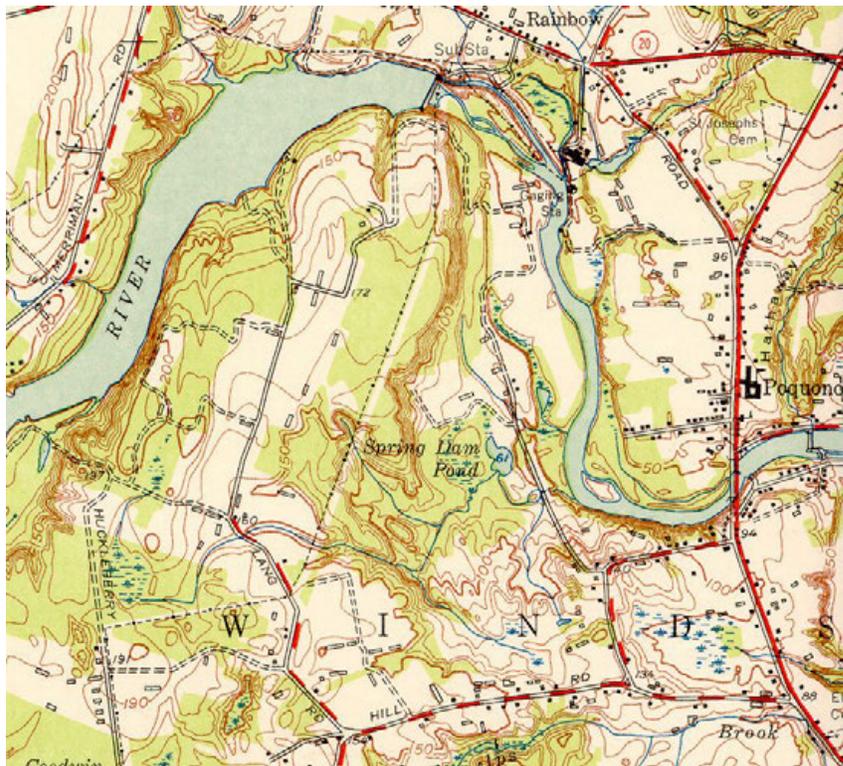
34. Detail from 1953 USGS map; note the tobacco sheds shown by open rectangles. Five sheds shown are no longer extant, while nine are still standing.
